Collision between two Formula 4 powerboats resulting in serious injury to one driver at Stewartby Lake on 2 July 2017

SUMMARY

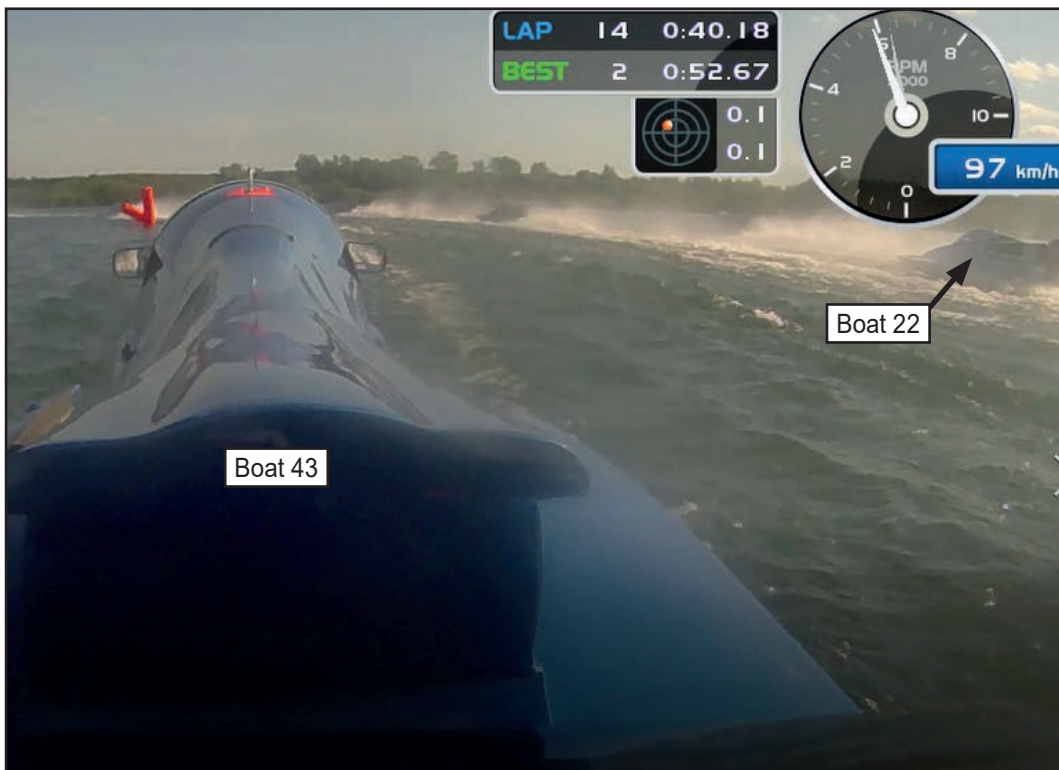
Shortly after the restart, at about 1709, *Boat 22* rounded Turn-1 on the outside and just ahead of *Boat 43* (**Figure 3**). As *Boat 22* began to straighten and head toward Turn-2 it suddenly veered violently to port and into the path of *Boat 43*. Travelling at a speed of 100km/h (62mph), *Boat 43* collided head-on with *Boat 22*'s port hull (**Figure 4**). The force of the impact caused *Boat 43* to flip into the air, roll to starboard and capsize. *Boat 22* remained upright but its port hull was holed and it began to sink. The OOD saw that an incident had occurred, raised a yellow flag and despatched the safety boats to the scene.

Figure 3: Picture from *Boat 43* onboard camera having just rounded Turn-5 with Turn-1 buoys visible

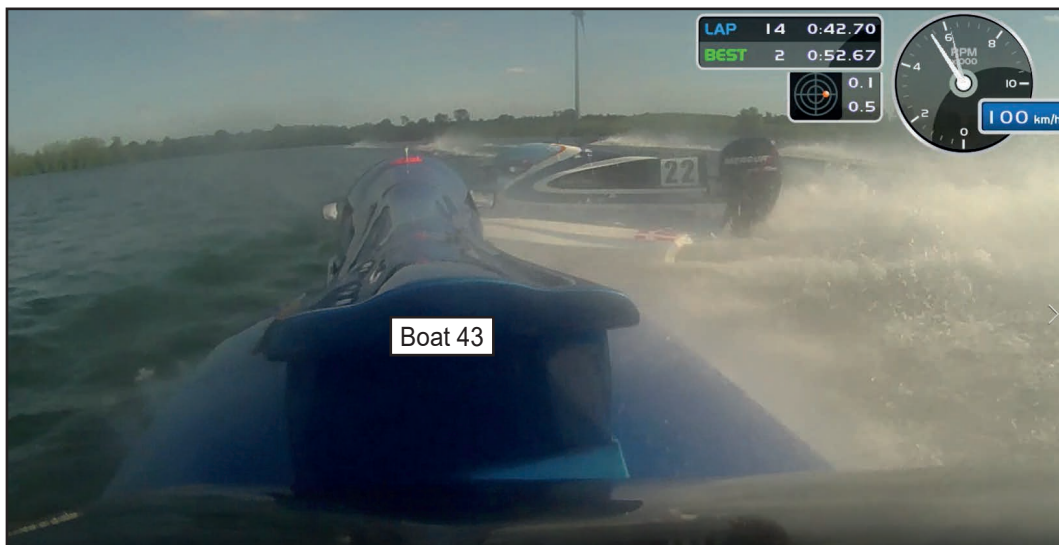
Figure 4: Picture of *Boat 43* and *Boat 22* immediately prior to collision

The collision occurred because *Boat 22* veered suddenly into the path of *Boat 43* and neither driver had time to react. *Boat 22* was not deliberately steered towards *Boat 43* and its steering control system did not fail. Footage captured by *Boat 43*'s engine-mounted video camera showed that *Boat 22* was crossing the wake of another boat just before it veered to port. The video footage also indicated that the hull panel recovered from the water after the accident came loose at the same time.

It was not possible to determine why the hull panel broke free; the two most likely reasons were contact with debris in the water or structural fatigue failure. Whatever the reason, the drag generated during the detachment was the most likely cause of *Boat 22*'s sudden change of direction. Thereafter, given the speed and proximity of *Boat 43*, the collision between the two powerboats was unavoidable.

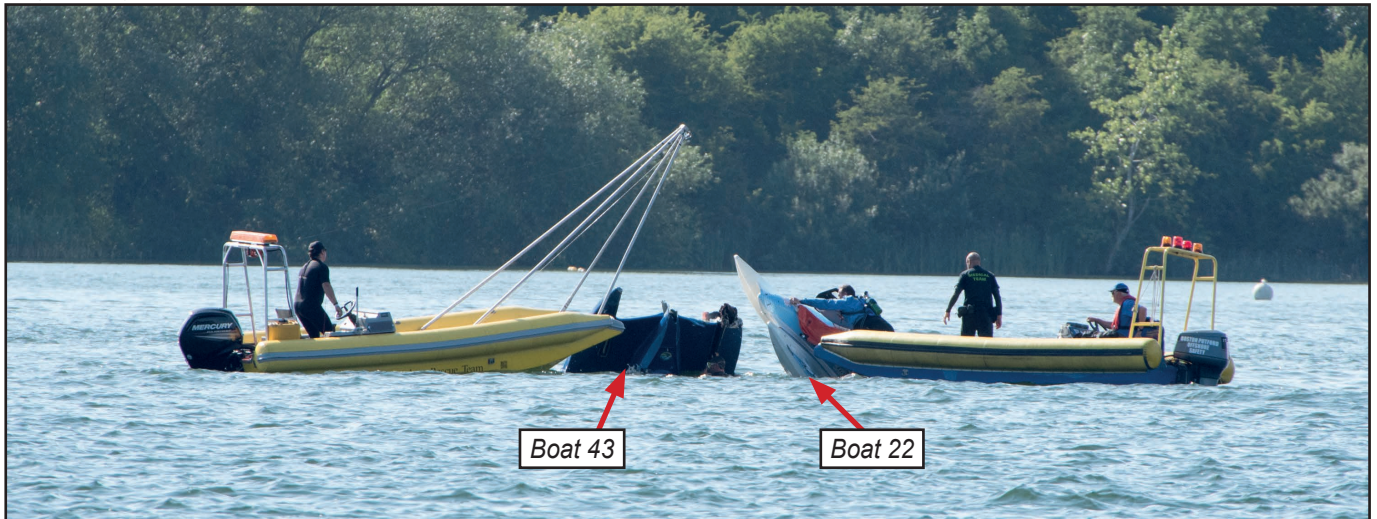
Within 40 seconds of the collision, two safety boats were at the scene and rescue divers were in the water (**Figure 5**). When the rescue divers looked through *Boat 43*'s canopy they saw its driver strapped in his seat and breathing from his emergency air supply. One of the rescue divers, positioned close to the bow, tried unsuccessfully to open the canopy using its main release handle. He then attempted to jettison the canopy but could not pull out its emergency release hinge pin.

Figure 5: Rescue boats arrive at the scene of the accident

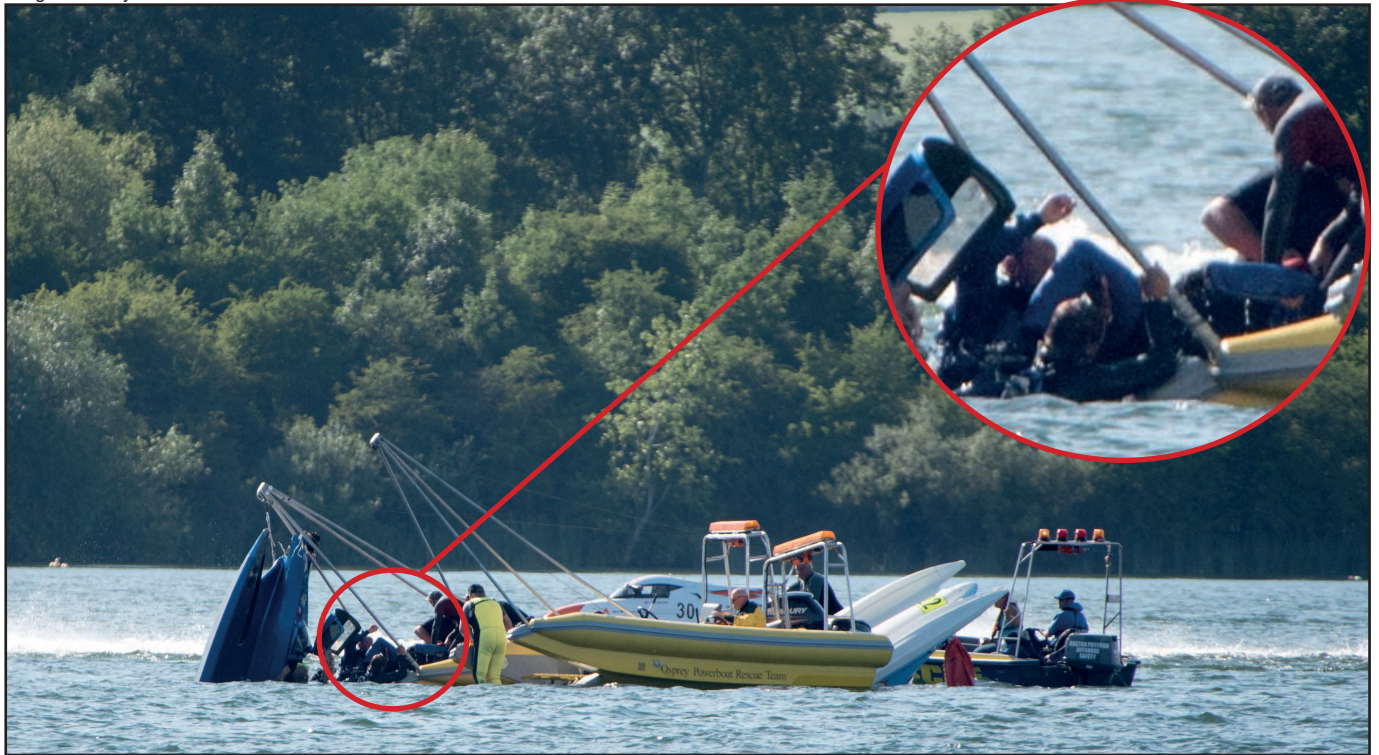
Once *Boat 43* was vertical, with its cockpit clear of the water, the rescue divers located and released the driver's seat harness buckle. About 5 minutes after the collision, the rescue boat crew pulled the unconscious driver into their boat (**Figure 6**); he was not breathing and his airway was full of water.

Figure 6: *Boat 43's* driver being pulled into a rescue boat

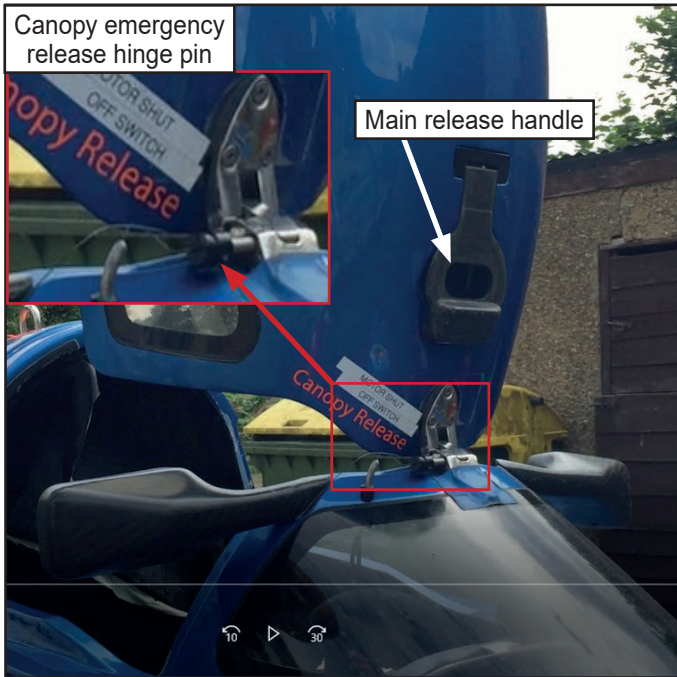
Figure 8: Boat 43's main canopy handle and hinge pin

- The canopy could be opened from both inside and outside the cockpit using the main handle.
- The canopy emergency release pin was a tight fit within the hinge and it required force to pull it out.
- The rim of the steering wheel was deformed, but it could still be removed as intended.
- The driver's carbon fibre seat was cracked; but,
- The cockpit safety cell remained intact.

Further investigation into the cause of the tight-fitting canopy hinge pin revealed that the driver had previously replaced the boat builder's metric-sized hinge with an imperial-sized spare but had retained the original release pin.

The reasons why the rescue divers had problems opening the canopy using its main handle and removing the boat's steering wheel are unclear as both functioned correctly during the post-accident inspections. However, when the divers experienced trouble opening the canopy, they should have been able to jettison it completely by simply pulling out its emergency release hinge pin. Unfortunately, this could not be done because the release pin had formed a tight fit within the canopy hinge. This situation arose when the driver replaced his boat's original metric-sized hinge with an imperial-sized spare and retained the original pin. Had the correct pin been used the canopy would have been quickly jettisoned, saving the rescue teams valuable time in gaining access to the injured driver.

- An incorrectly sized emergency release hinge pin prevented the canopy from being jettisoned, and cost the rescue divers valuable time gaining access to the injured driver.

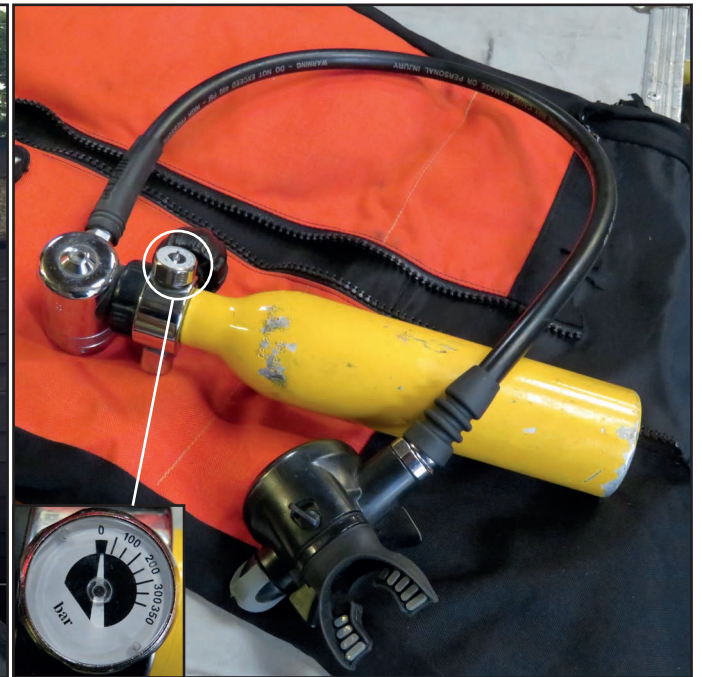
The emergency air supply allowed the driver to breathe while escaping from an immersed cockpit. The UIM rules for offshore racing required a minimum air duration of 10 minutes; a minimum duration for circuit racing had not been set. *Boat 43's* driver had a 0.7 litre portable air cylinder (**Figure 9**) that he had attached to the bottom of his seat. His son's boat was fitted with a 1.5 litre air cylinder that was connected to his racing helmet and released air automatically when the helmet was immersed in water. *Boat 22* was equipped with a portable 1.5 litre air cylinder. All three air cylinders were charged to about 170bar. The design working pressure of *Boat 43's* air cylinder was 232bar (this was stamped on the neck of the cylinder).

Figure 9: Boat 43's air cylinder with (inset) close-up of the air bottle gauge

In the absence of a clear requirement, it was evident that the F4 drivers were equipping their boats to differing standards. Interestingly, *Boat 43*'s driver had provided his 17-year-old son with a hi-tech emergency air supply system that had more than twice the capacity of his own. This demonstrated a high level of confidence, based on experience, in his own ability to self-rescue. This was supported by the fact that he did not charge his air cylinder to its full design pressure. Using an air consumption of 60 litres per minute set by UIM offshore racers, it is likely that *Boat 43*'s driver's air supply of 0.7 litre at 170bar would have lasted no longer than 2 minutes⁹. Had the bottle been fully charged, it would have provided an additional 40 seconds of air.

- *Boat 43*'s driver's emergency air supply cylinder was not charged to its full design pressure. Had it been, he might have escaped or been rescued before he lost consciousness. Had the F4 powerboat carried a 10-minute duration air supply, as required for offshore powerboats, the driver would have escaped unharmed.

- To require the wearing of FHR during immersion training;
- Mandate a minimum onboard air supply of 400 litres, carried in bottles that are at least 2 litre capacity, with sufficient hose to allow the driver to move clear of the hull during the escape.

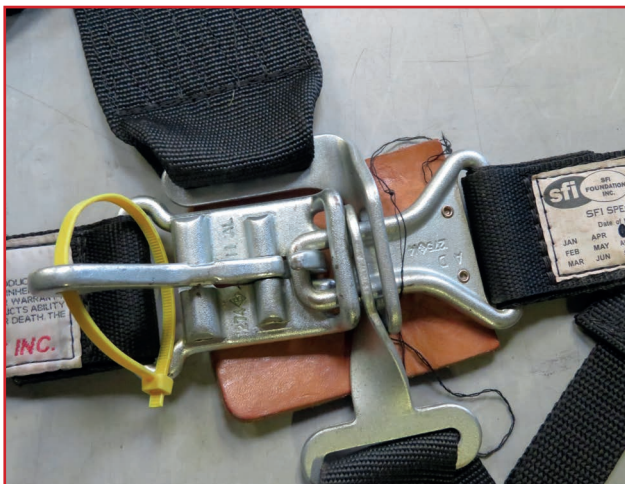
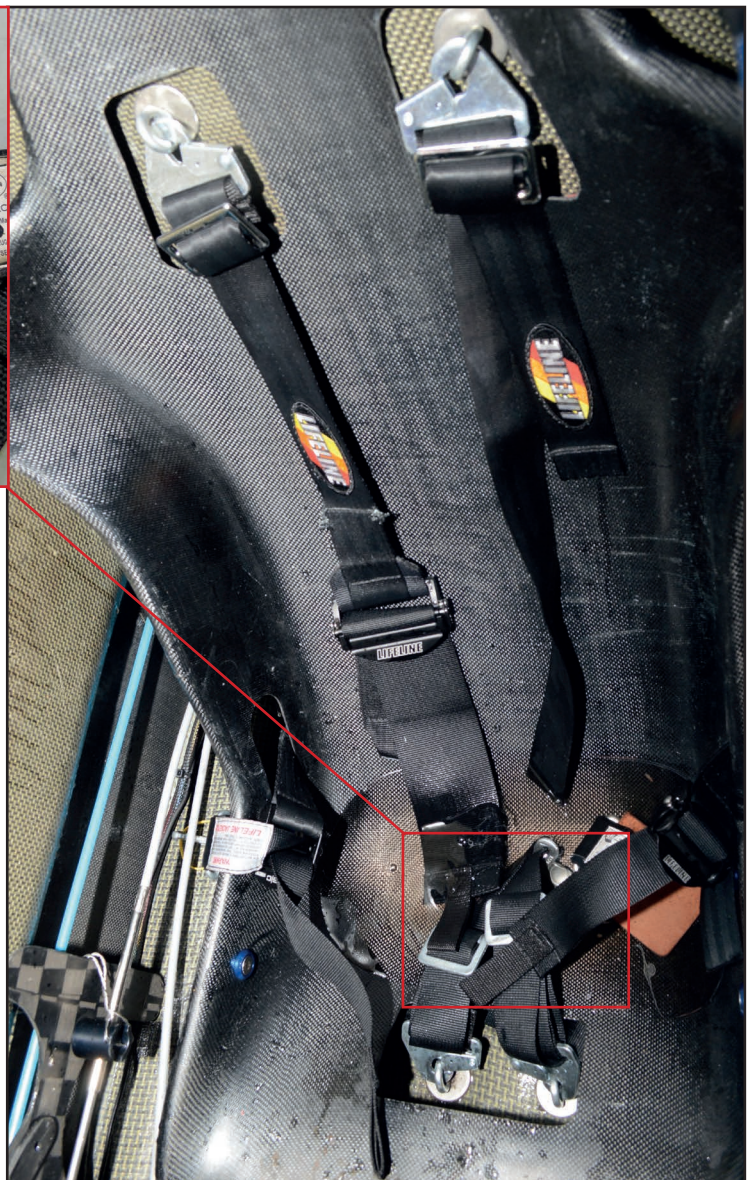
Figure 10: Boat 43 driver's harness with (inset) close-up of harness release and cable tie

- The driver's six-point harness buckle (**Figure 10**) was undamaged and could be operated normally.
- The driver had attempted to cut through a harness seam where the strap was of double thickness and heavily stitched.

It was noted that a cable tie had been fitted to the harness buckle's release lever (**Figure 10 inset**). This was a modification made by many drivers to make it easier to locate and pull the lever with a gloved hand.

The extraction was further delayed because the rescue divers, like the driver, were unable to locate the seat harness release buckle. The release buckle was probably concealed by the abdomen and cell suit of the upside-down driver, and access to it was made more difficult because the rescue divers were unable to remove the boat's steering wheel. The driver had anticipated the difficulty of locating the seat harness release buckle and, to mitigate it, he had fitted a cable tie to the buckle release lever and carried a knife for cutting through the harness straps. On this occasion, the addition of the cable tie did not help the driver or his rescuers locate the harness buckle release lever. Nevertheless, the fitting of a more substantial and visible marker or lanyard to the release lever might have addressed this.

- The rescue divers had difficulty locating the seat harness release buckle because it was obscured by the driver's body and cell suit.
- The carriage of a suitable knife for cutting the driver's harness in an emergency is a sensible precaution.

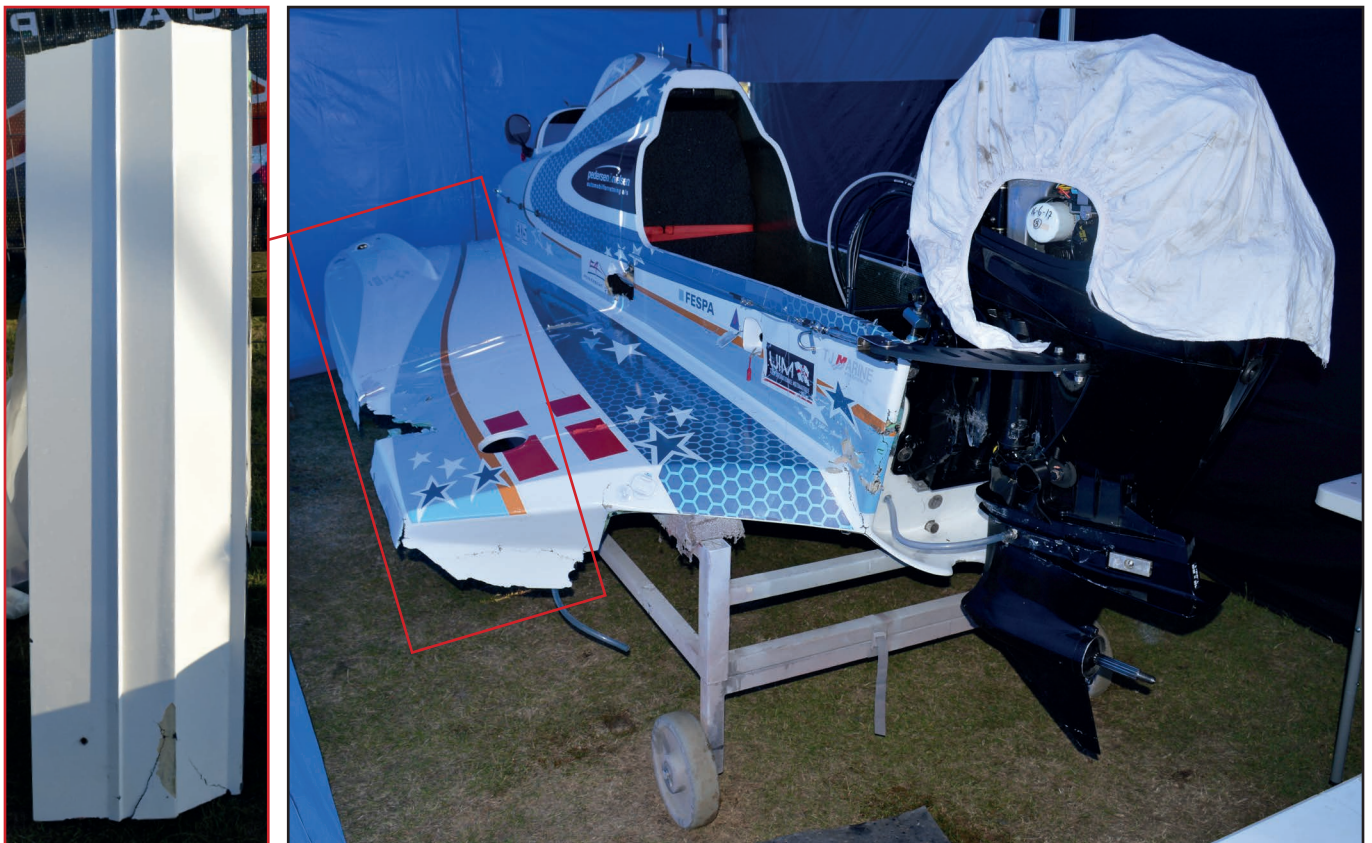
Boat 22's safety cell remained intact and its steering system was found to be functioning correctly during post-accident tests. Close inspection of the port hull identified that a small outer panel from the bottom of the boat, adjacent to the impact area, was missing. This panel (**Figure 11**) was later recovered from the water; it showed no sign of lateral impact.

Figure 11: *Boat 22* showing impact damage to port side and detached hull section

- A structural failure to *Boat 22*'s port hull probably caused it to turn into the path of *Boat 43*. Thereafter, the proximity and speed of the boats meant that the collision between them was unavoidable.

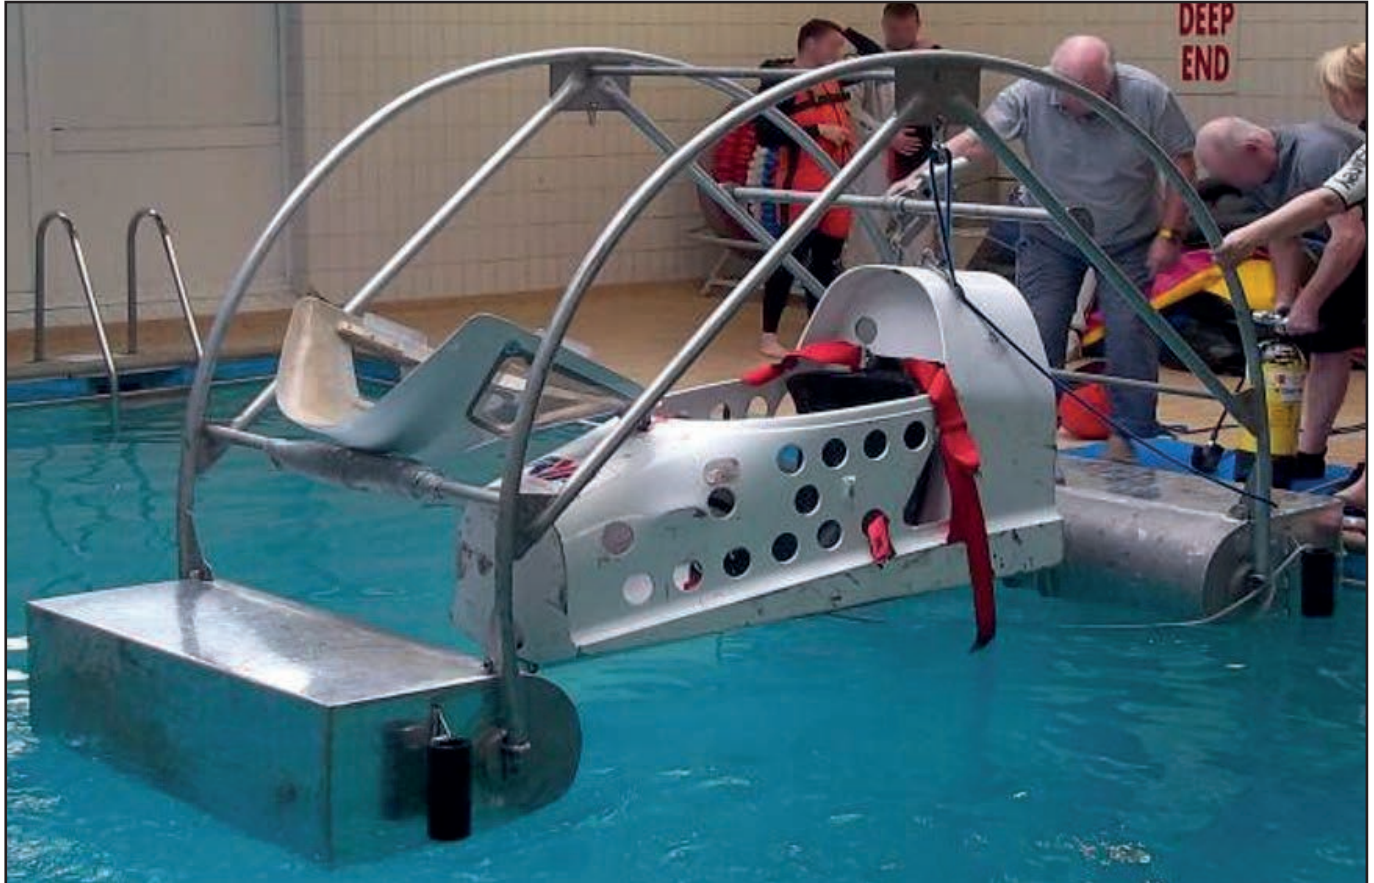
Boat 43's driver undertook his annual tests in the powerboat cockpit test rig (**Figure 12**) at Osprey Powerboat Rescue Team Ltd's (Osprey) training centre. Osprey was one of two UK training providers approved by the RYA to conduct the immersion escape tests.

To pass the immersion test, Osprey required each driver to complete three escapes: the first without using the onboard air supply; the second using the air supply; and the third wearing blackout goggles and using air supply. The escape protocol using the onboard air supply taught by Osprey was as follows:

- Strap into test rig cockpit seat.
- Hold breath as the test rig is tipped over.
- Start breathing from the emergency air supply and await the signal from safety diver to escape.
- Release and open the canopy (using the canopy handle).
- Remove the steering wheel.
- Release the FHR.
- Release the seat harness.
- Place hands on sides of canopy and forward roll out of the cockpit and swim to the surface.

Figure 12: Osprey Powerboat Rescue Team's cockpit test rig for immersion training

- 2018/113** Review the escape protocols taught by its approved driver immersion test centres to ensure they are in accordance with UIM guidance and include lessons learnt from this accident, such as the importance of the emergency air supply, access to harness release buckles and the carriage and use of a rescue knife.
