River Barle, Dulverton, Somerset

An Advisory Visit by the Wild Trout Trust August 2016

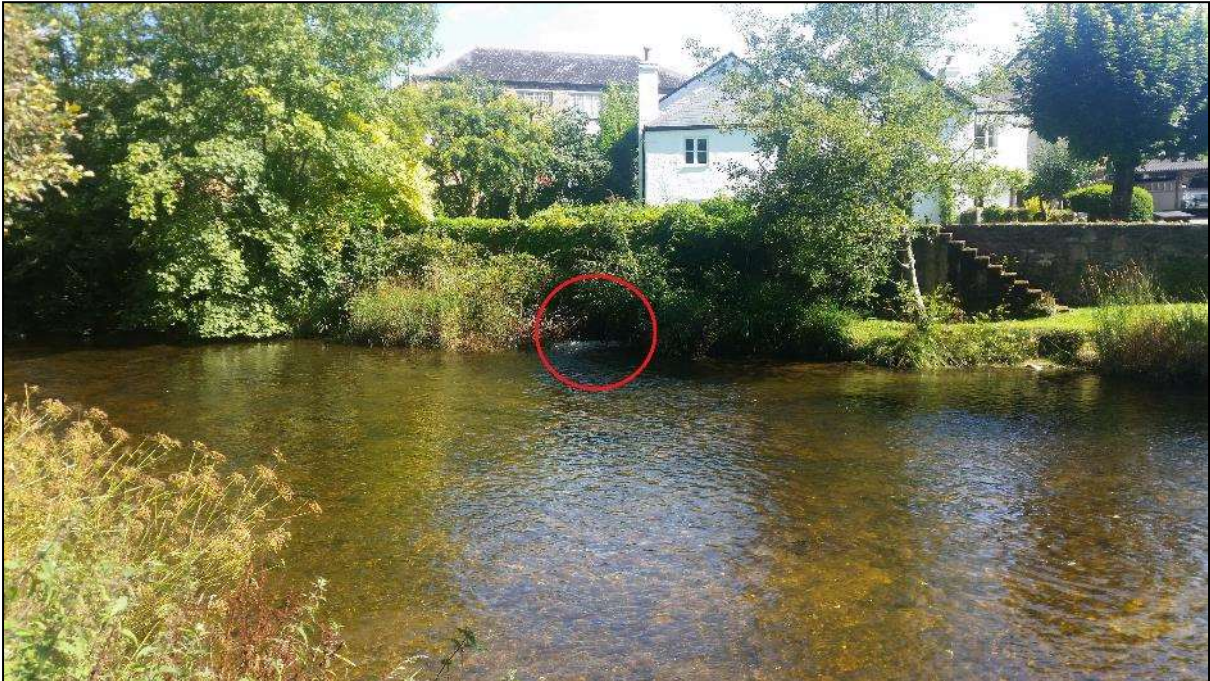
At SS 91245 27734 Dulverton leat discharges back into the main Barle via a small culvert. (Figures 2 and 3).

Figure 2: The outfall of the mill leat (circled in red) where it discharges back into the main Barle

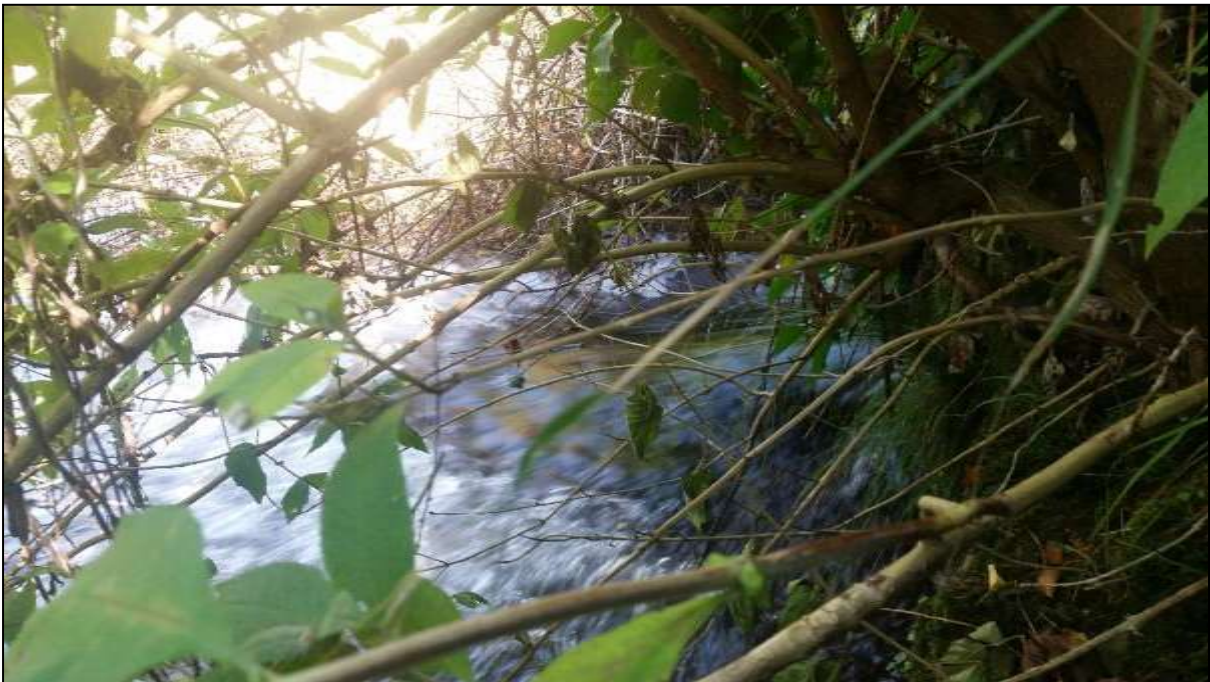
Figure 3: The culvert discharges over a shallow concrete apron

The culvert is relatively narrow and discharges over a concrete apron to prevent the bed from undercutting the hard-engineered bank revetment. Due to the

narrow diameter of the culvert, the flow speed through it is accelerated. Under the flow conditions observed on the day of the visit, the culvert represents a complete barrier to fish passage. Even a strong-swimming adult salmonid would be extremely unlikely to successfully leap into the culvert and maintain a sufficient burst of exertion to then traverse it. When water level in the main Barle is higher, it may be that the culvert is more accessible, however, under such circumstances, it is almost certain that the volume of water discharging through the culvert will also be higher, potentially negating any easing of fish passage.

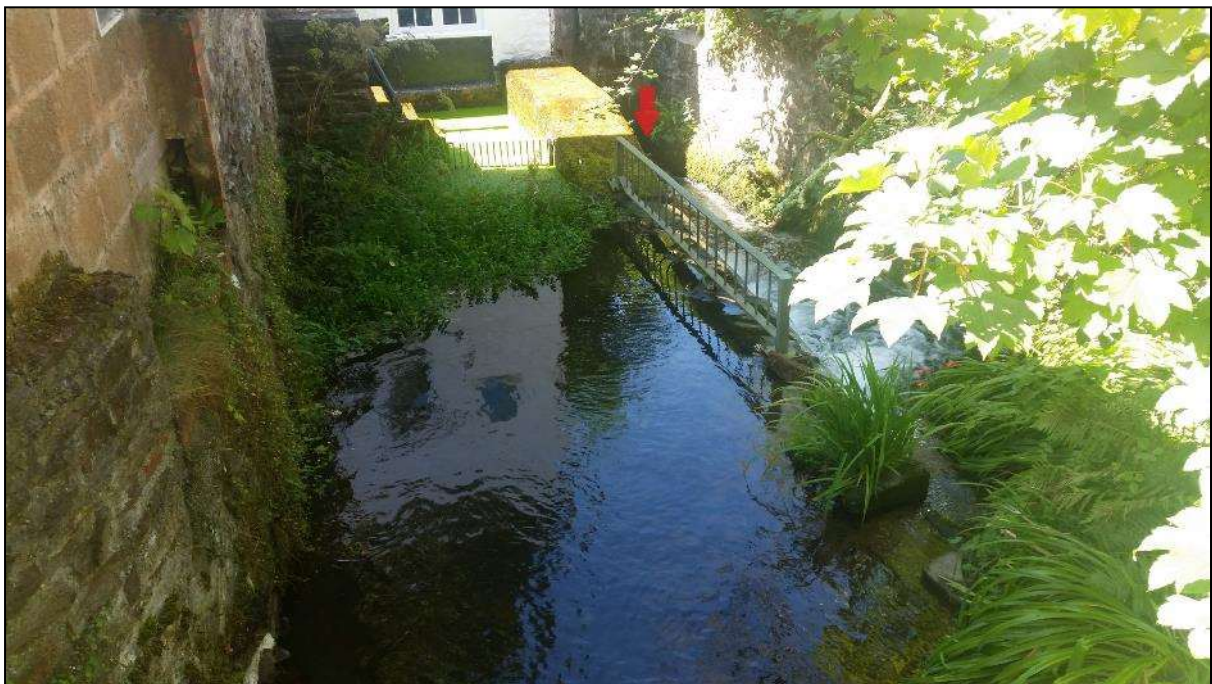
Even if fish are able to traverse the culvert, they are immediately met with another obstacle to overcome, at the remnants of the lowest mill on the leat (now Dulverton Laundry, Figure 4).

To successfully continue upstream, any fish that make it through the culvert will have to pass over the weir and through or around the trash screen affixed on its crest. As with the culvert itself, the weir may be more passable under higher flow conditions when the head drop (the difference in water level above the weir compared to below it) is reduced.

Figure 4: The entrance to the culvert (red arrow) is below an old mill weir

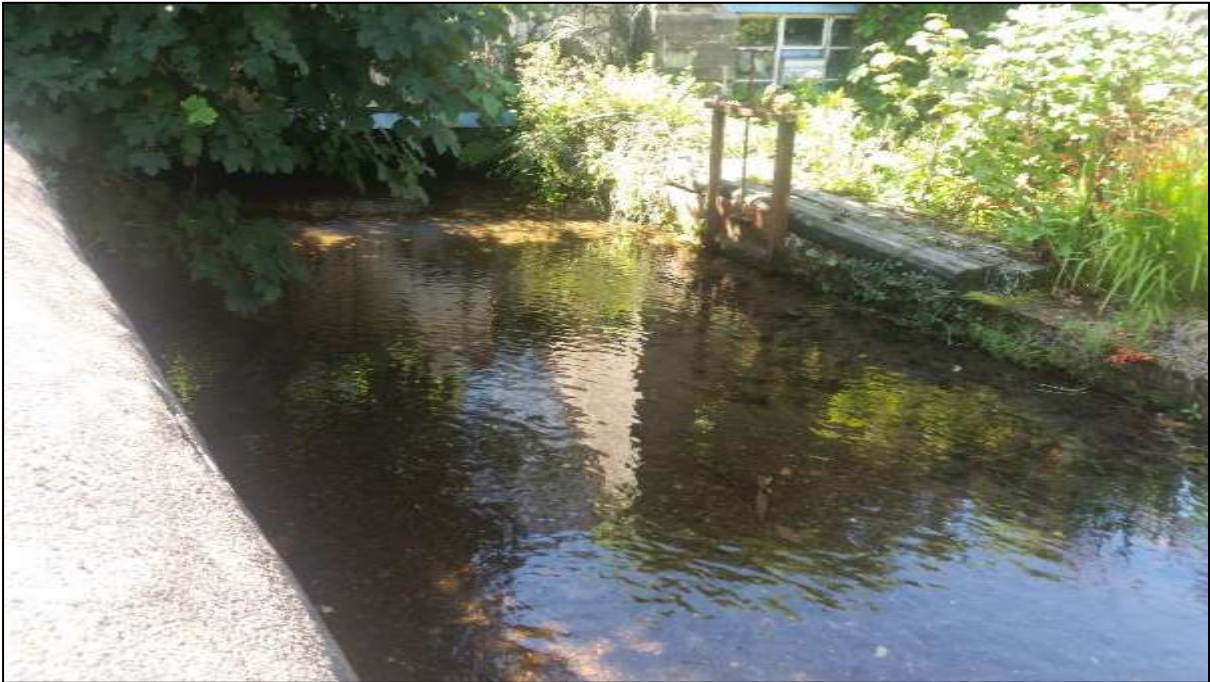
The river upstream is impounded (held up and ponded) by the weir and the bed has reportedly risen over the past few decades (Pers. Comm. Peter Romain). A sluice gate (closed) controls flow through a secondary culvert (dry) that was presumably part of the operation of the mill. The closed sluice and dry culvert are probably what has caused the bed to rise at this location as sediment carried through the mill has steadily dropped out of suspension in the slow, impounded flow above the weir. The interruption of sediment transport caused by impounding structures such as weirs causes fine sediment to drop out of suspension and smother the bed. The result is a uniform, flat and silty riverbed with a significantly

Figure 5: The riverbed above the weir has risen as sediment has accumulated. When the mill was in operation the sluice pictured would have regularly diverted flow through a secondary culvert and flushed the channel

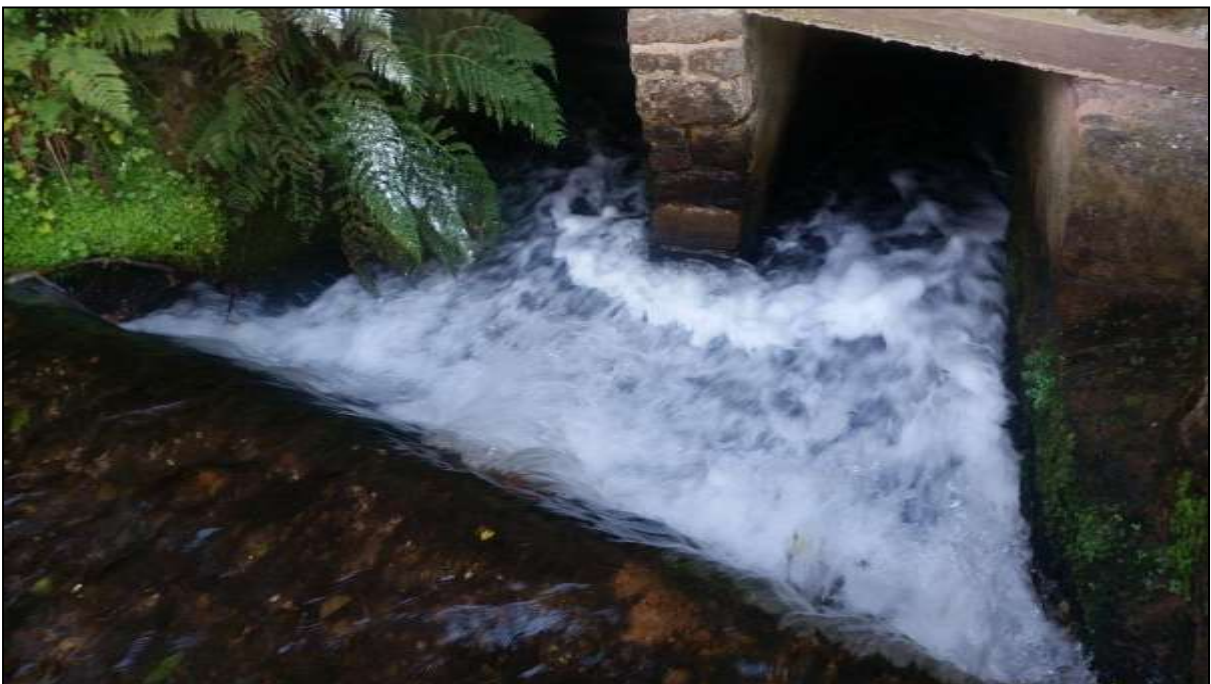
The next mill is just a few metres upstream (Town Mills). Here the leat flows directly under the old mill building. As with the mill downstream, flow above Town Mills was originally split into two channels and controlled by a sluice. This was common practice with many water mills, granting millers the ability control the rate of flow through the mill works. The sluice is now derelict and the majority (but not all) of the flow is carried under the old mill. The culvert under the mill is broad with a natural bed (which is generally good news for fish passage). However, the weir immediately above the culvert is a major barrier to fish passage (Figure 7).

Figure 7: The weir immediately upstream of Town Mills

The fact that the weir is so close to the mill building and culvert also means that it would be extremely difficult to improve fish passage at this location. The weir could be notched to create a low area to ease fish passage but this would require an assessment by a structural engineer to ensure that doing so would not compromise the mill building. Easing fish passage through the other culvert would also be a very difficult undertaking. This culvert has a steep gradient and curves sharply, making working in such a confined space (an already risky option), almost impossible. Other common options, such as de-culverting (excavating), are also unlikely to be feasible at such a historic, and almost certainly listed location.

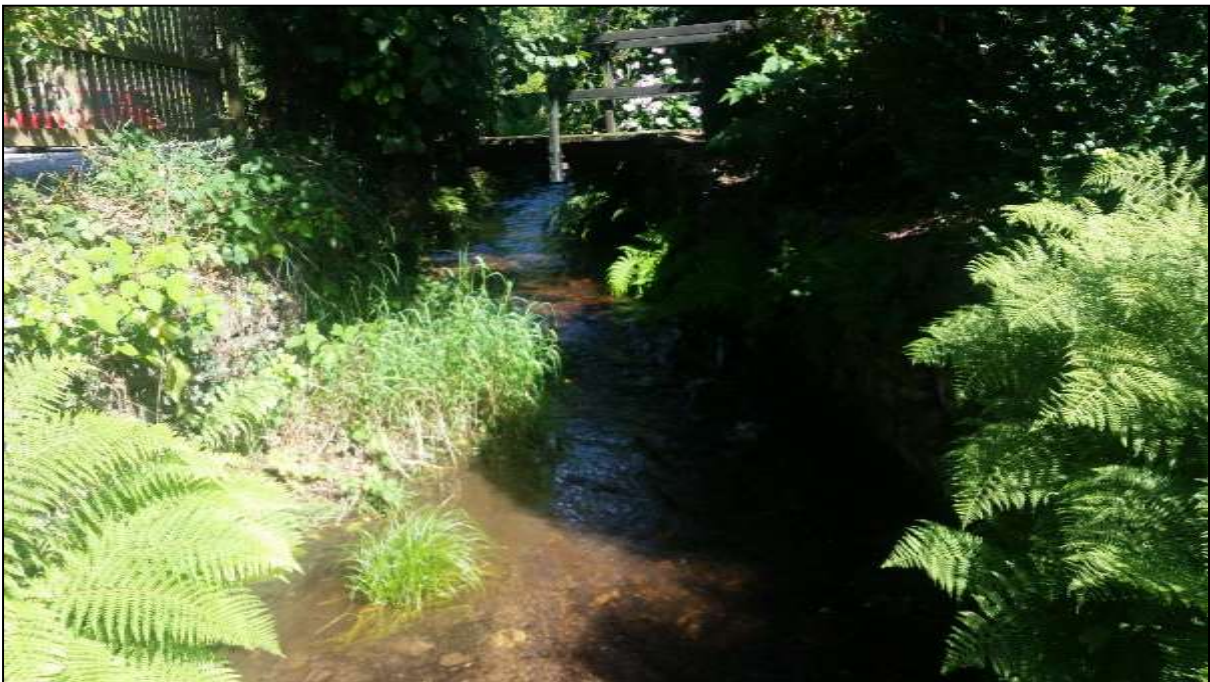
Figure 8: Some good natural features observed between the Heritage Centre and Police Station

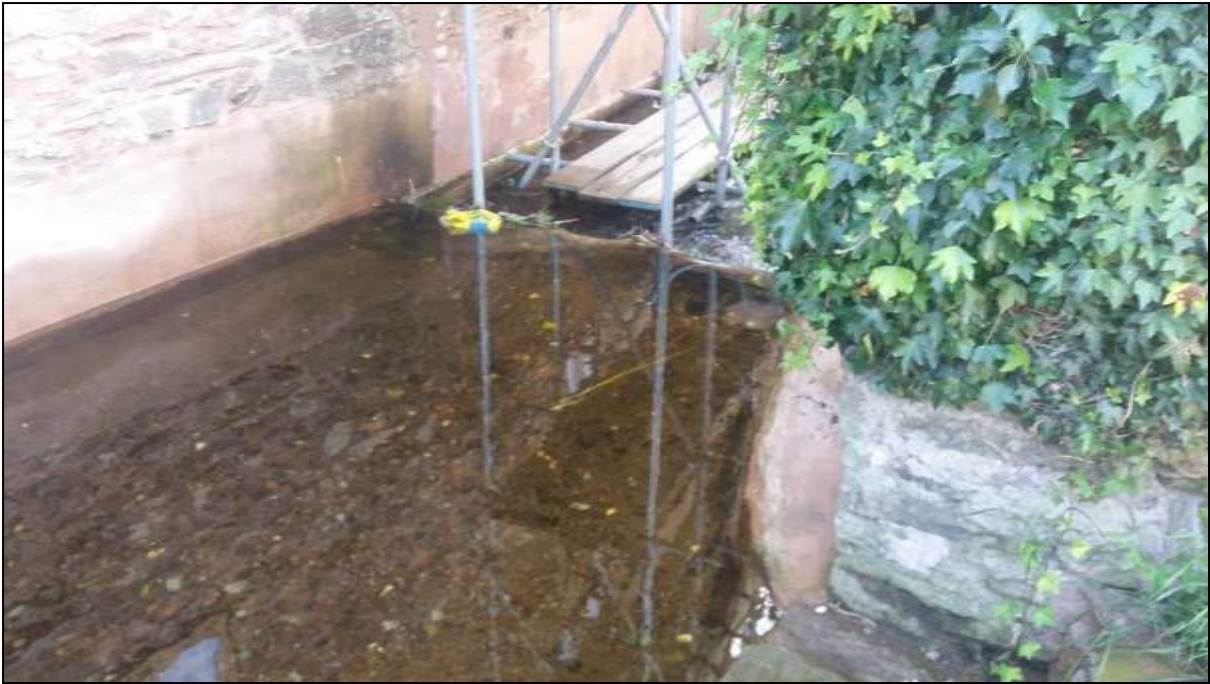
Figure 9: A small stoplog in the river should be removed

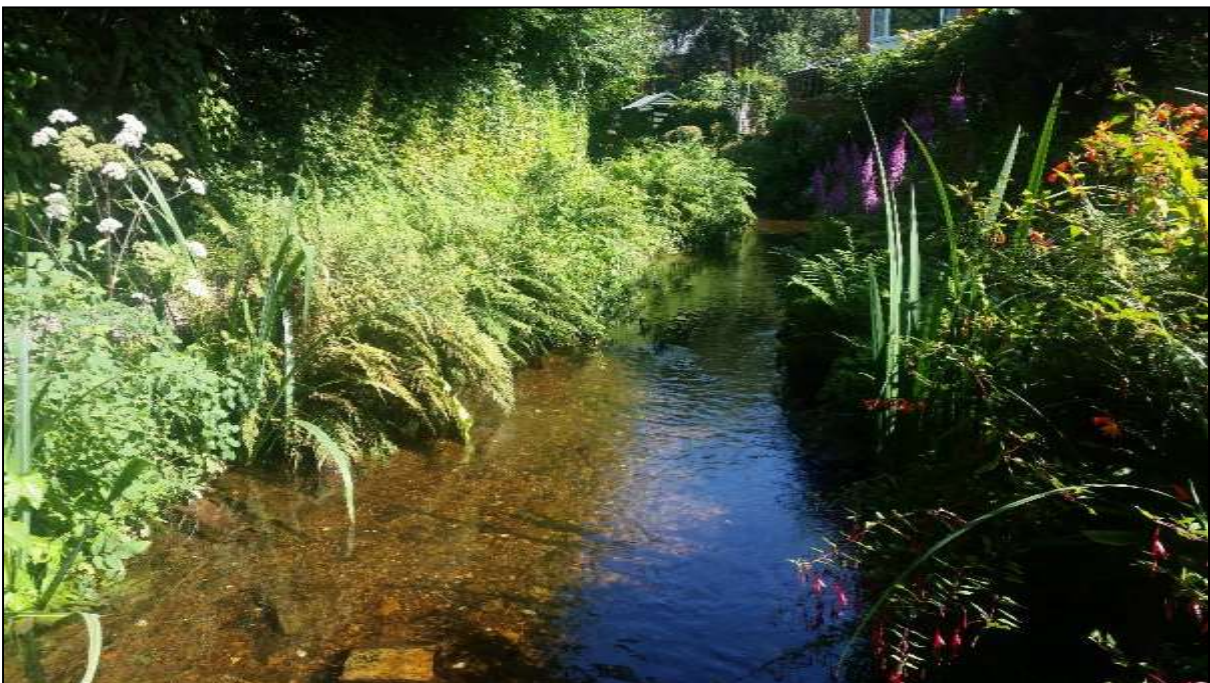
Figure 10: Marginal plants, even if not necessarily true marginal wetland species, provide good cover habitat

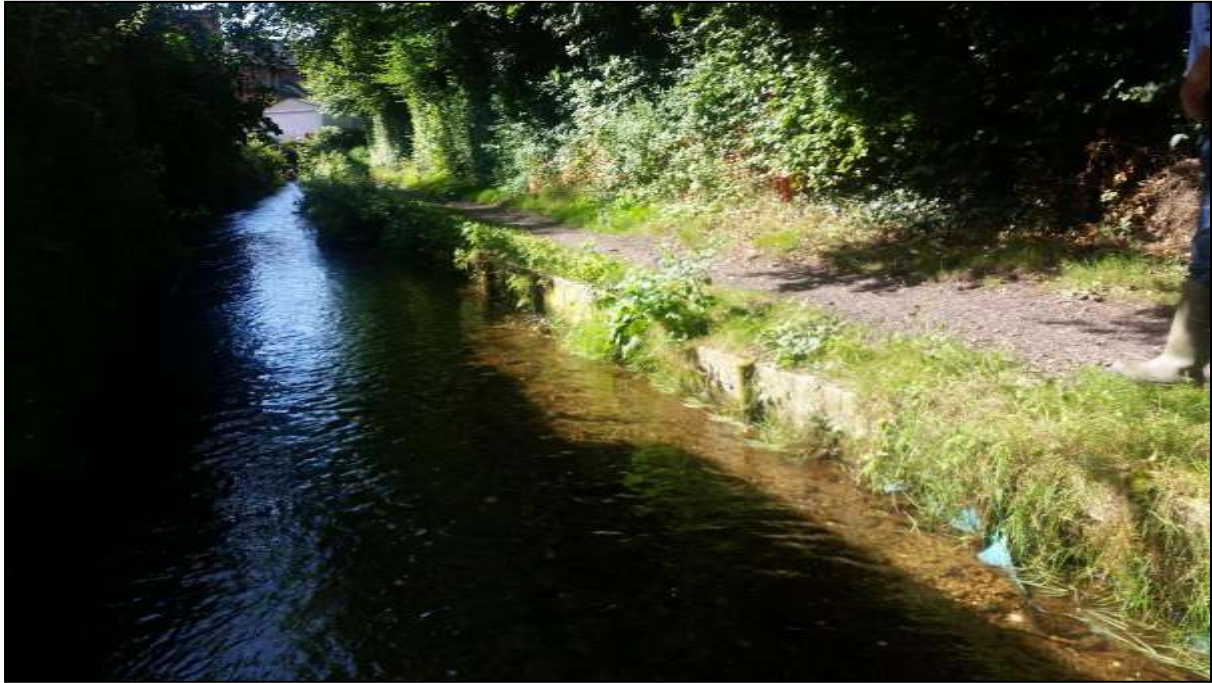
However, for most of this reach the RB consists of vertical timber shuttering (Figure 11) which denudes the stream of marginal habitat and significantly limits biodiversity. Occasionally, a clump of vegetation has established in front of the

shuttering, which helps to soften the hard edge and provide some degree of marginal cover but the reach could be significantly improved by replacing the shuttering with a softer medium in which a greater diversity of marginal plant species could establish and thrive.

Figure 11: Wooden shuttering inhibits marginal habitat

1. Replace the toe board shuttering along the public footpath between Lady Street and the Heritage Centre with a soft-engineered and diverse margin of true marginal wetland plant species. There are a number of techniques that could be employed to achieve this and a number of specialist soft-engineering/river restoration companies that can supply and install such features. Perhaps the most cost-effective option is to make use of locally-won brushwood arising from 'skylighting' tree works to create a narrow brushwood shelf (Figure 24 and as described on page 13). These features act as silt traps, slowing flow through them and encouraging fine sediment to drop out of suspension. Given sufficient time and afforded sufficient sunlight, the silt-laden brushwood will

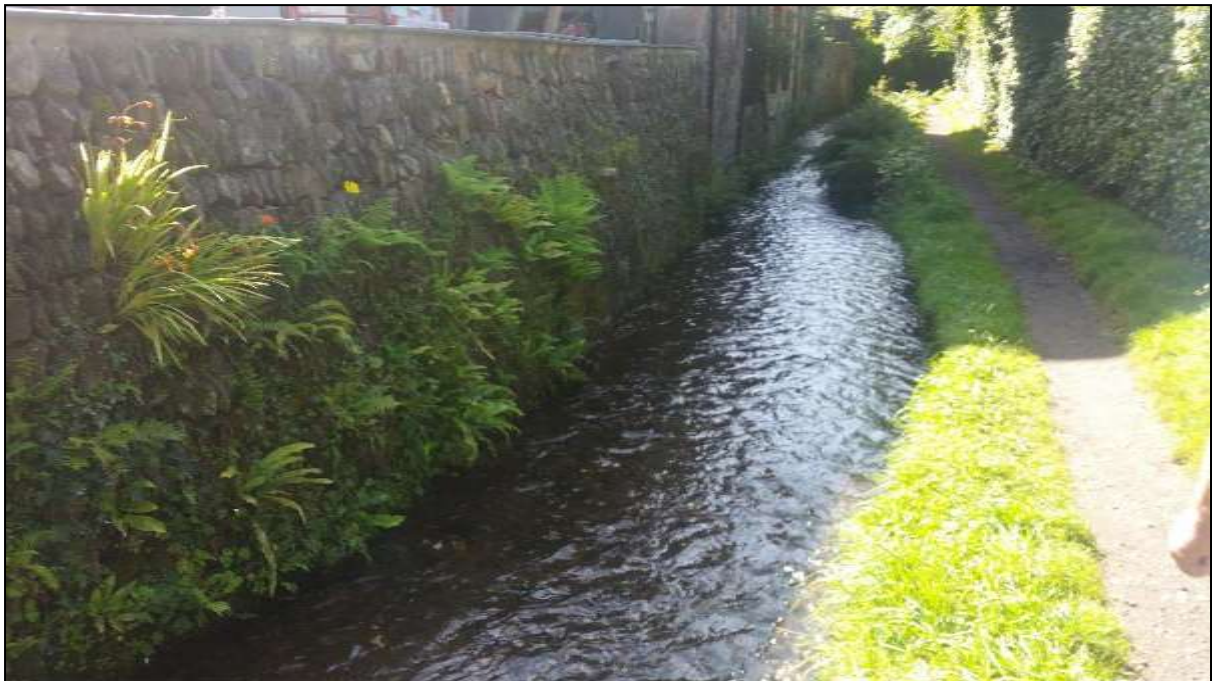
The LB throughout this reach consists mainly of a tall, vertical stone revetment at the rear of the Lady Street properties (Figure 12).

Figure 12: The tall wall on the LB colonised by a few ferns but otherwise providing very little habitat

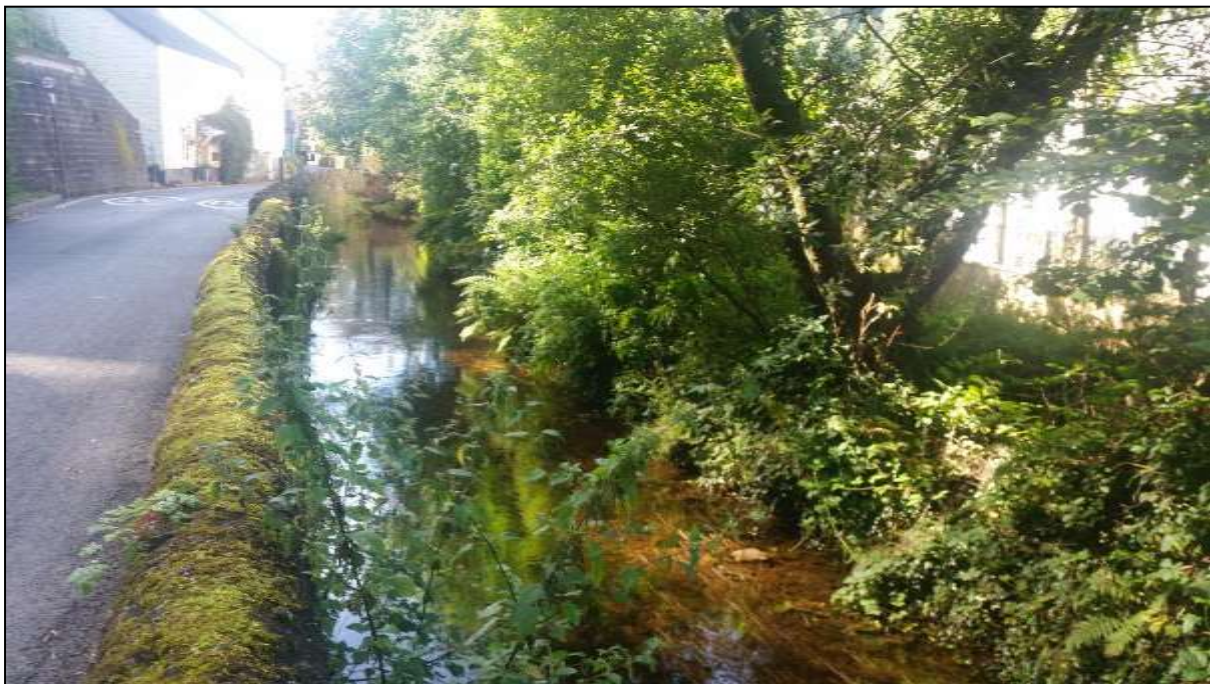
Upstream of the reach with the footpath, the leat flows alongside Northmoor Road. Both banks of the leat are hard-engineered vertical revetments offering very little refuge habitat. Some low cover habitat is provided by small trees, shrubs and ferns that overhang the river from the RB (Figure 13).

Figure 13: Low overhanging vegetation provides cover and softens the hard-engineered channel

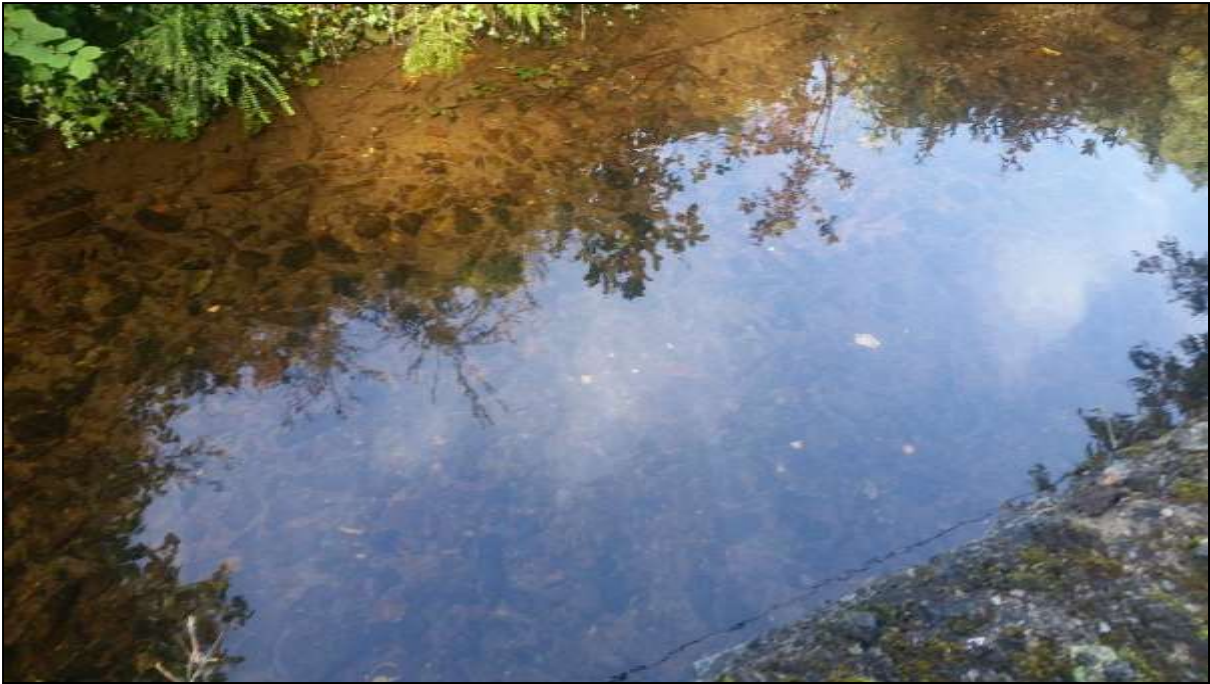
The leat appears to have a more-or-less natural bed but is cobbled in places. It is also possible that it is hard-engineered below some of the natural substrate. The riverbed that is present is compacted and 'armoured' (i.e. consists of a coarse surface layer of large stones over finer material, Figure 14). This occurs as smaller gravel grains are transported away, leaving larger material behind.

Figure 14: The riverbed is cobbled or otherwise armoured in many places.

This armoured and compacted bed is unsuitable spawning habitat for gravel spawning fish like trout, grayling and salmon. Even if fish were able to cut a redd (nest) in the hard bed, the eggs they deposited would almost certainly become smothered in fine sediment and suffocate. The lack of space between the gravels/cobbles, owing to inundation with finer material, also greatly degrades it as invertebrate habitat.

3. Where the bed of the leat is cobbled, armoured or otherwise too hard to penetrate with stakes or rebar, consider improving marginal habitat by introducing stone berms back-filled with gravel and soil. This technique has proved successful elsewhere in the county (Figure 26). Depending on the flow speeds and shear forces experienced in the leat during spate conditions, it may be prudent to fix every third or fourth stone to the bed by drilling into the stone, chemi-fixing a short section of threaded bar into the hole and then drilling another hole in the bed and placing the bar into it. This technique has been used in a concrete channel on a spate-prone section of the River Meon in Hampshire.

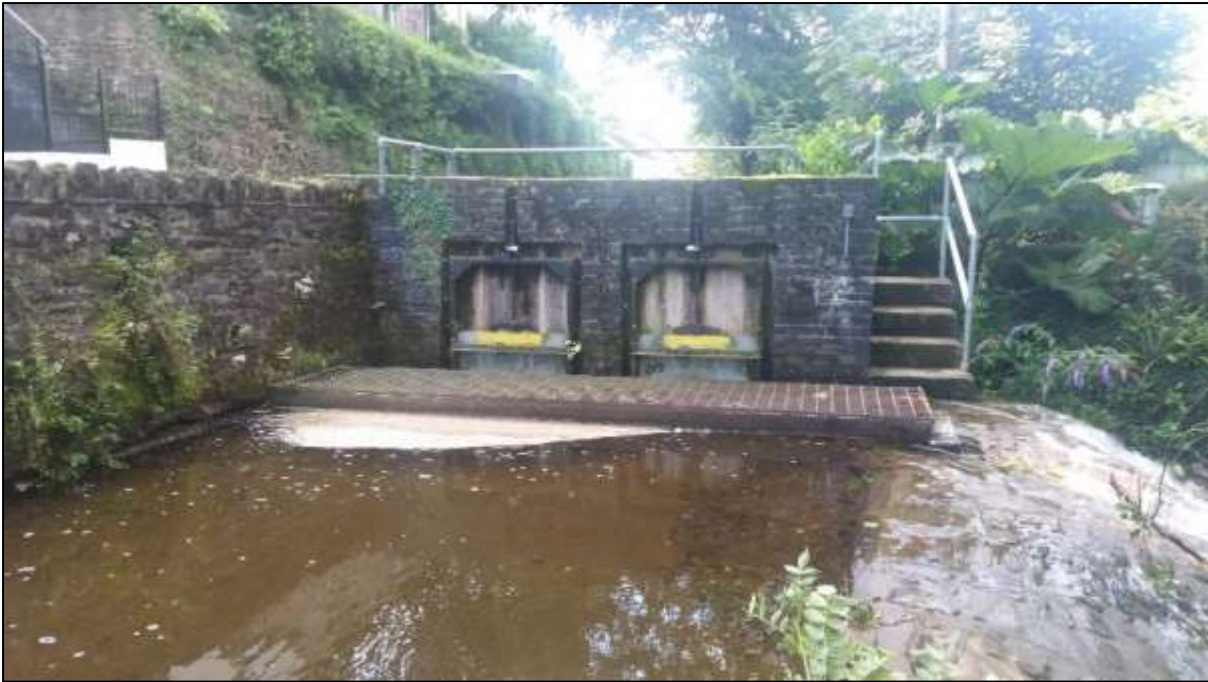
At the head of the leat is a relatively modern undershot sluice (Figure 15). This structure controls what proportion of the available flow is diverted through the leat and what proportion of flow instead flows over the weir. Undershot sluice gates (where water flows beneath the sluice) are better for habitat both in terms of connectivity and quality than overshot sluices (where water flows over the sluice). Fish, invertebrates and other aquatic wildlife can easily pass through the sluice except under very high (and therefore fast) flow conditions. The sluice also allows for relatively natural sediment transport.

Figure 15: An view from upstream of the undershot sluices

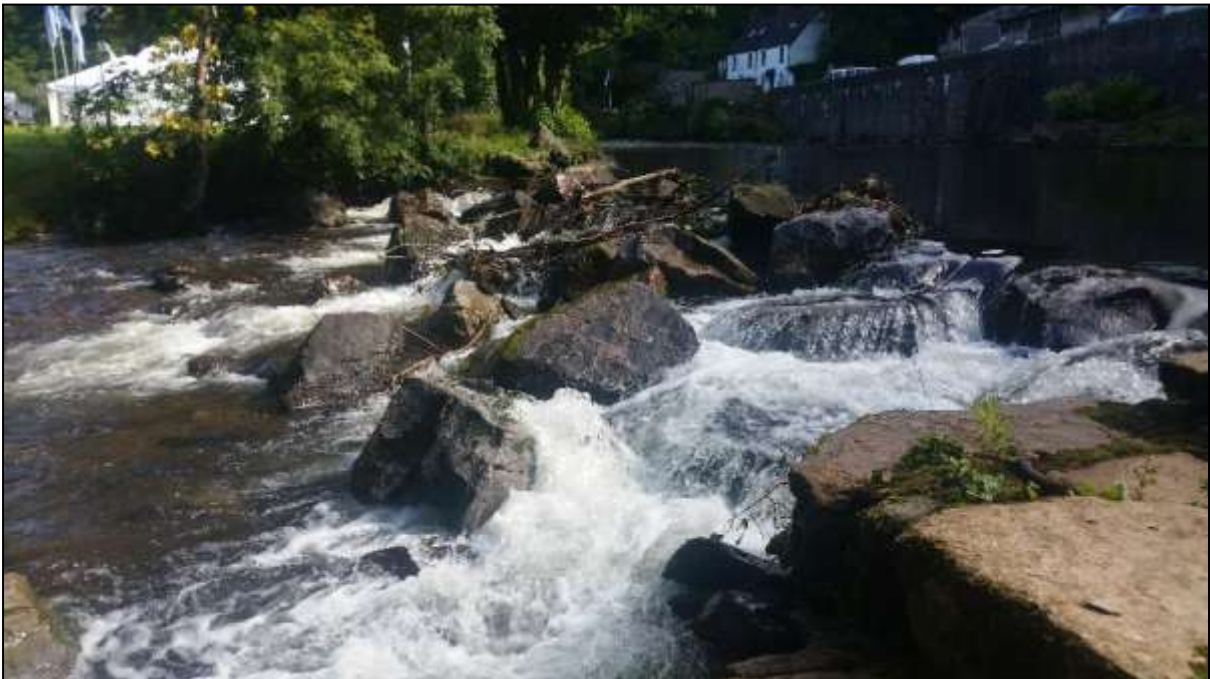
At the RB end of the weir is a 16m long boulder ramp that serves as a 'rock ramp' type fish easement (Figure 16). This type of easement mimics the structural variety of natural rocky 'rapid' features usually found in high energy rivers. These features are relatively passable to fish as the roughness and randomised arrangement of boulders baffle flows and provide an abundance of small 'pockets' where fish can rest. The complexity, diversity and roughness of such features can ease passage for a broad range of fish species including eels. Rock ramp fish easements can reduce problems with attraction flow that hinders the performance of some technical passes but they are often less passable by adult fish at lower flows.

Figure 16: The nature-like fish pass on Dulverton Weir.

5. The existing nature-like fish pass on Dulverton Weir eases passage for a range of species and sizes of fish. This structure should be retained and enhanced if possible. If the restoration of the weir requires a new fish pass to be created, a number of key factors need to be considered

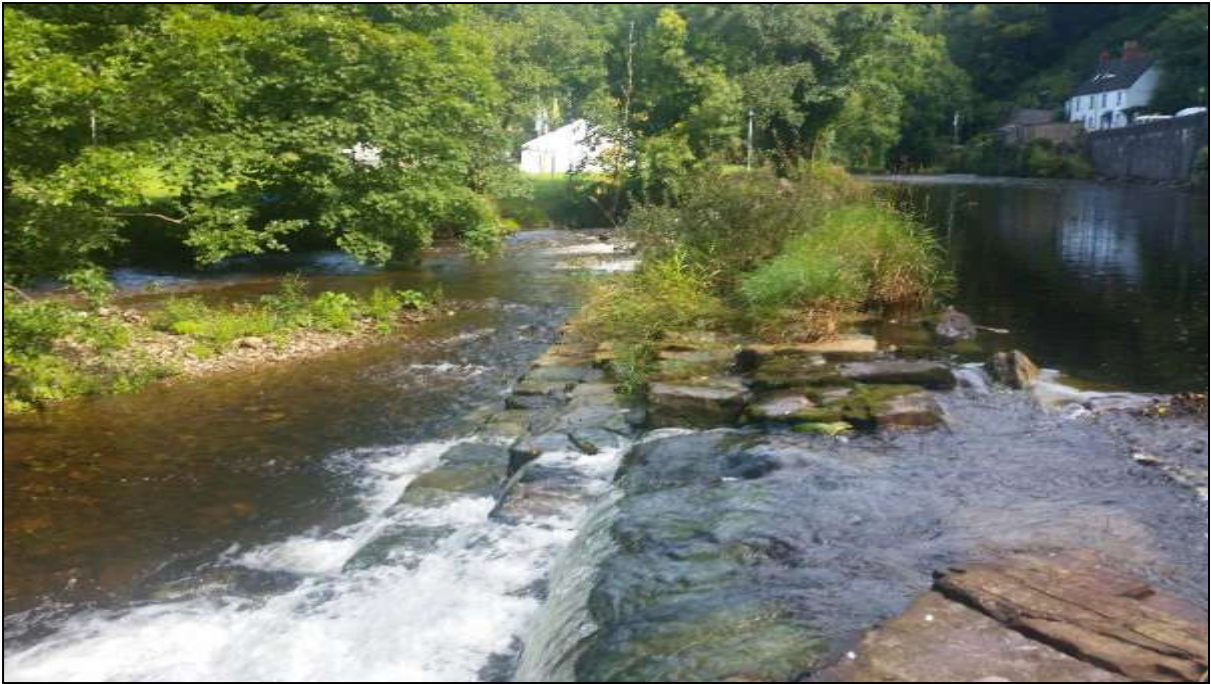
The middle-right 22m section of the weir consists of a modern block stone repair undertaken in 1993 and 2000 (Figure 17). This section is not passable for fish under normal flow conditions but is probably passable to strong-swimming fish under high flow conditions.

Figure 17: The blockstone (middle) section of the weir

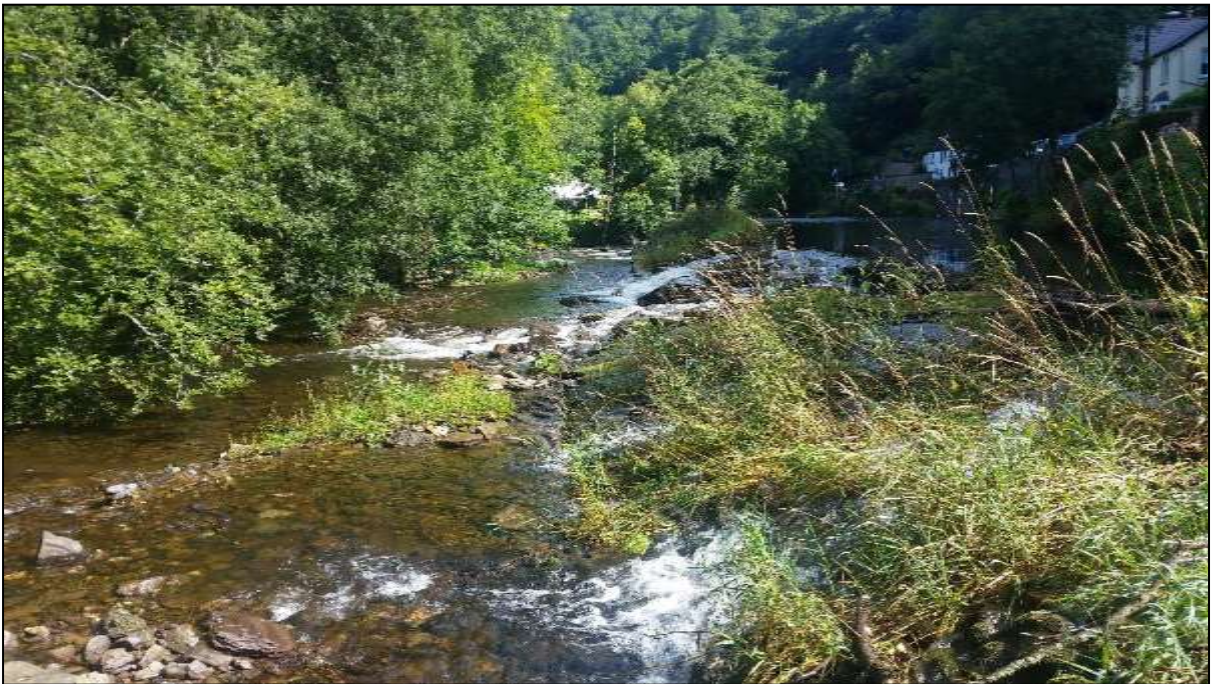
The middle-left 27 metres of the weir consist of the surviving ancient structure constructed from wooden stakes and large, rounded stones (Figure 18). The upper part of the ancient weir is protected by a row of gabions.

Figure 18: The oldest part of the weir constructed from wooden stakes and hand-placed stones.

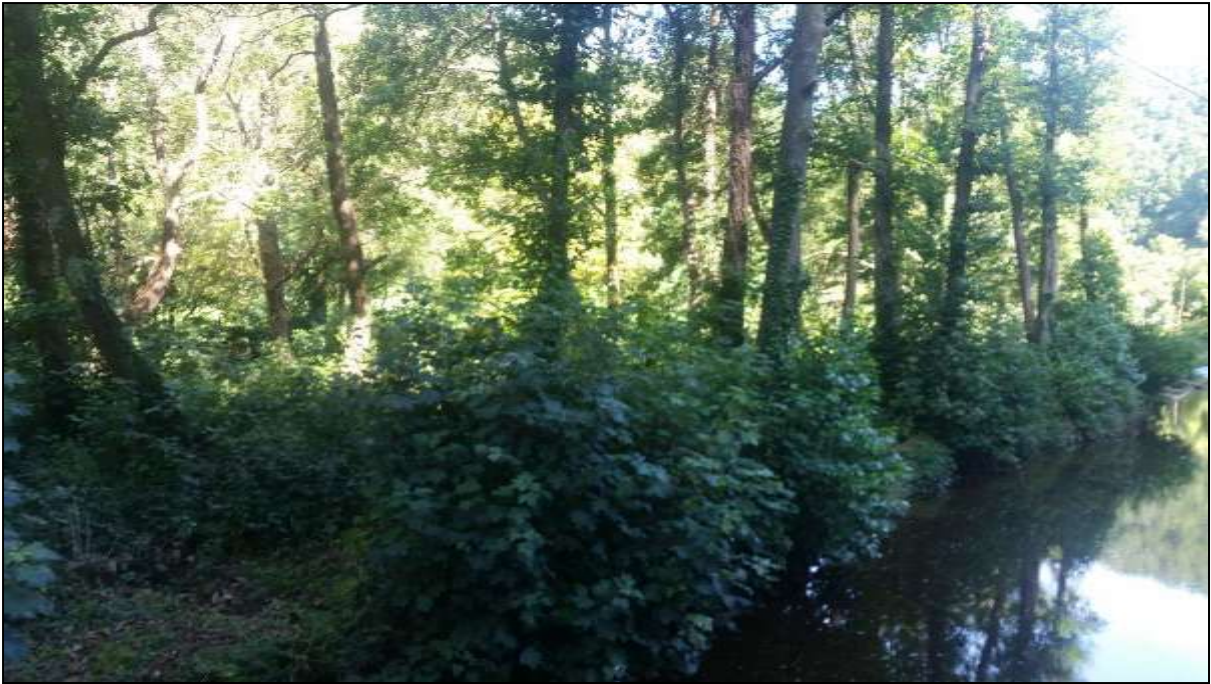
The weir then continues a further 48m in the form of a stone revetment along the left-hand side of an island. This island is densely wooded (Figure 19) and is bisected by a small channel which is dry under normal summer flows (Figure 20).

The island is undoubtedly a small wildlife haven and should be managed as such. The alien invasive species Himalayan balsam (*Impatiens glandulifera*) is present on the island. Himalayan balsam (HB for short) is prolific both in its rate of growth and its reproduction. It can rapidly out-compete native wetland species and disperse seeds by means of exploding seed pods. Not only can HB fire seeds over 7m in any direction, these seeds also float, making them particularly invasive within river corridors. HB is particularly shallow rooted and dies back during the winter leaving riverbanks exposed and vulnerable to erosion. Annual eradication efforts should be included in the ongoing management of the island.

Figure 19: The heavily wooded island

6. Try to maintain the island on the weir as a wildlife refuge and resist the temptation to 'garden' it too heavily. Reducing disturbance will make the island more attractive to birds and mammals such as otters (*Lutra lutra*), particularly as there is a hidden channel through the island's centre (see Figure 20).

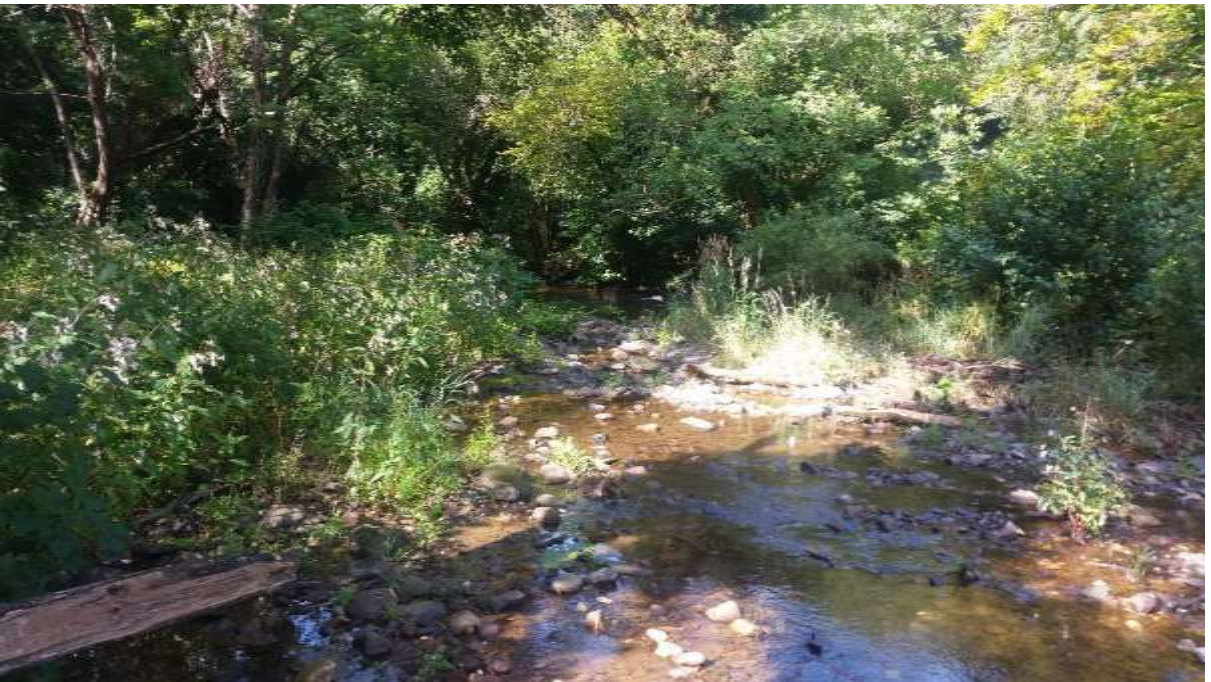
Figure 20: A hidden channel in the middle of the island (note Himalayan balsam on the left).

However, Himalayan balsam will need to be managed. This is best done with volunteer work parties hand-pulling the plants in late spring before the seed pods develop. A secondary pull later in the summer, to eradicate any later sprouting plants may also be beneficial. The nature of HB is such that only a concerted joined-up source-to-sea effort will effectively eradicate the species from a river. However, blitzing it annually at a local level will minimise its impact and safeguard biodiversity (e.g. http://www.sciencecodex.com/global_plant_diversity_hinges_on_local_battles_against_invasive_species-105553).

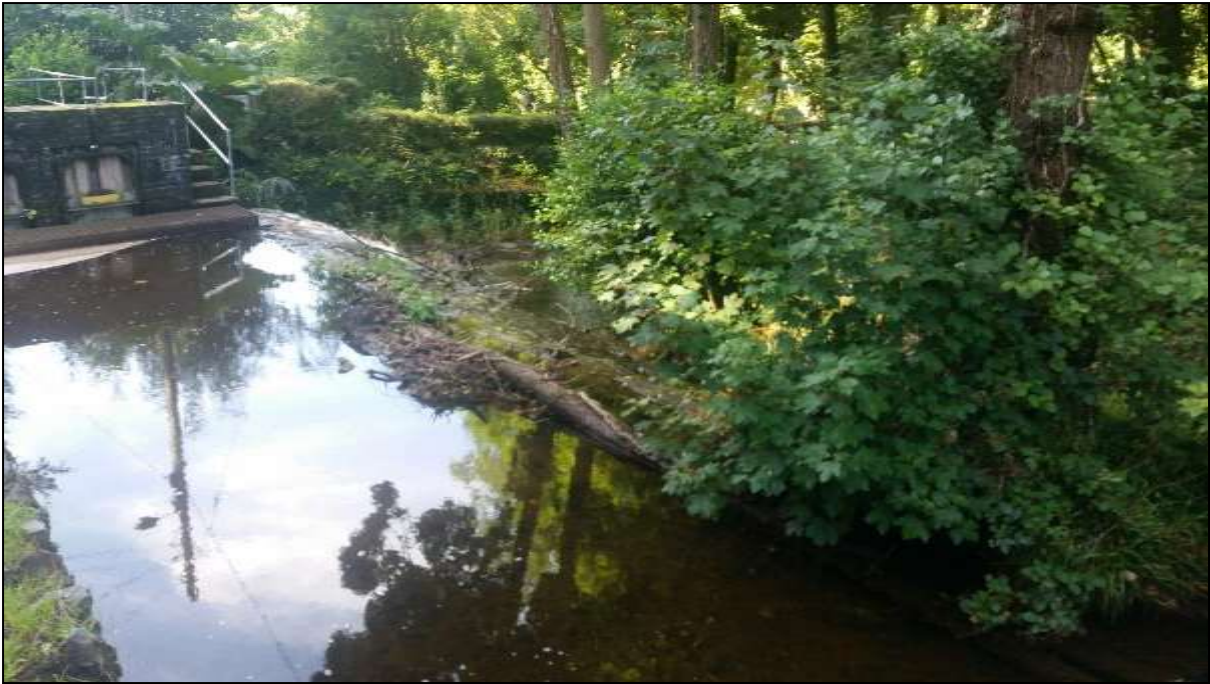
Adjacent to the sluices is a further 7m wide section of stone weir (Figure 21) that carries flow along the back of the island to re-join the main Barle.

Figure 21: The 7m section of weir next to the sluice diverts excess flow around the island
