## Feasibility Report for 2 Winter Pitches at Llangynwyd Rangers BGCW FC, Maesteg

**Mr Peter Watkin Jones BSc MSc MIAgrE**  
**Oolong Sports Pitch Consultancy**  
**February 2020**

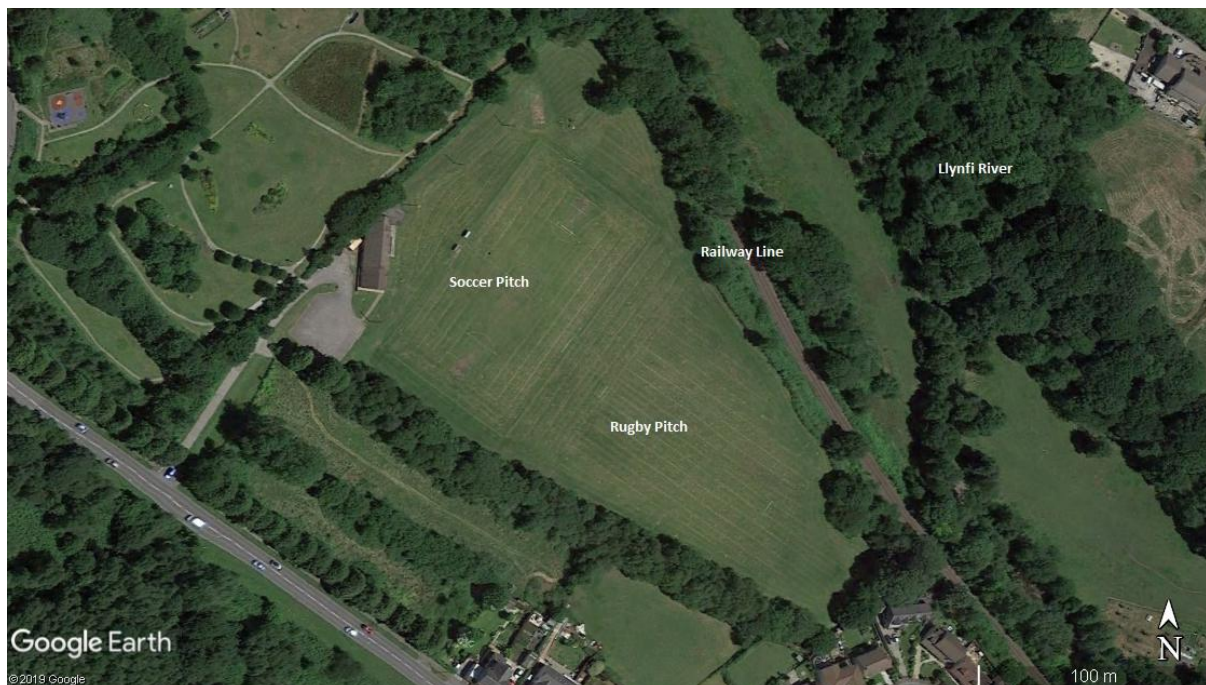
**Figure 1 - Outline of the pitches at Llangynwyd Rangers BGCW FC**

There is a changing block facility, a single soccer pitch and a single rugby pitch on the site. The River Llynfi is situated to the north east adjacent to a main railway line.

Both pitches suffer significant waterlogging conditions which cause postponement of fixtures.

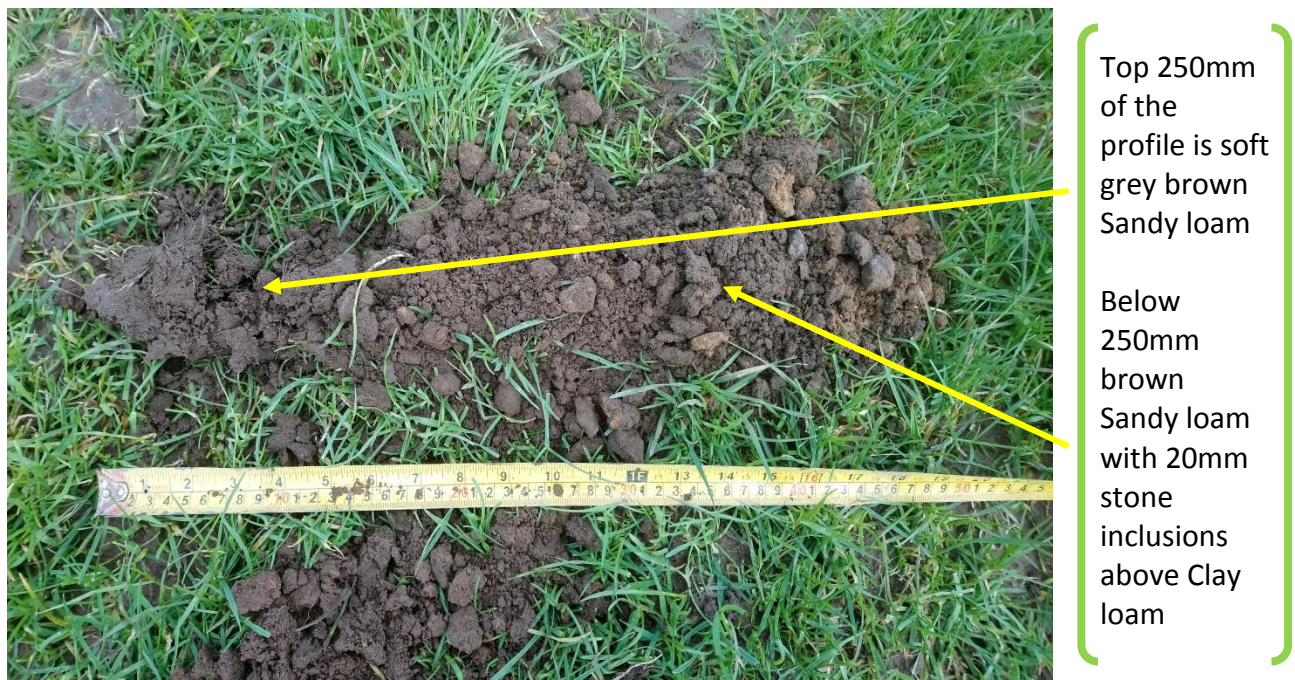
**Figure 2 - Typical soil profile of the soccer pitch**

Topsoil depths measured in the field were found to be approximately 300mm deep with some stone from 250mm and consistent across the site. The upper 100mm soils were noticeably de-structured with poor shear strength capacity.

Subsoil depths were assessed to a maximum of 450mm below ground level using a combination of hand augering and open trial holes, the profiles showed a consistent layer of Clay loam subsoil throughout.

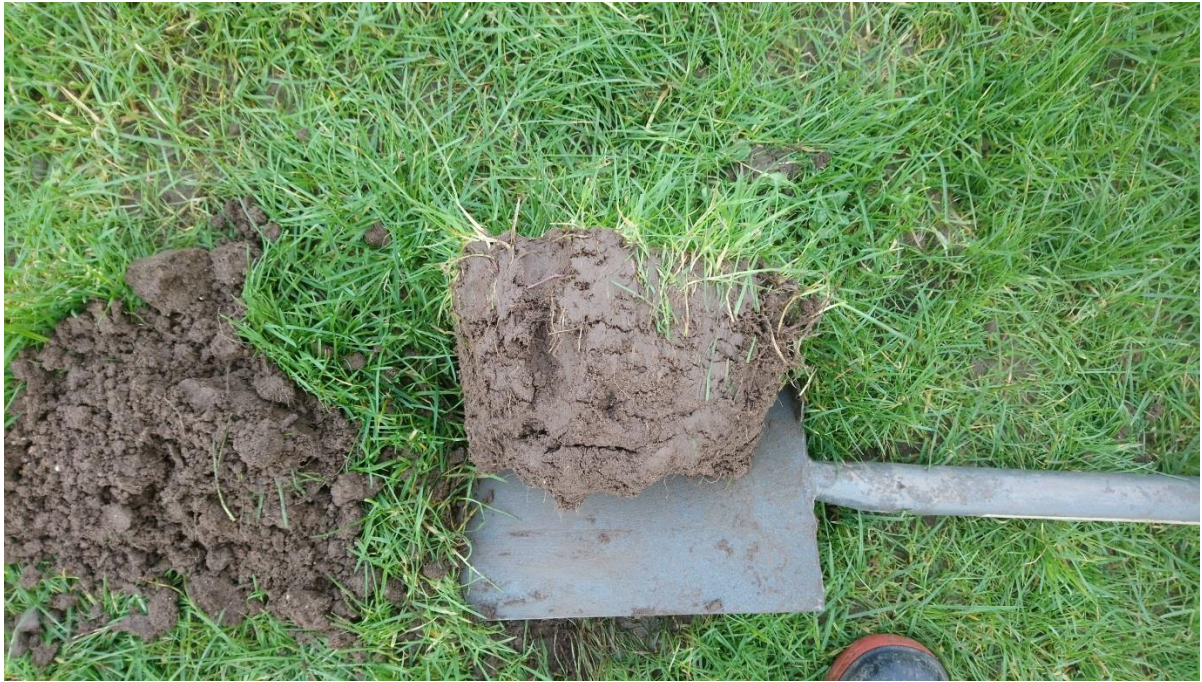
**Figure 2 – Typical topsoil structure**

The upper 100mm of topsoil is compacted and shows signs of long term sustained damage. Below 100mm the profile shows compacted and poorly structured soil. The rooting depth is typically 130mm.

The Clay subsoil below 300mm is also poorly structured and will impair drainage.

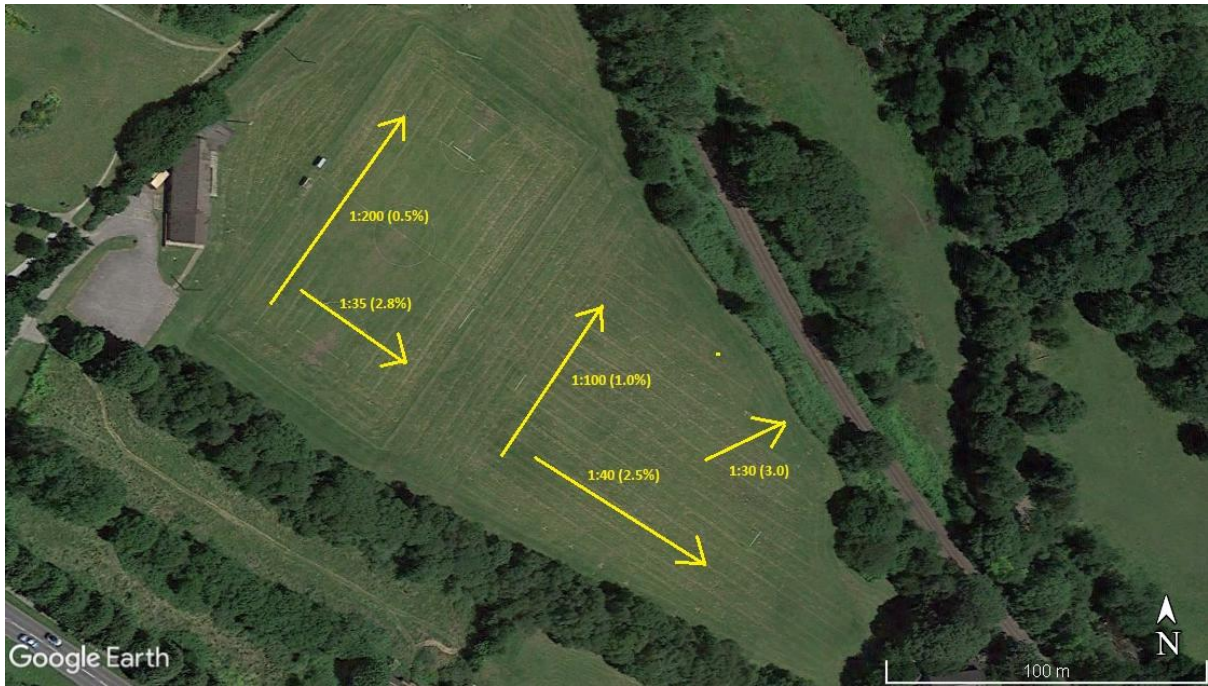
**Figure 3 – General ground slopes**

The site has a general slope north west to south east and is significant. The steepest gradients are found at the eastern boundary of the rugby pitch which increases towards the site boundary.

The soccer pitch has a cross field slope of approximately 1:35 and has marked undulations throughout (it is not flat).

The rugby pitch has a lengthways slope of approximately 1:40 with a cross-field slope of 1:100 but falls off dramatically at the eastern boundary, see **Figures 3 and 6**.

Both pitches fall below the minimum standards bench marked by the Institute of Groundsmanship (IOG) Performance Quality Standards (PQS) on pitch slope.

The surface gradient (slopes) should be reduced by re-profiling the ground and the movement of surface water through the profile should be improved by the installation of a comprehensive drainage system.

1. Re-profile to reduce the pitch gradients and the evenness of the surface
2. Install new drainage systems comprising of primary underdrainage pipework with secondary drainage sand grooving
3. Surface establishment of a suitable grass sward using a sports grass cultivar mix and improve the soil chemistry
4. Include an annual maintenance programme

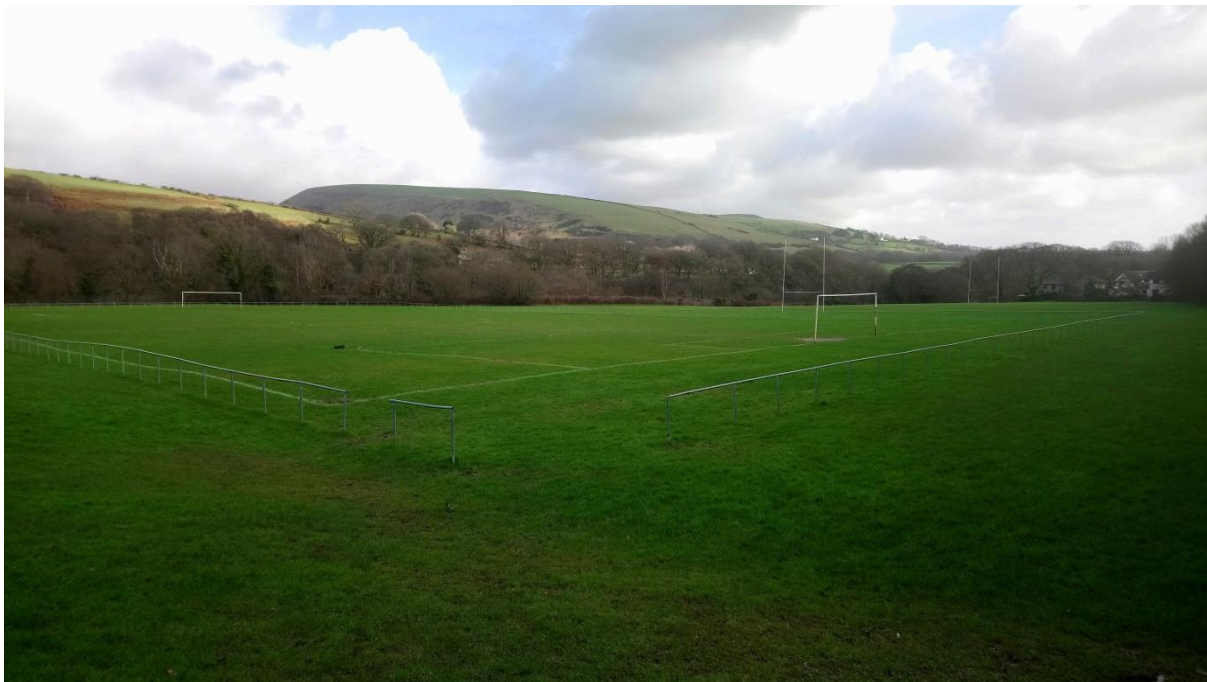
**Figure 4 – View of the soccer pitch**

The cross-field gradient of the soccer pitch is excessive and falls below the basic category for the PQS. An additional problem which is immediately noticeable is the undulating nature of the ground (the ground is not flat). This causes peculiar playing conditions and is outside the PQS.

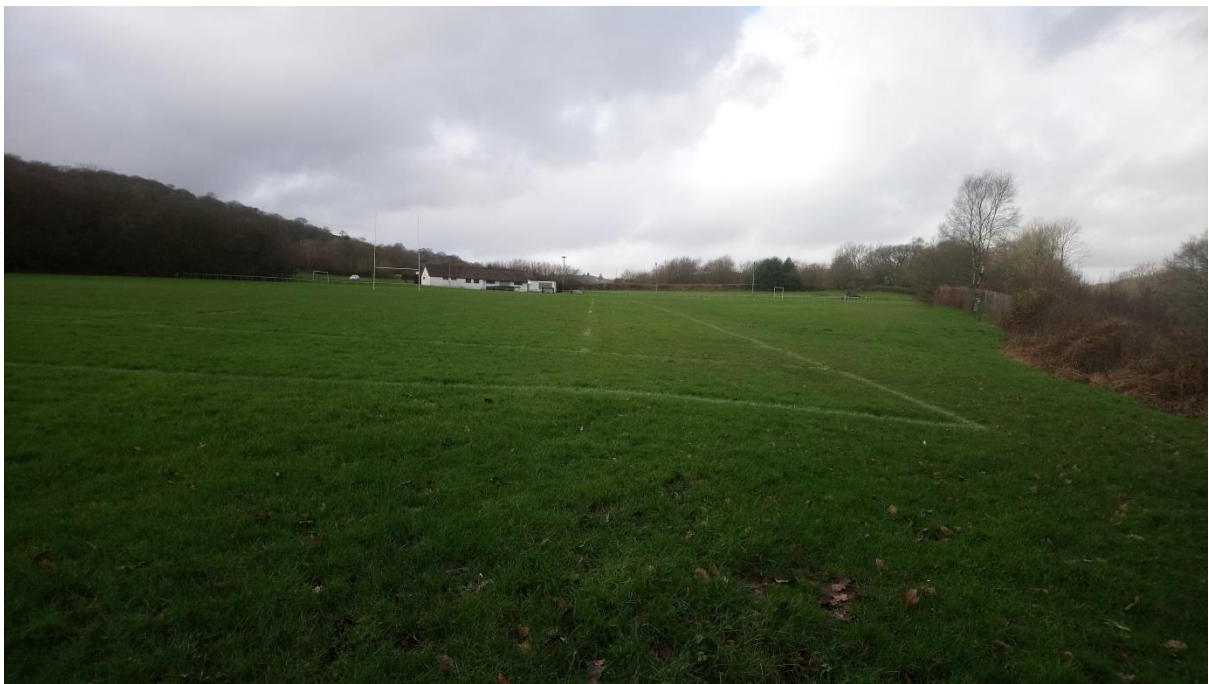
**Figure 6 – Steepest gradients on the rugby pitch**

The rugby pitch has a similar cross-filed slope which becomes more marked towards the eastern boundary and again falls below the basic category for the PQS. Some re-profiling of the ground to reduce the pitch slopes would improve this aspect of the PQS status.

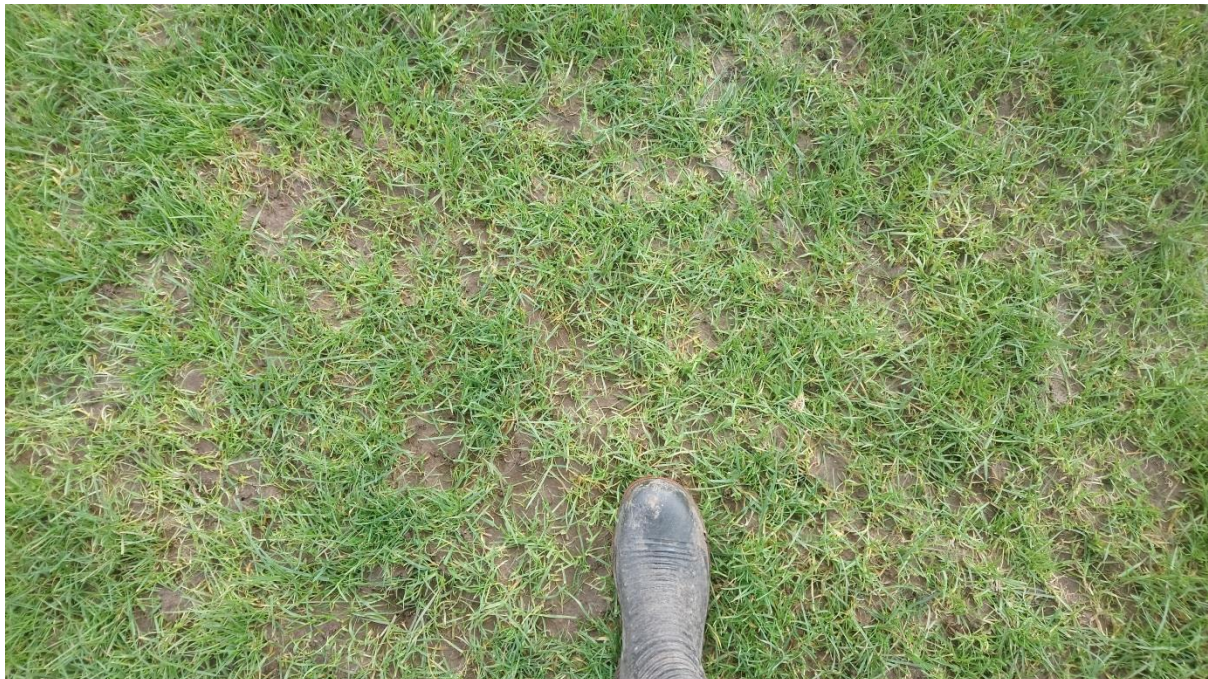
**Figure 7 – Typical grass cover**

The area has vegetative coverage of 75% which lies within the basic category of the IOG specification, the approximate coverage is made up of the following grasses:

75%	PERENNIAL RYEGRASS	<i>Lolium perenne</i>
5%	BROWNTOP BENT	<i>Agrostis capillaris</i>
5%	FESCUE	<i>Festuca spp</i>

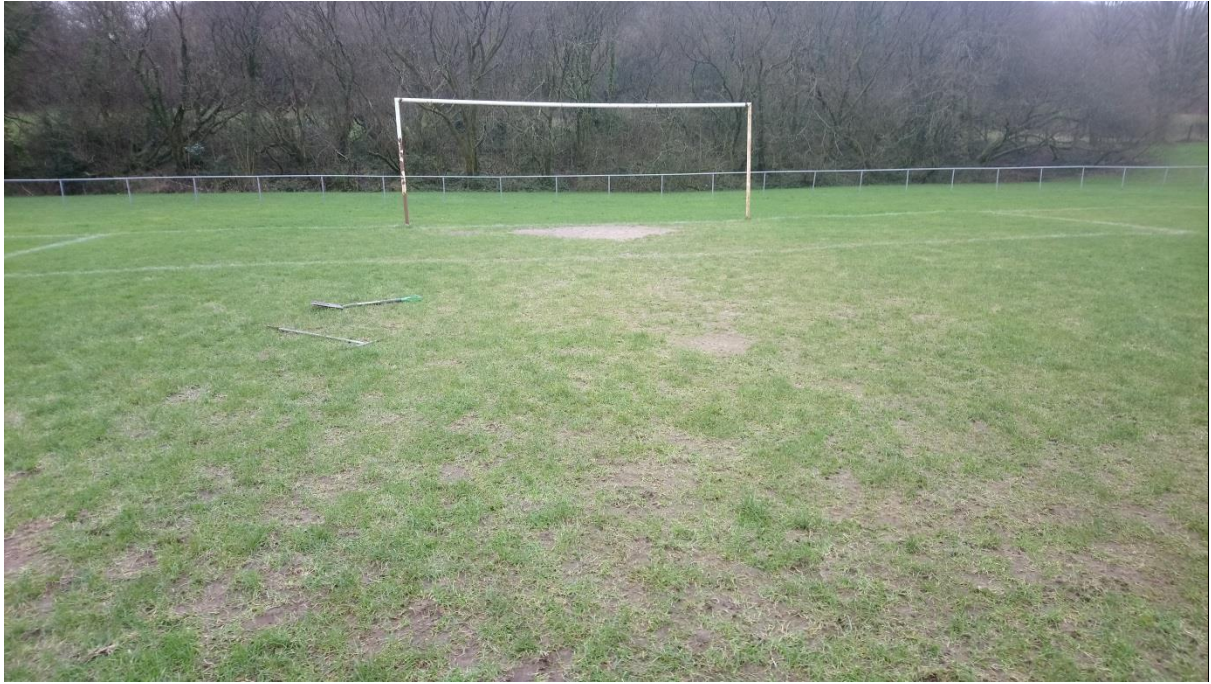
**Figure 8 – Showing bare ground within the goal areas**

Both pitches show characteristics of surface drainage problems. The soccer pitch was reasonably dry and firm on the day of the visit however visual inspections of the surface highlighted areas of bare soil and poor grass health. Further investigations showed the upper soil profile to be compacted and de-structured which limit the infiltration of surface water through the profile and cause waterlogged surface conditions.

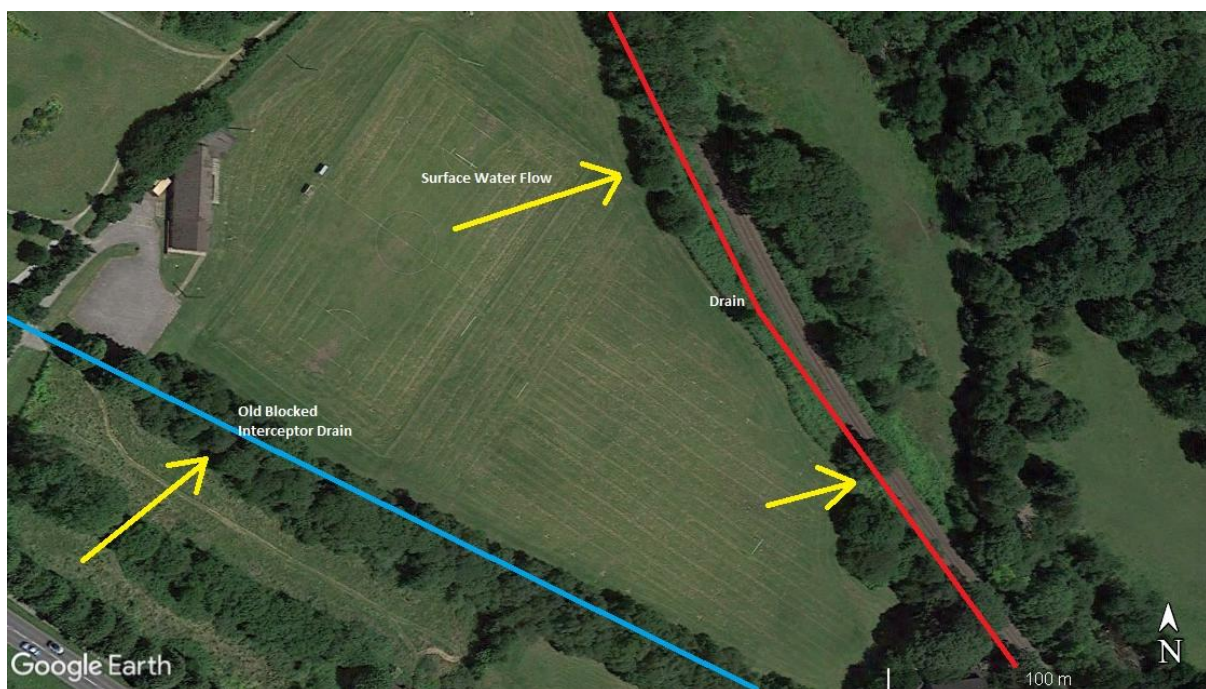
**Figure 11 – Catchment Hydrology showing drainage and surface water flow**

There is no evidence of any active drainage infrastructure on either of the pitches. The ground conditions display the characteristic features of a soil profile which is de-structured, has inherent low permeability and has no drainage capabilities and therefore is prone to saturated soil conditions and waterlogging.

There is an old drainage ditch/pipe which runs through the tree line along the south west boundary. This used to intercept surface water from the adjacent ground above but has since become blocked and overgrown. Consequently the surface water generated now runs directly onto the playing field and contributes to the overall wet conditions found on the ground.

The soccer pitch relies on surface water run-off to remove accumulated water. This water runs in a north east direction and is eventually discharged via a drain next to the railway line.

Similarly surface water from the rugby pitch runs towards the railway line to the east and discharges through the existing drain. This could be a useful outfall for any drainage system considered in the future.
