# Viewpoint Visualisations for Residential Development at Christmas House, Shalford

**Mr T. Shea**

Project No.: YTOB101/003

December 2020

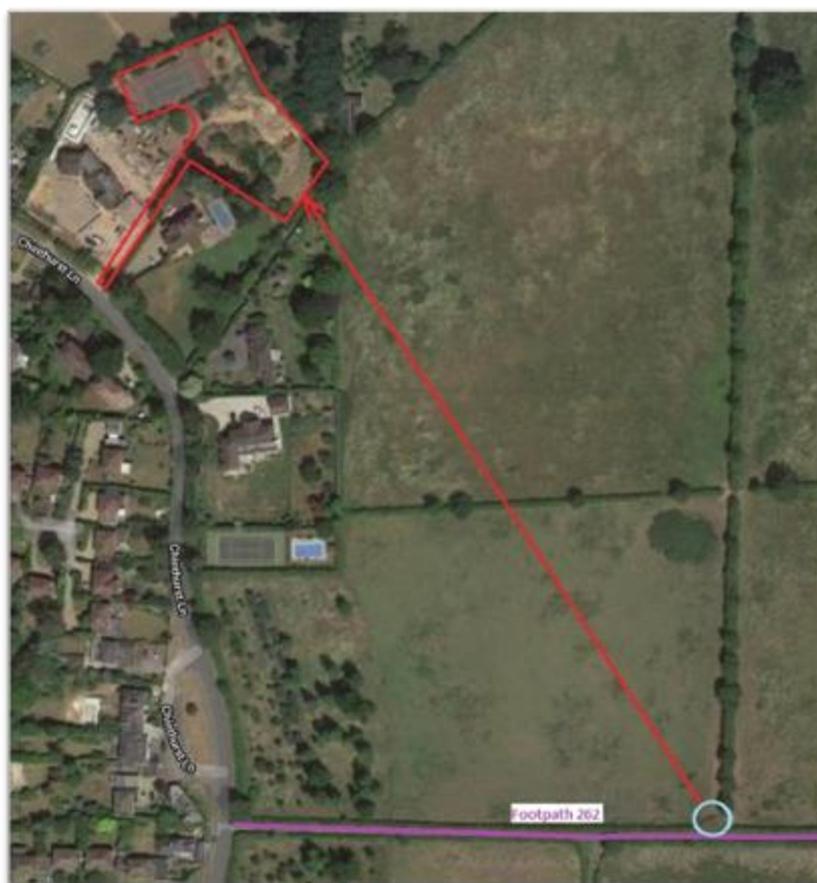
Figure 1: Location 1 – location and sight line to development site

Footpath 262 runs west-east from Chinthurst Lane through open countryside which rises gently to the east. Although reasonably wide, the footpath is bounded on each side by mature dense hawthorn hedge varying between 2.5m and 3m in height. The first point at which there is a clear line of sight towards the development site is at the corner of the first field approximately 200m along from Chinthurst Lane (Figure 1).

The development site is heavily screened by existing boundary trees and fences, as well as substantial and varied vegetation immediately adjacent to and along the boundary of the nearby properties, which further reduce the visible area of the site. Between the viewpoint and the development site there is also a mature field hedge approximately 3m in height running east-west screen across the field, interspersed with several large mature trees.

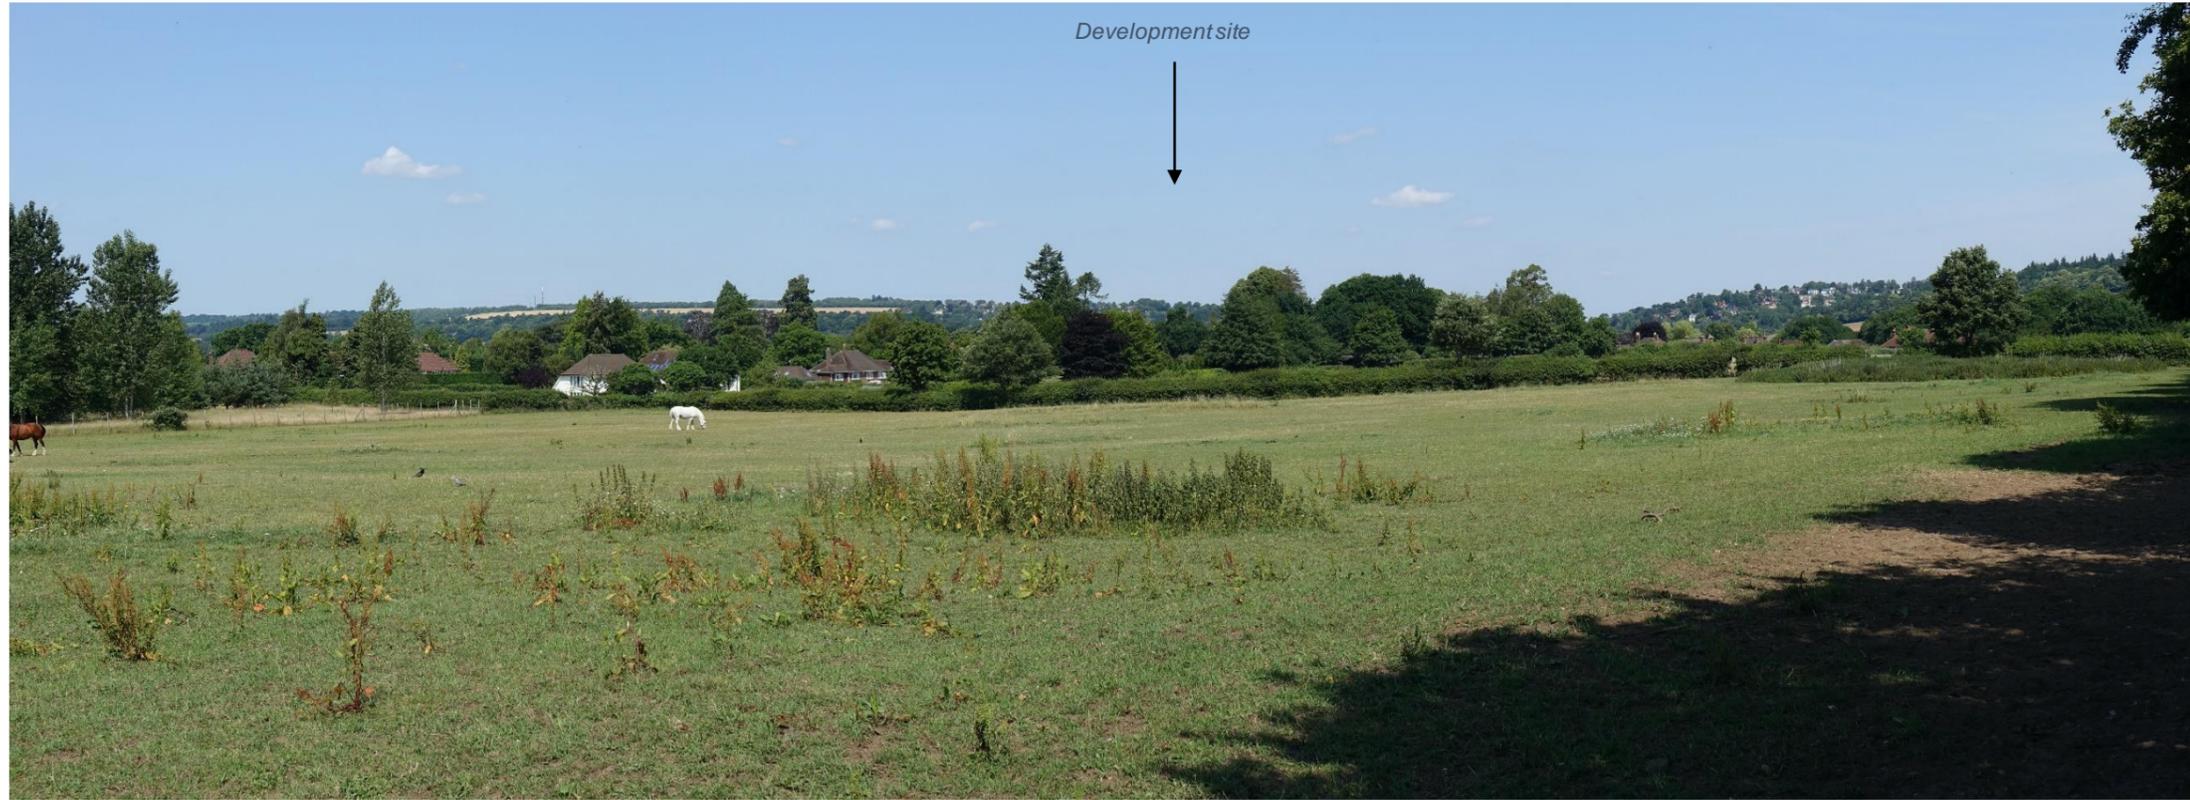
Figure 2: Location 1 - view towards development site - existing

A representative photograph from this location has been used to create the visualisation. Figure 2 shows the existing view without new development. Using the computer model and known heights of trees within and immediately adjacent to the site, it was possible to calculate the position and height of the new houses and hence create a visualisation of their visibility between the trees and hedges. As can be seen from Figure 3, only the upper part of the roof of the house closest to the boundary of the Christmas House site would be visible through a narrow gap in the tree line. Compared to the nearby properties which are prominent in the view, the proposed new house would be a very small element within a significant treescape.

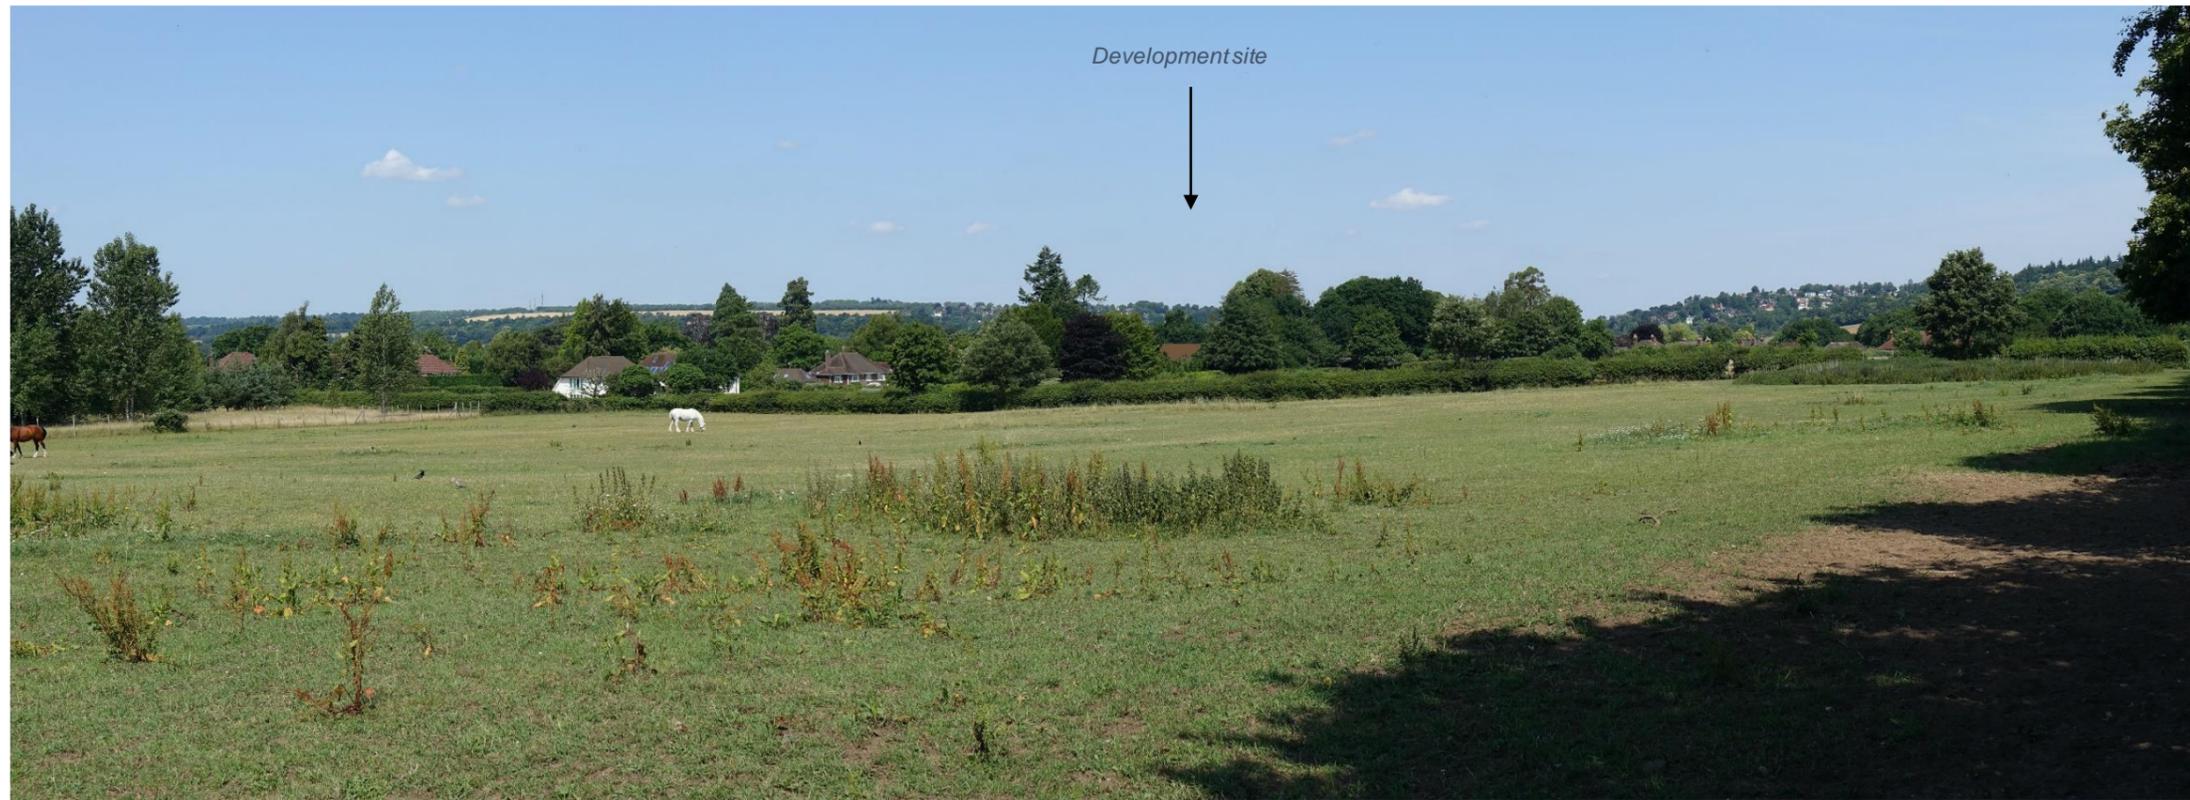
Figure 3: Location 1 - view towards development site - with development

The proposed new houses would be c.7.6m in height to the ridge of the roof. Therefore, this would mean that less than 2m i.e. the roof, of the house would be visible from this viewpoint location, as shown in Figure 3. Compared to the previous application, there would be a very marginal increase in the area of building seen by virtue of the fact the proposed house extends across most of the width of the site. However, taking into account the slightly lower building height, the overall impact would remain the same.

The photograph used for this visualisation was taken in July 2020, since when the boundary conifer trees have grown a further c.0.75m. Over time these will continue to grow and thicken, enhancing the screening effect and further reducing the visibility of the house in the landscape.

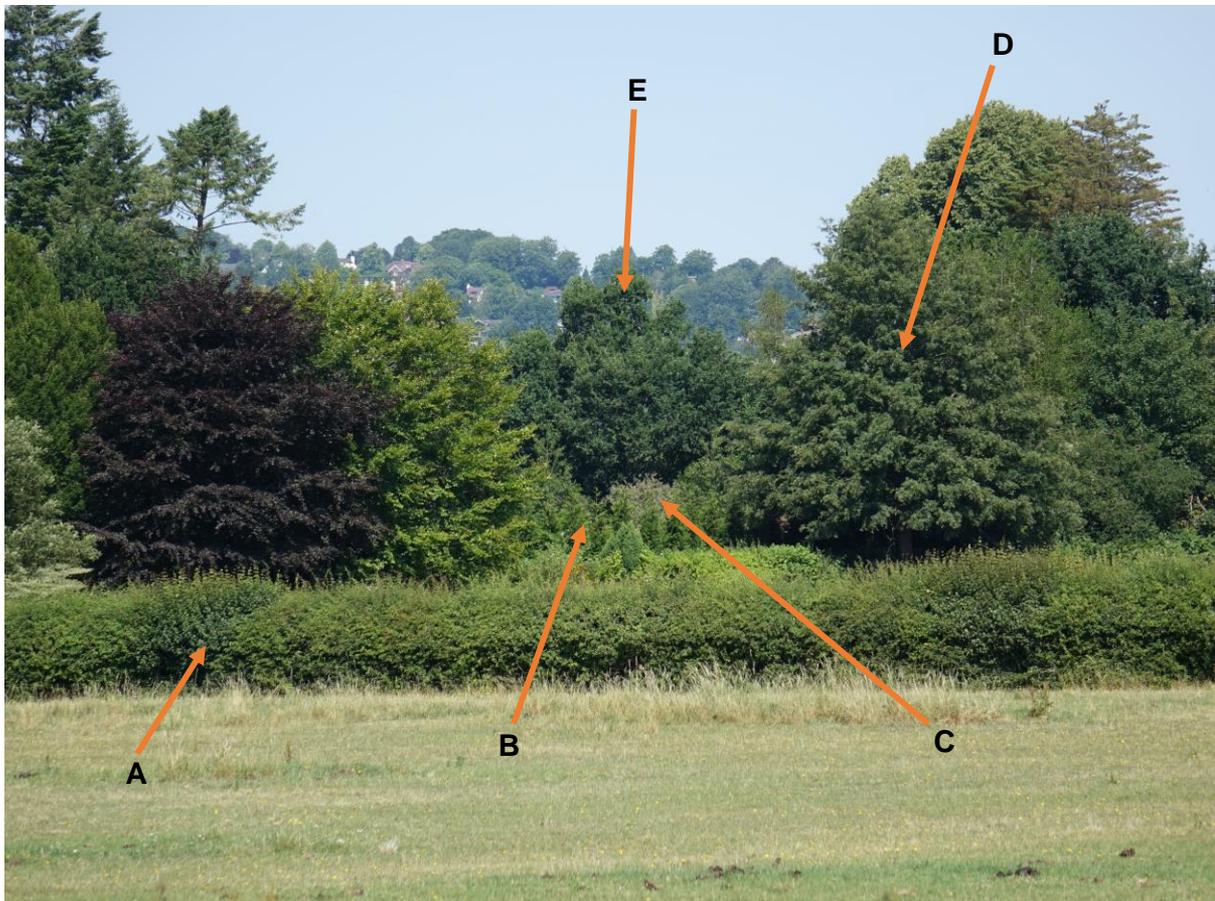
Figure 4: 'Zoomed in' shot from Location 1 showing key vegetation:

To provide further context, Figure shows a 'zoomed in' photo from the field gate. This has been annotated with details of the trees and hedges to provide visual perspective. All quoted tree heights are taken from the arboricultural report prepared for the development, with the exception of the field hedge, which was estimated based on the height of the hedge that runs either side of the Footpath 262 at Location 1.

A – hawthorn hedge across field c.3m height

B – line of conifers inside site boundary c.5m height

C – cherry tree within site boundary c.6m height

D – large oak tree adjacent to southeast boundary site c.20m height

E – large mature oak tree on far boundary of site c.20m height

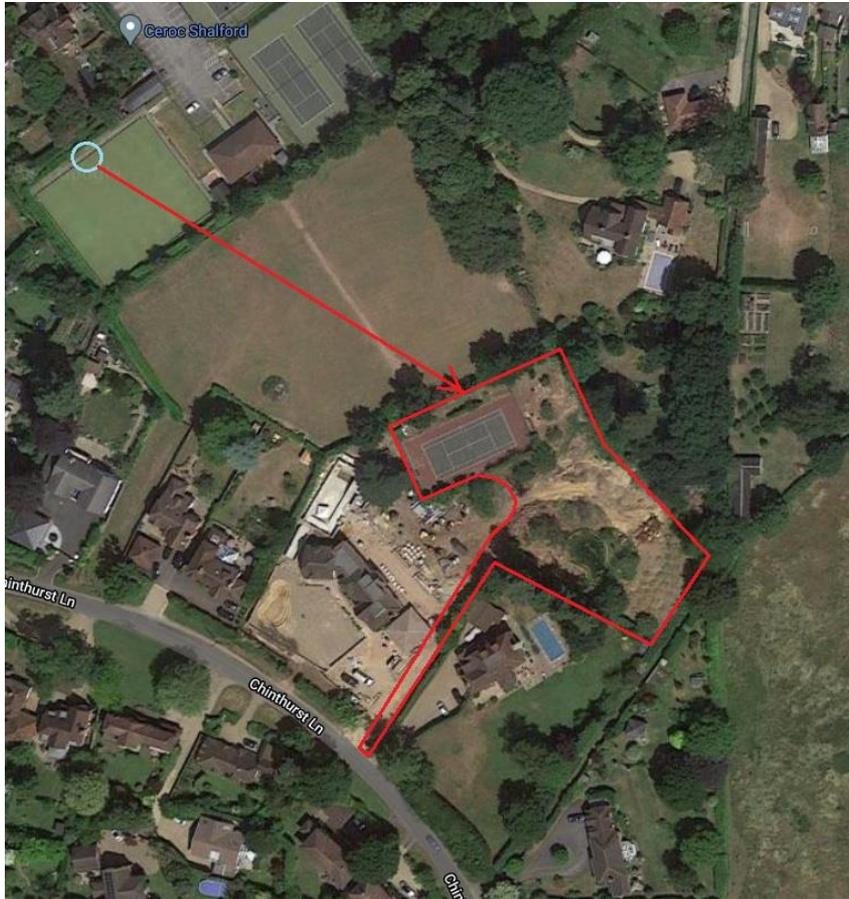
Figure 5: Location 2 – location and sight line to development site

Location 2 is the tennis courts at Shalford Tennis Club adjacent to the Village Hall on the edge of the village. The club sits at the bottom of the hill with an open field between it and the development site (Figure 5).

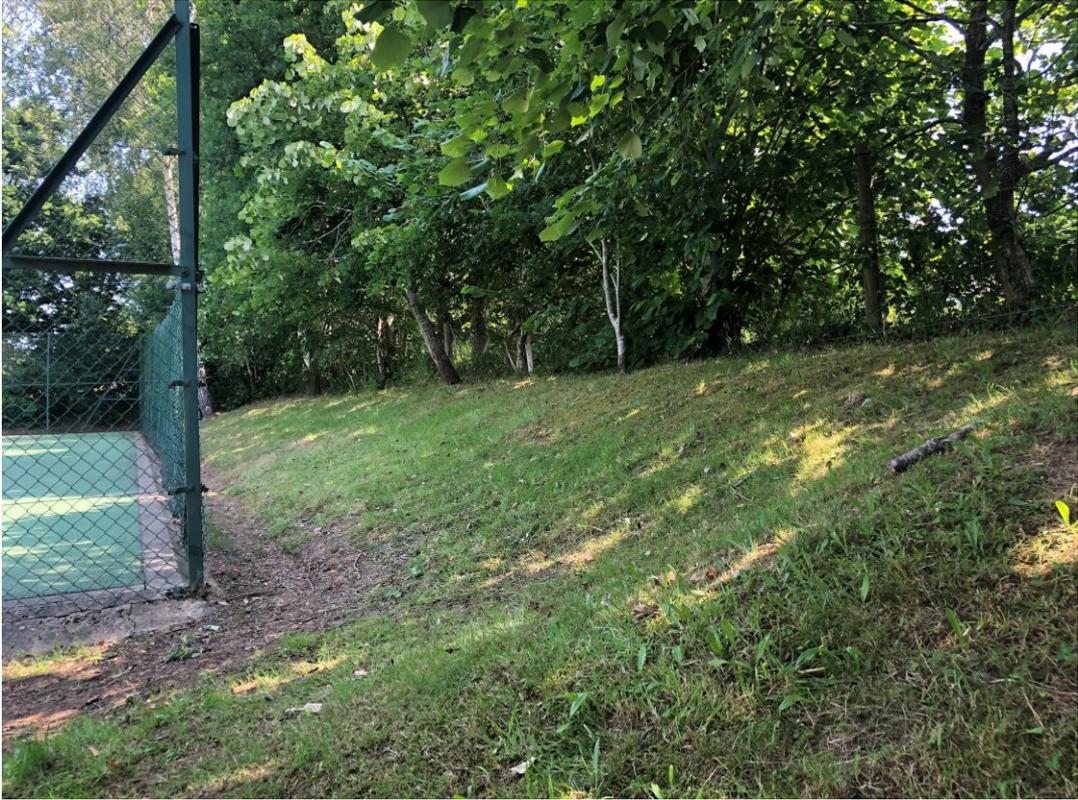
*Figure 6: View to NE of steep bank along rear of tennis courts*

Along the southeast boundary of the tennis club there is a steep earth bank rising approximately 1-1.5m above the level of the nearest tennis court. Along the top of the bank is a line of mature trees and hedges. This runs most of the length of the boundary of the village hall site which also includes the adjacent bowling club. Beyond this, the land rises sharply up towards the development site. Figures 6 and 7 show views along the bank behind the tennis courts and the Upper Hall building. Figure 8 is a photo taken at eye level (c.1.75m) towards the development site from the path alongside the Upper Hall. Although this is approximately 0.8m below the level of the tennis courts, there is no clear view through the lower vegetation. Figure 6 clearly shows that the base of the line of trees and hedges is approximately at eye level when standing on the court. Views through and up the hill beyond would be heavily filtered by the vegetation.

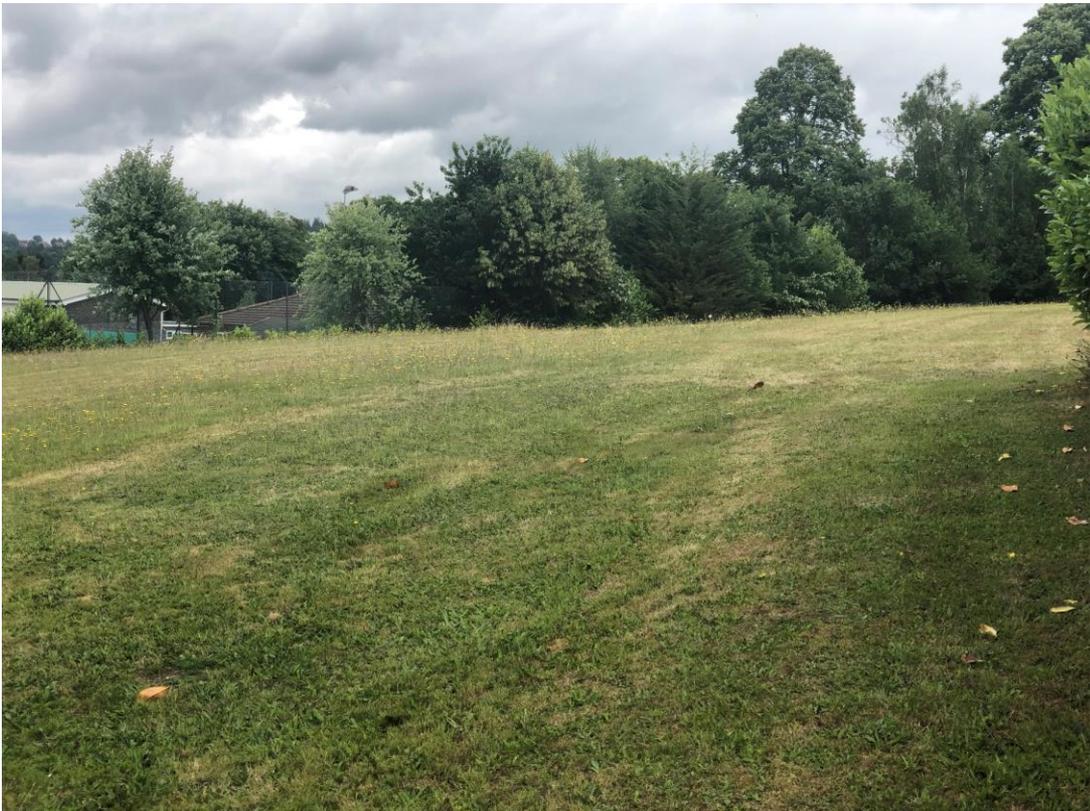
*Figure 9: View N-NE across field towards tennis courts*

To provide further context, Figure 9 shows a view across the field between the tennis club and development site the gate taken from the gate at the corner of Footpath 266 which runs from Chinthurst Lane down to the A248. It shows how the land immediately adjacent the southeastern boundary of the tennis club rises.

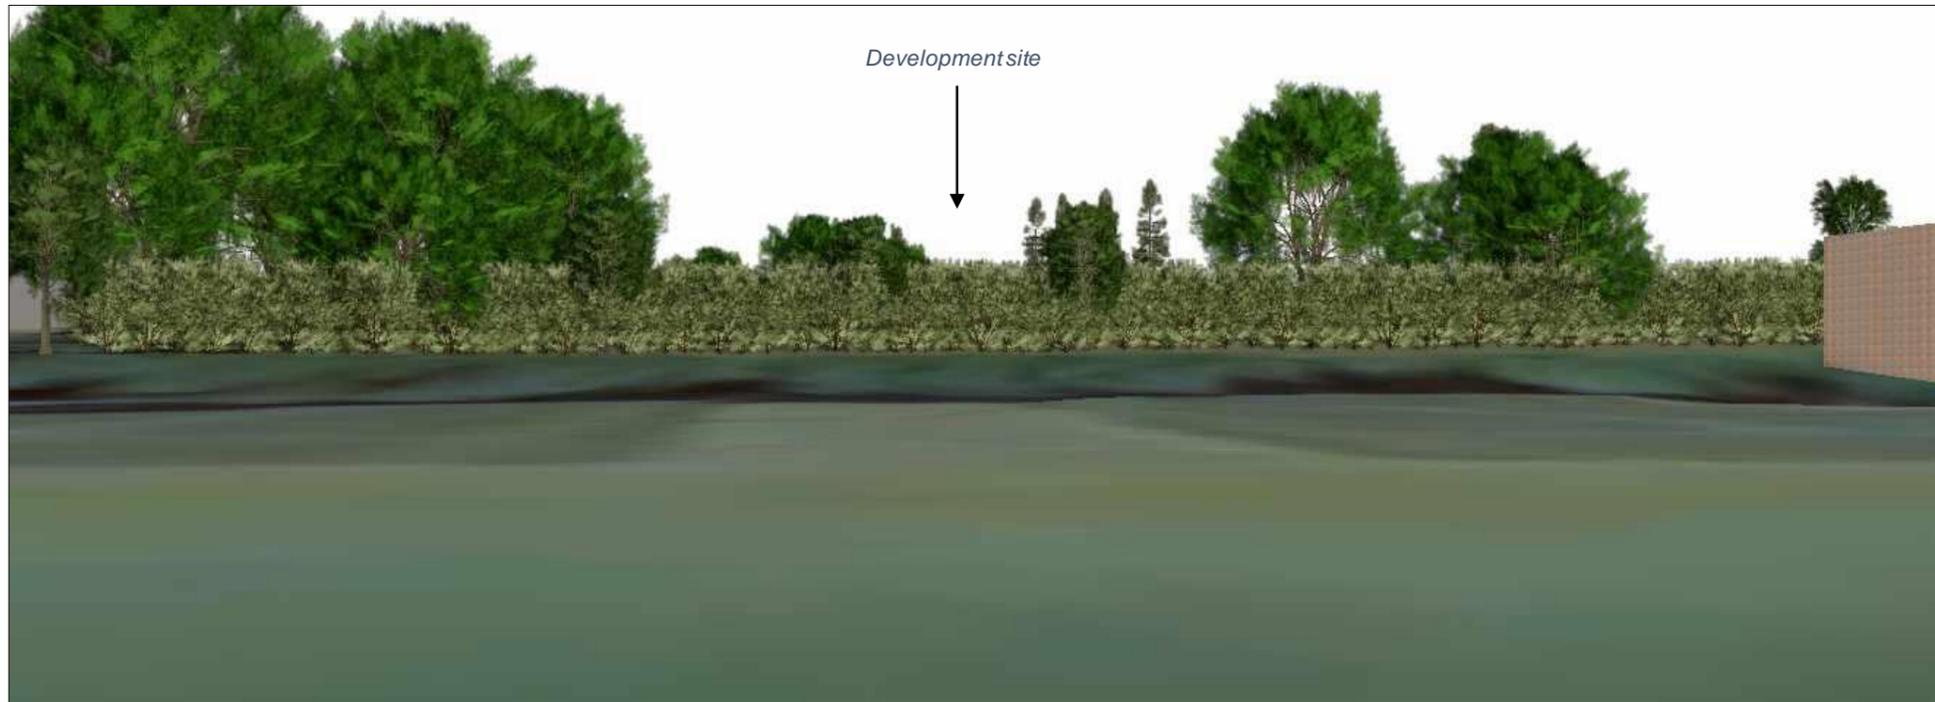
Figure 10: View from forecourt of tennis court towards development site (c.2m eye level)

Using the GIS computer model a visualisation has been generated from a nominal point roughly at the centre (forecourt) of one of the courts (Figure 10). Due to the limitations of the available tree types within the GIS model, the visualisation cannot recreate the detail of the actual tree line but it is a good representation of the average height. It is noted that the new house designs have reduced the height to the ridge of the roof from 7.8m in the previous scheme to 7.6m in the new scheme. At this elevation it is clear there would be no visibility of the house closest to the boundary of the Christmas House.

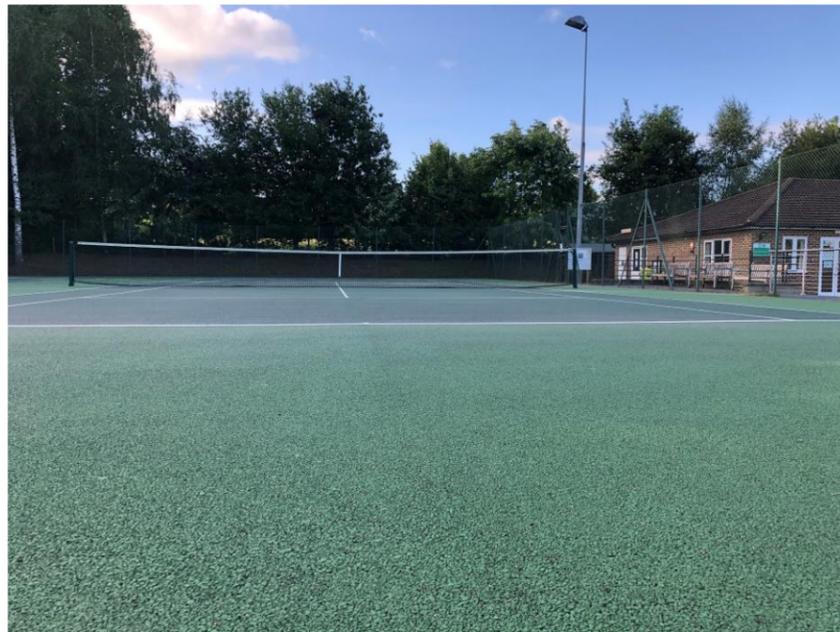
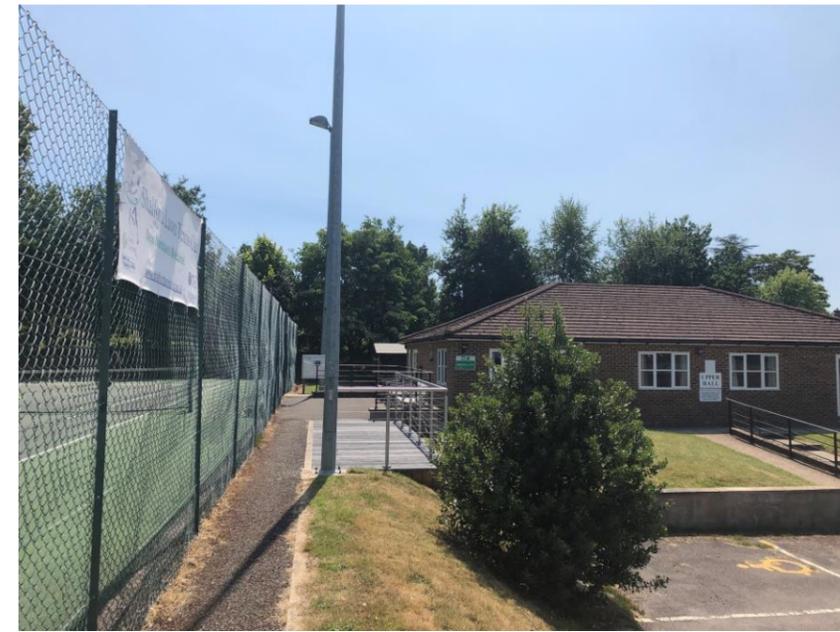
The photos in Figures 11 and 12 are provided for context. The first was taken from the farthest (northwest) boundary fence of the upper tennis courts. Unfortunately, there is a mesh screen along most of the fence which shields the view through so the only view possible was from approximately 0.5m above ground level where there is no mesh covering. However, even this shows how the trees and hedges along the field boundary form an almost solid screen. The second photo was taken from the top of the steps leading up from the car park to the entry gate into the upper tennis courts at the northwestern end and was an eye level view (c.1.75m) directly towards the development site. Given the fairly dense foliage, it is unlikely players at the far end of the courts facing towards the site would see anything beyond the tree line.

Figure 11: Wide angle view from NW end of tennis court towards the development site (c.0.5m above ground level)

Figure 12: View towards the development site taken from top of steps at NW corner of tennis courts

It is also worth noting that anyone standing at the end of the courts closest to the field boundary would, for the most part, be facing the opposite direction to the development site whilst playing. Even then, the substantial treeline along the boundary of the development site would provide screening and it would require someone to make a conscious effort to look through to see up the hill to the development site.

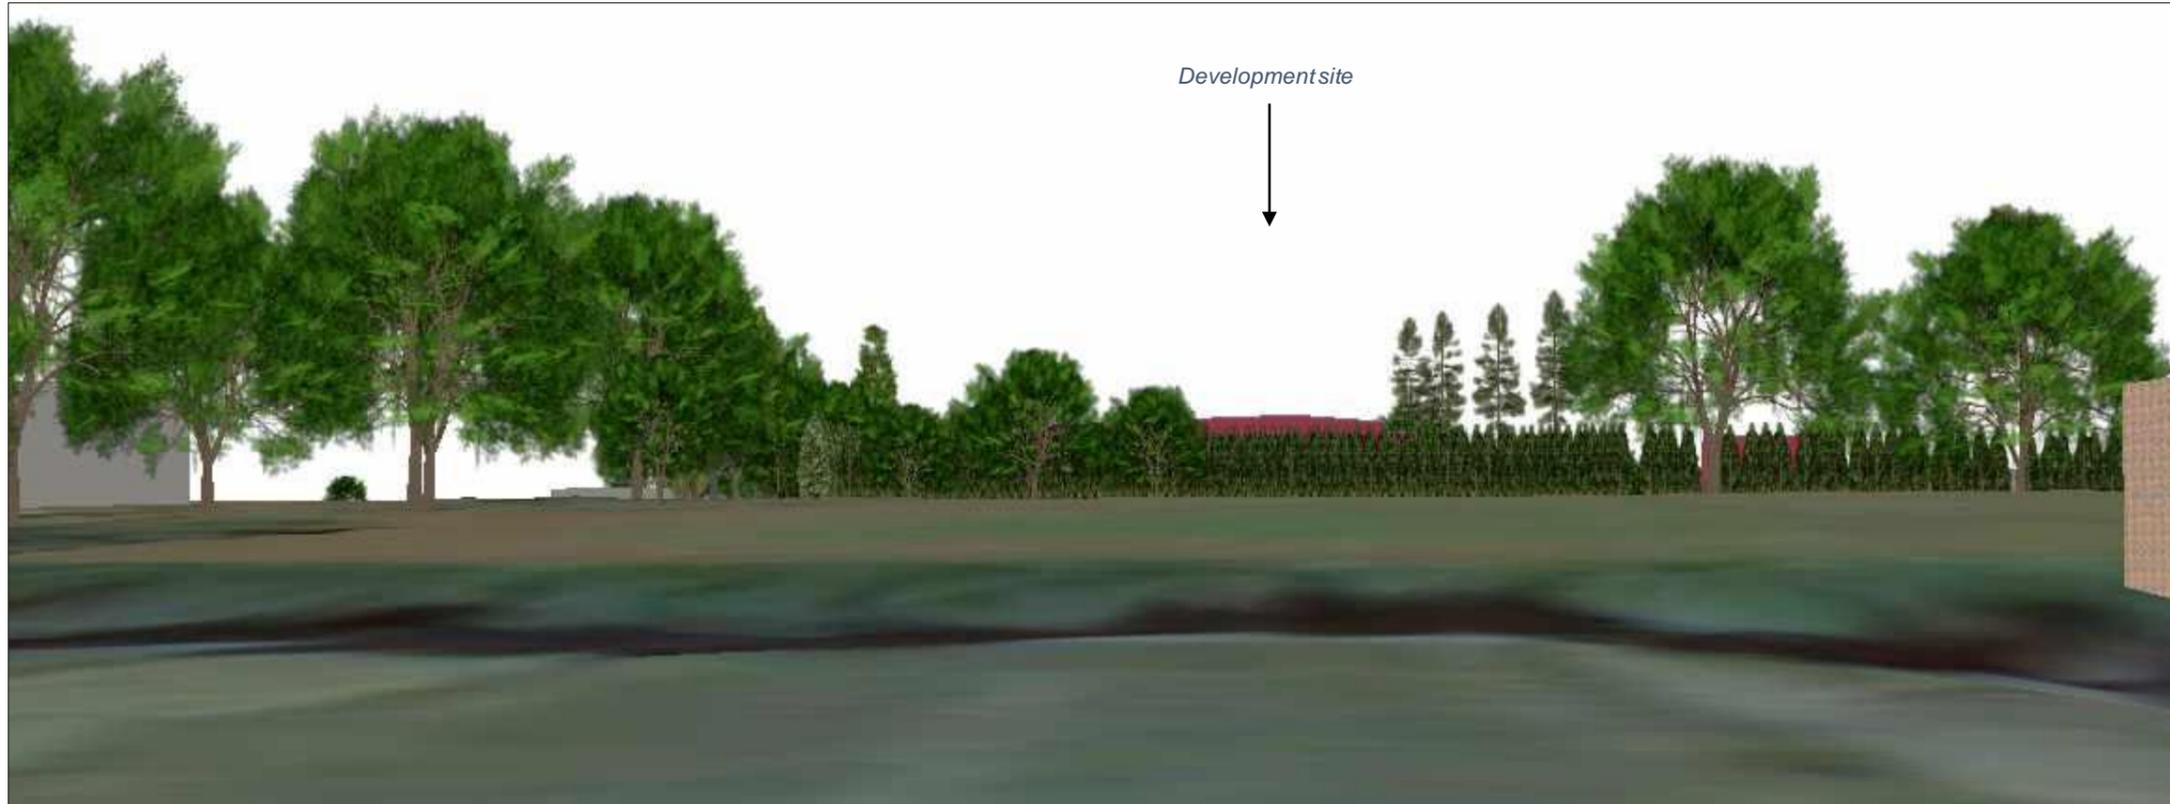
Figure 13: Location 2 - Worst case 'winter' view with boundary vegetation removed

At the time of writing, trees were beginning to shed their leaves but it was not yet possible to do winter view photographs. However, a 'worst case' representation of the view from the tennis courts in the winter has been produced by simply removing the vegetation immediately adjacent to the courts from the 3D model, thereby creating an unobstructed view up the hill towards the development site. This is shown in Figure 13. As can be seen, even with no intervening vegetation the new houses would be mostly screened by the evergreen cypress hedge along the inside boundary of the development site, with only the top section of roof being visible.

The only time of year when there may be more open views would be during the winter months when most of the trees have shed their leaves. However, the tennis courts are unlikely to be as busy, if used at all, due to the shorter days and generally colder, more inclement weather during the winter months. Nonetheless, views would still be filtered by the tree trunks, stems and branches. Along the boundary of the development site there is a c.6m high dense evergreen cypress hedge which would screen most of the new houses all year round with only the roofs likely to be visible.

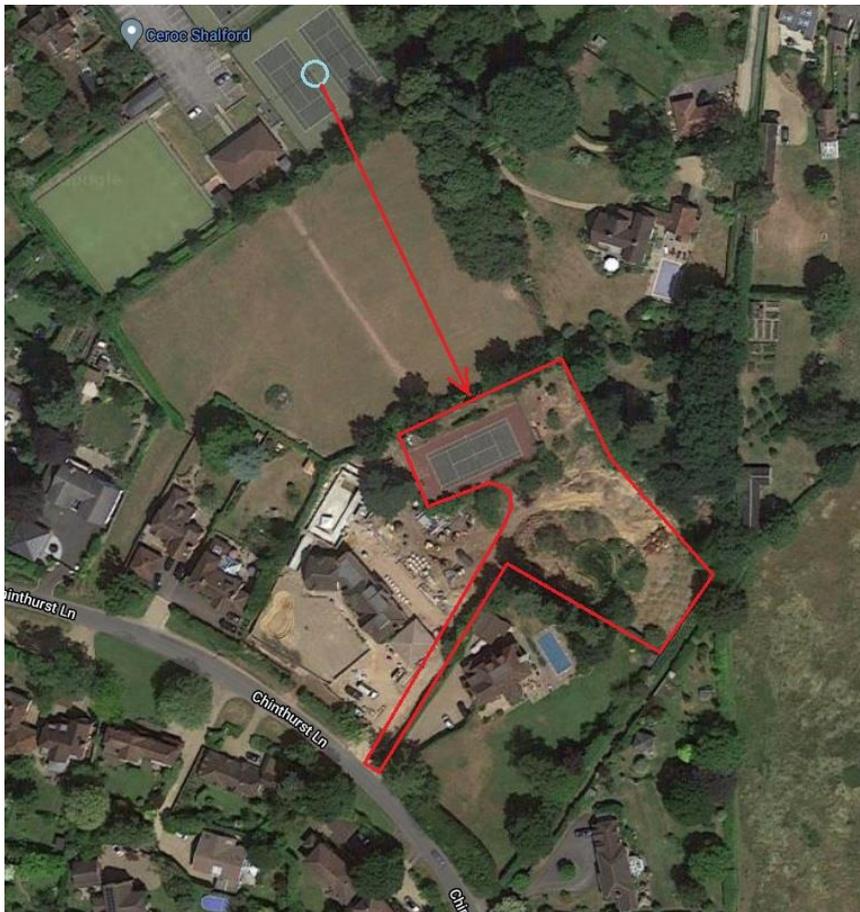
Figure 14: Location 3 - location and sight line to development site

Location 3 is roughly the middle of the northwestern end of the green at the Shalford Bowling Club adjacent to the Village Hall on the edge of the village. As with the tennis club, it sits at the bottom of the hill with an open field between it and the development site (Figure 14).

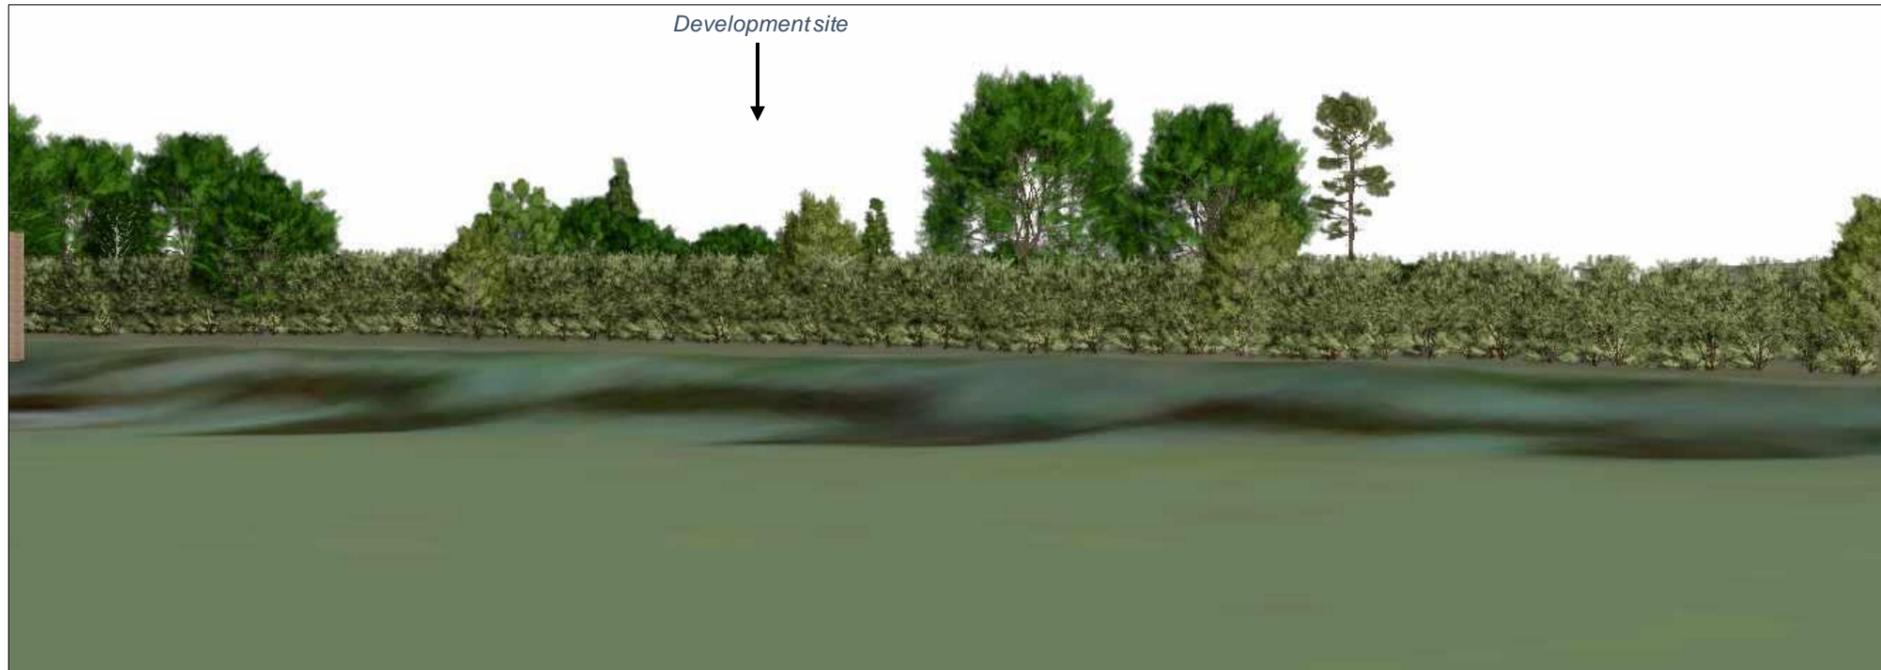
Figure 15: Location 3 - view from NW end of bowling green looking towards the development site (c.2m eye level)

Based on the field observations, a visualisation has been generated using the computer model (Figure 15). At an eye level of c.2m the existing hedgerow along the club boundary, together with the trees along the boundary of the development site, appear to create an effective screen to views. Notwithstanding the limitations of the model, at most all that might be seen would be the tops of the roofs of the closest houses. However, these would

be filtered by the hedge and tree line, including that along the immediate boundary of the development site, and would not likely be significant elements in the general view. It is also noted that there are several other properties along Chinthurst Lane that are much closer to the bowling club and which will already be visible to players.

The southeastern boundary of the bowling green comprises a mix of gabion wall, ornamental hedge and nature hedgerow interspersed with mature trees. From observations made during the site visit the green is first bounded by a gabion retaining wall that runs the length of the boundary and is approximately 1m high. Behind and atop this there is a laurel hedge of a similar height. Beyond that and the boundary fence, there is a natural hedgerow varying in height approximately 0.5-1.0m above the laurel hedge, effectively creating a visual screen ranging 2.5-3.0m in height at the closest points on the bowling green. There are approximately 5 trees within the hedgerow roughly evenly spaced along the boundary. Due to the lack of access it was not possible to take any representative photographs looking up the hill towards the development site.

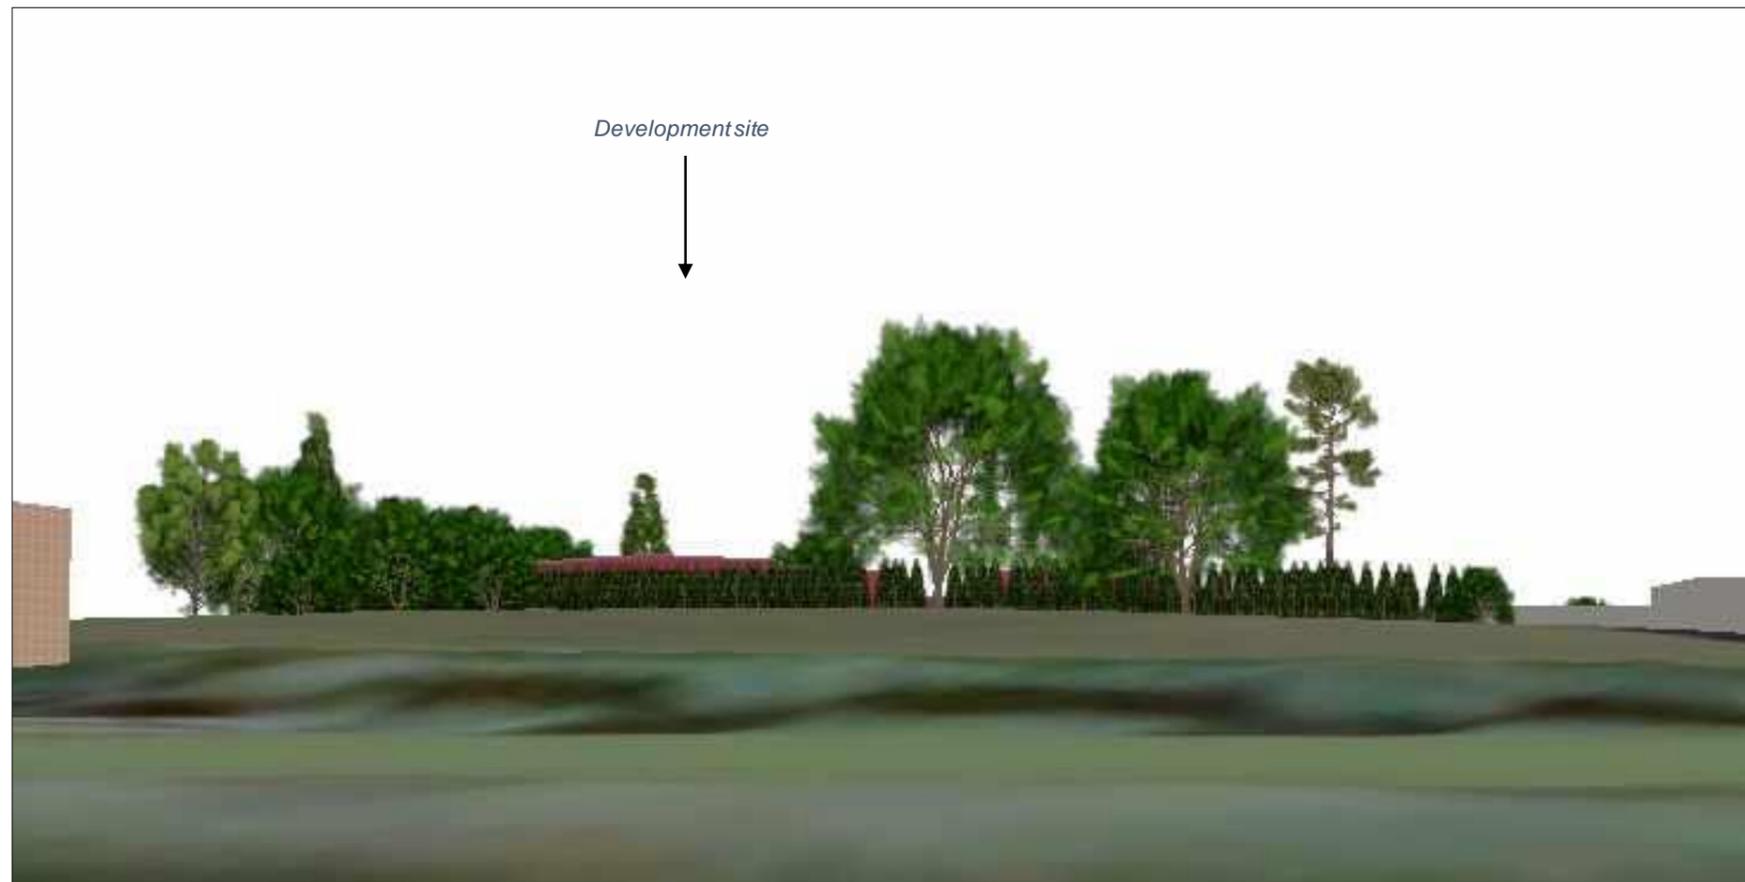
Figure 16: Location 3 - Worst case 'winter' view with boundary vegetation removed.

As with the tennis club, active use of the bowling green is likely to be reduced during winter due to colder and more inclement weather conditions. Figure 16 is a further visualisation from within the bowling green at 2m eye level but with the existing hedges and trees along the bowling club boundary removed representing an 'worst case' unobstructed view during winter months when trees and shrubs have shed their leaves. This provides a clear view up the hill towards the development site but even in this scenario the closest new house would be mostly screened with just the top of the roof visible.
