Response of *Ruppia tuberosa* in the Coorong South Lagoon to environmental water delivery over summer 2012-13

David C. Paton & Colin P. Bailey

**School of Earth and Environmental Sciences
University of Adelaide
Adelaide**

June 2013

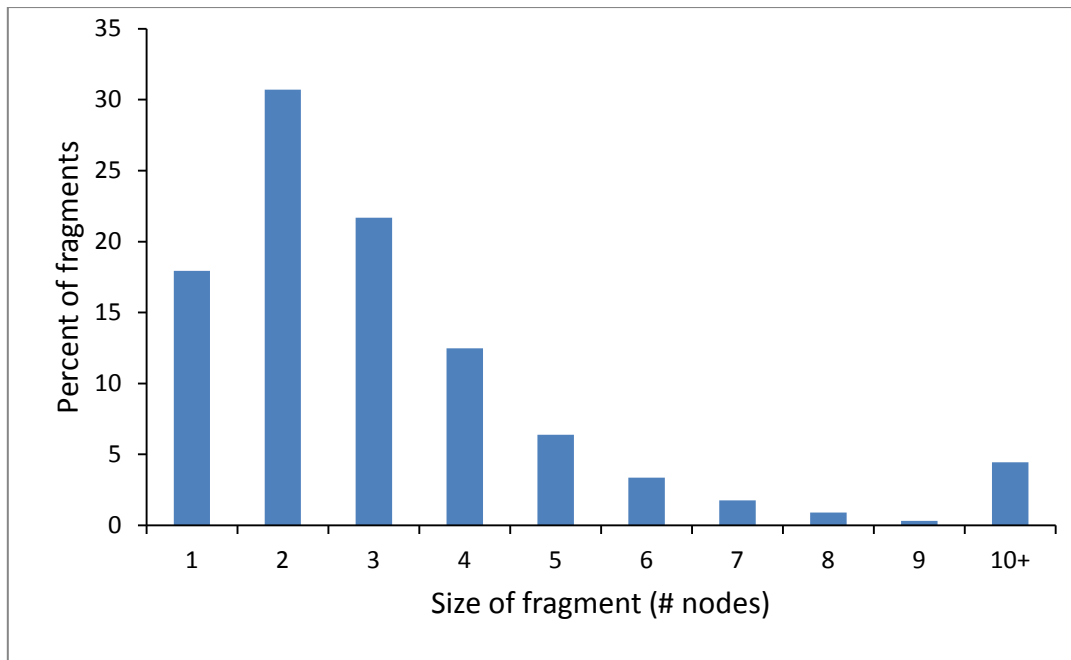
Figure 2. Frequency of different sized fragments of *Ruppia tuberosa* plants washed to shore along the eastern side of the southern Coorong. Size of fragments was determined by the number of nodes producing leaf shoots along a segment of stolon. Data based on scoring 5,789 fragments.

Small fragments of *Ruppia tuberosa* were being washed ashore along the length of the South Lagoon. The fragment lengths were typically around 3-4 nodes in length (measured as the number of leaf shoots (nodes) along a section of stolon (stem giving rise to roots and shoots; Fig. 2). The numbers of fragments washed ashore varied within and between sites in part reflecting changes in local topography and the direction of wave movement relative to the section of shoreline being measured (Fig. 3). The variation between transects at a site is shown by the large standard errors at many locations shown in Figure 3. However, there was a tendency for the amount of material to be higher near areas with higher abundances of *Ruppia* (e.g. S33, S34; Fig. 3). All sections of shoreline that were surveyed had filamentous green algae being washed ashore as well, and many of the *Ruppia tuberosa* fragments had filamentous algae attached to them if not entangling them.

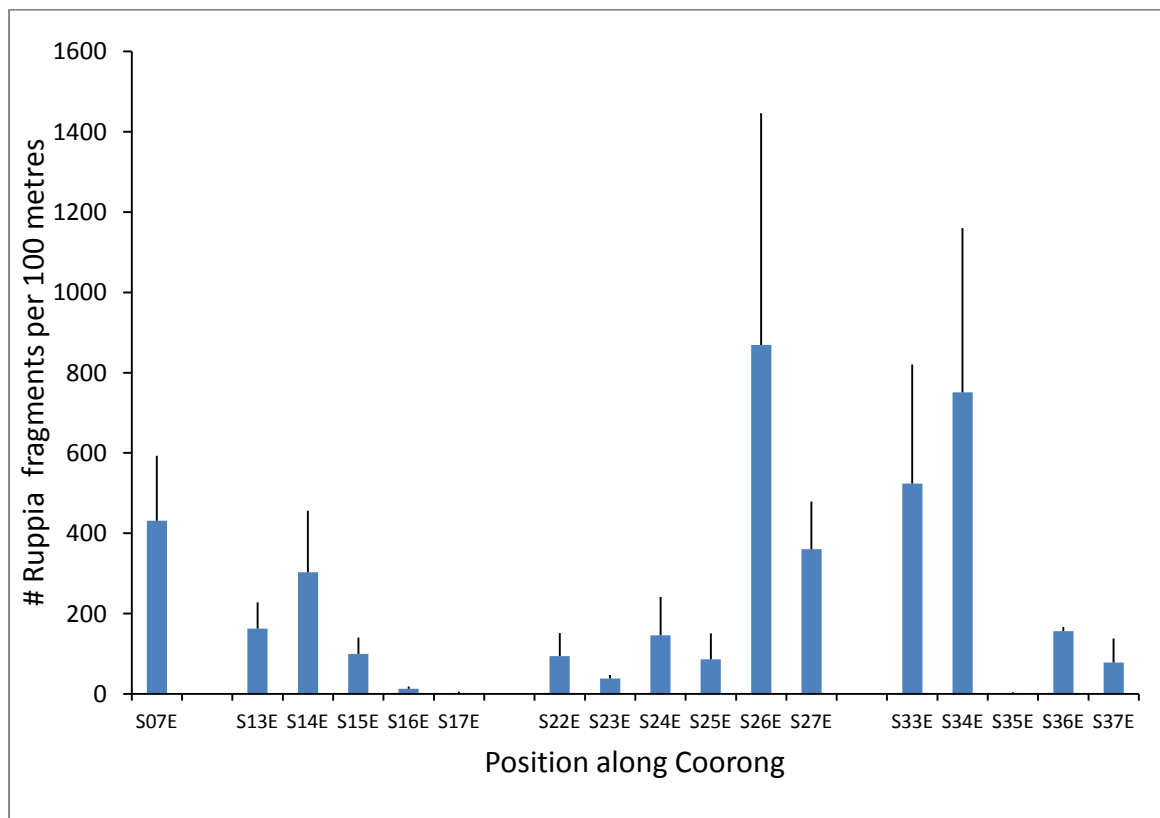
Figure 3. Abundances of small fragments of *Ruppia tuberosa* (# fragments/100 m) washed ashore along the eastern side of the Coorong. Locations are defined by the lagoon (S = South Lagoon), distance (km) S from the junction of the two lagoons, and E for the eastern shore. Data are means + s.e. for three replicate 50m transects at each site. Note for S07E the transect length was 20m.

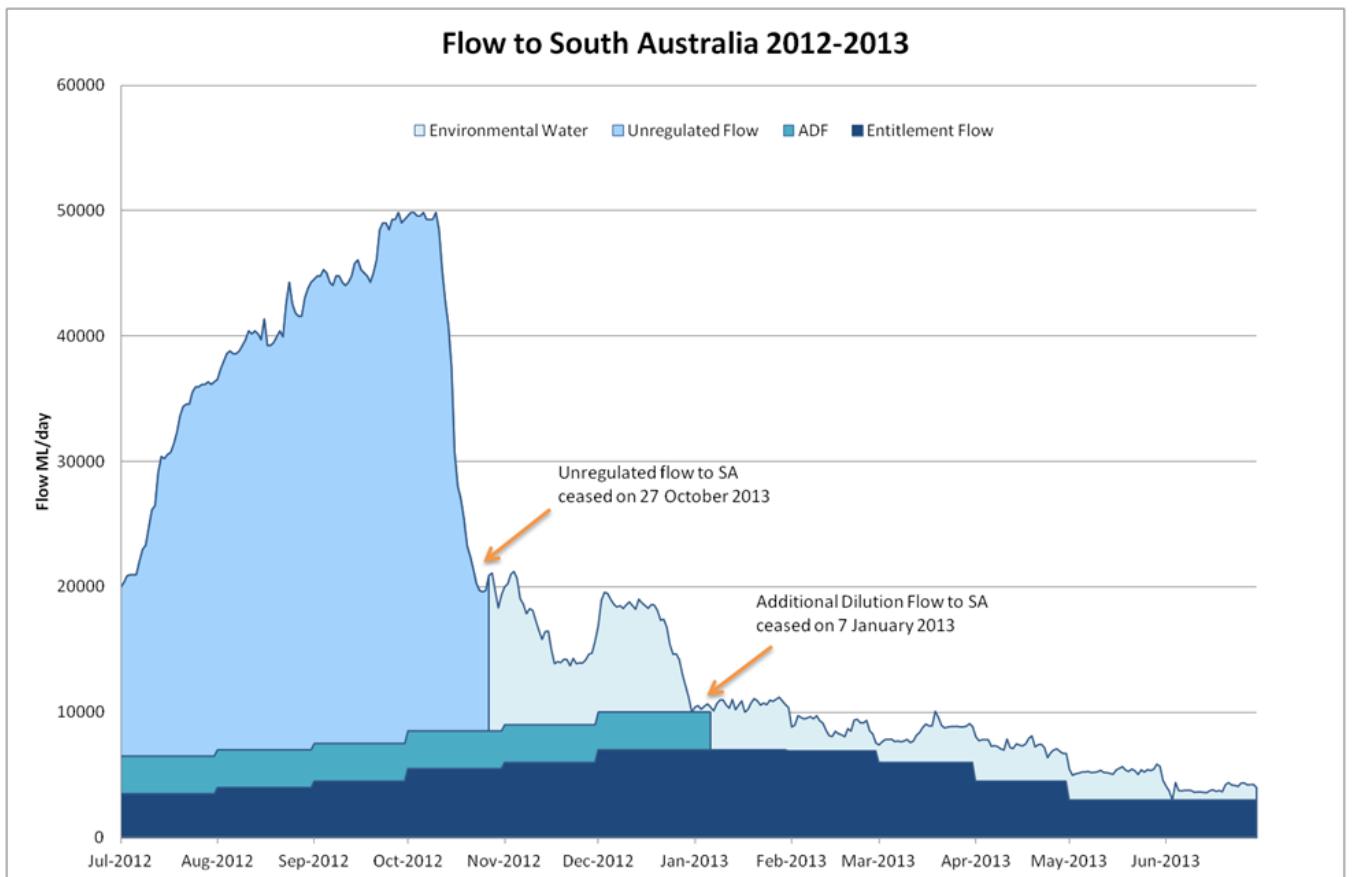
Appendix 1. Daily flows of water to South Australia along the Murray River during 2012-13, indicating the sources of water and seasonal patterns of flow. Figure provided by Adrienne Frears (DEWNR)
