# Vegetation, Flora, Fauna and Environmental Considerations, and Targeted Flora Report

Shire of Esperance Strategic Purpose Permit 2021/22  
Site B – Cascade Road Bend

February 2021

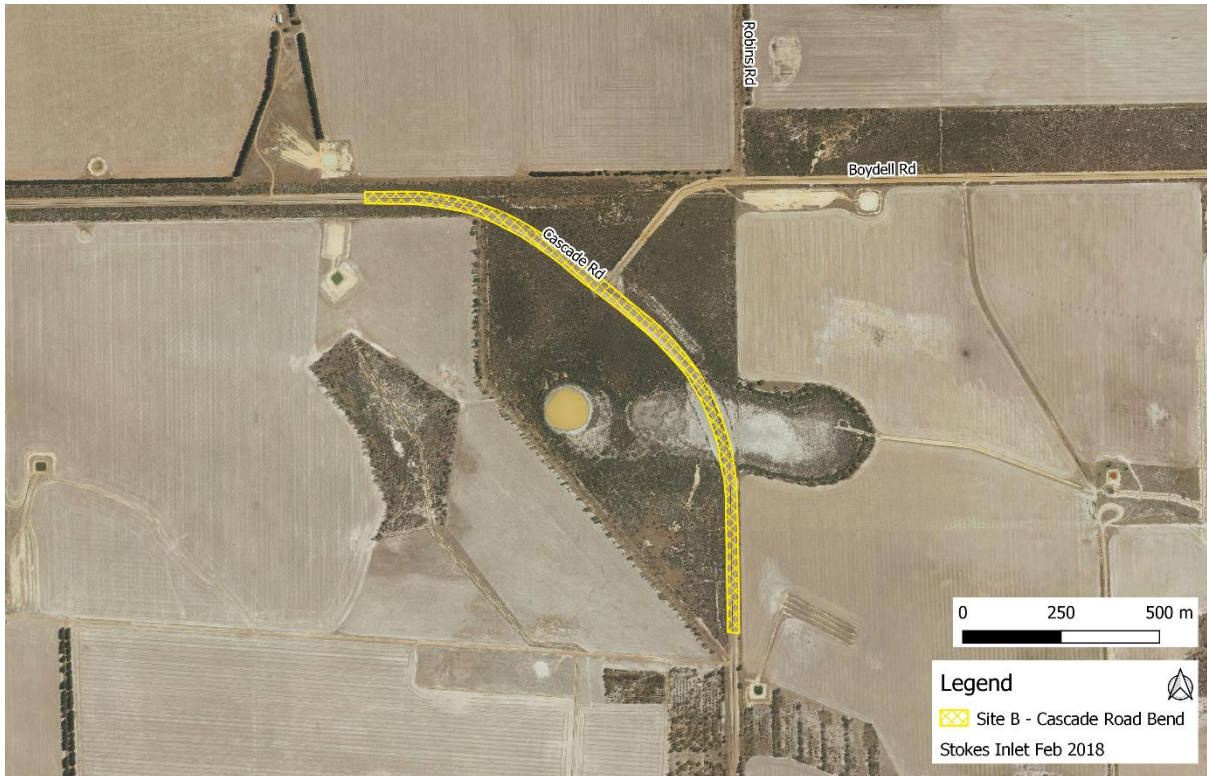
**Figure 1.** Location of proposed 'Site B - Cascade Road Bend', map depicting area of vegetation clearance.

The Shire of Esperance endeavors to maintain a high level of road safety, being proactive in identifying high risk road designs and progressively upgrading them. The Shire of Esperance manages the largest road network of any local government in Western Australia, encompassing a total of 4 593 km of road. The Shire of Esperance is submitting 'Site B – Cascade Road Bend' project as Site B under the '2022 Strategic Purpose Permit' (Figure 1).

To complete these works, native vegetation up to 4.5m from the current road footprint on both sides of the road is required to be cleared, increasing the active road footprint to 21m. The road footprint is already at a width of 21m at most points except along the salt lake present within the project area. The project constitutes clearing 0.125ha of native vegetation. To mitigate impact of clearing vegetation, where feasible clearing will not occur to the full permitted width, conserving vegetation.

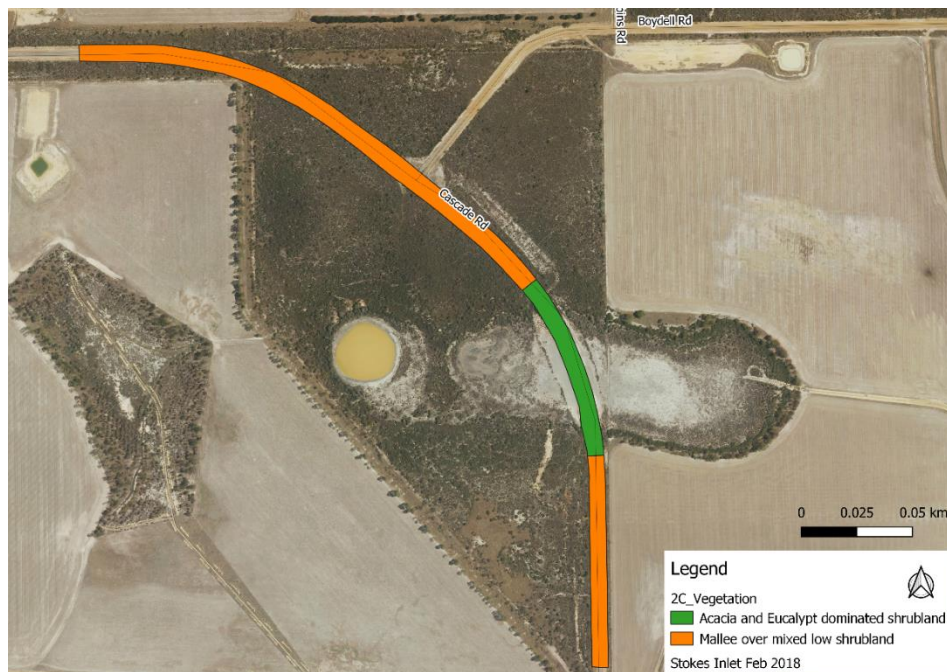
**Figure 2.** Vegetation types within the 'Site B – Cascade Road Bend' area, from SLK 12.95 km to 14.67 along Cascade Road.

Two vegetation communities were identified within the 'Site B – Cascade Road Bend', as defined by structure and composition (Table 2). The incidental flora list identified a total of 135 native species and 9 weeds across all vegetation communities. It is believed that the Beard (1973) vegetation associations identified in Section 3.7 are an appropriate match for one of the vegetation types observed. The other vegetation type was not mapped by Beard.

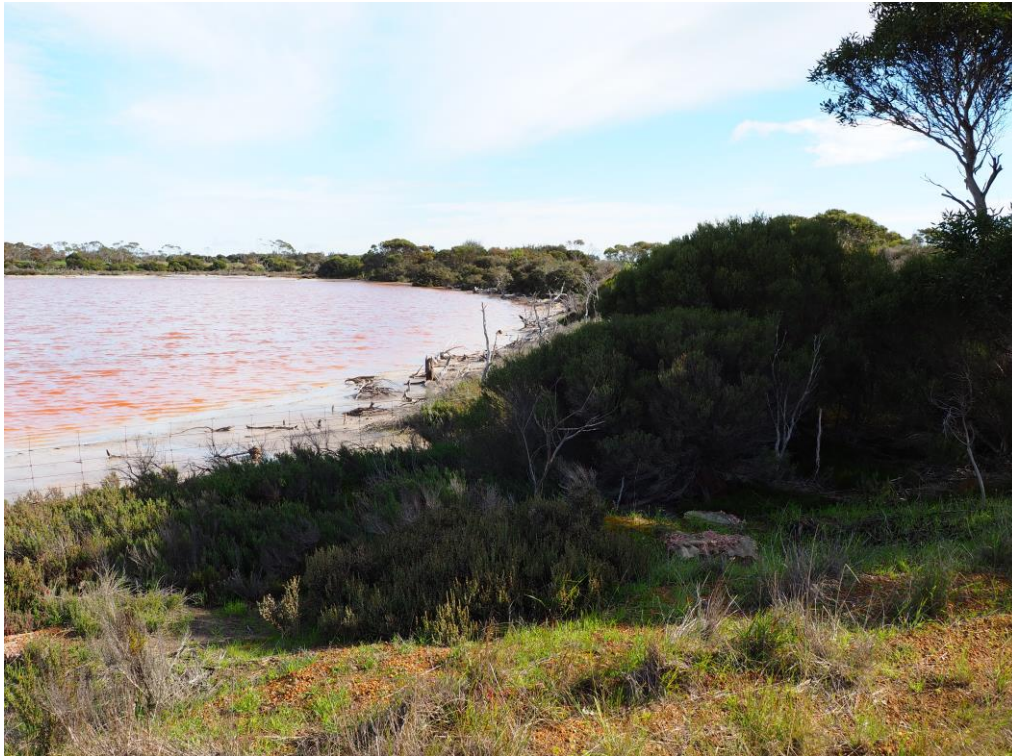
**Figure 3.** Vegetation type A identified in 'Site B – Cascade Road Bend' project, described as '*Melaleuca brevifolia* and *M. cuticularis* dominated salt lake fringe with *Eucalypts angulosa* and *Acacia cyclops*.'

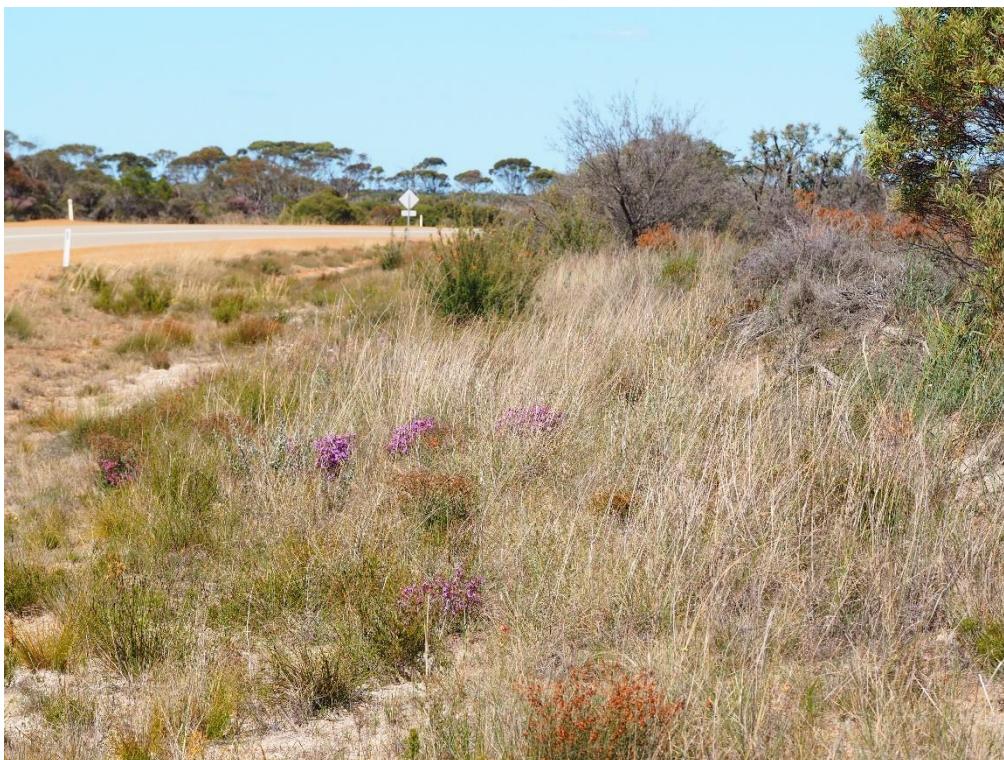
**Figure 4.** Vegetation type B identified in 'Site B – Cascade Road Bend' project, described as 'Scattered Mallee over mixed proteaceous dominated shrubland with Fabaceae and Goodeniaceae shrubs.'

Vegetation type B described as 'Scattered Mallee over mixed proteaceous dominated shrubland with Fabaceae and Goodeniaceae shrubs' met the criteria to be considered as Kwongkan TEC. The presence of Kwongkan TEC was considered when selecting the road profile and the areas with Kwongkan TEC were currently wide enough to meet the road requirements. No clearing of Kwongkan TEC will occur.

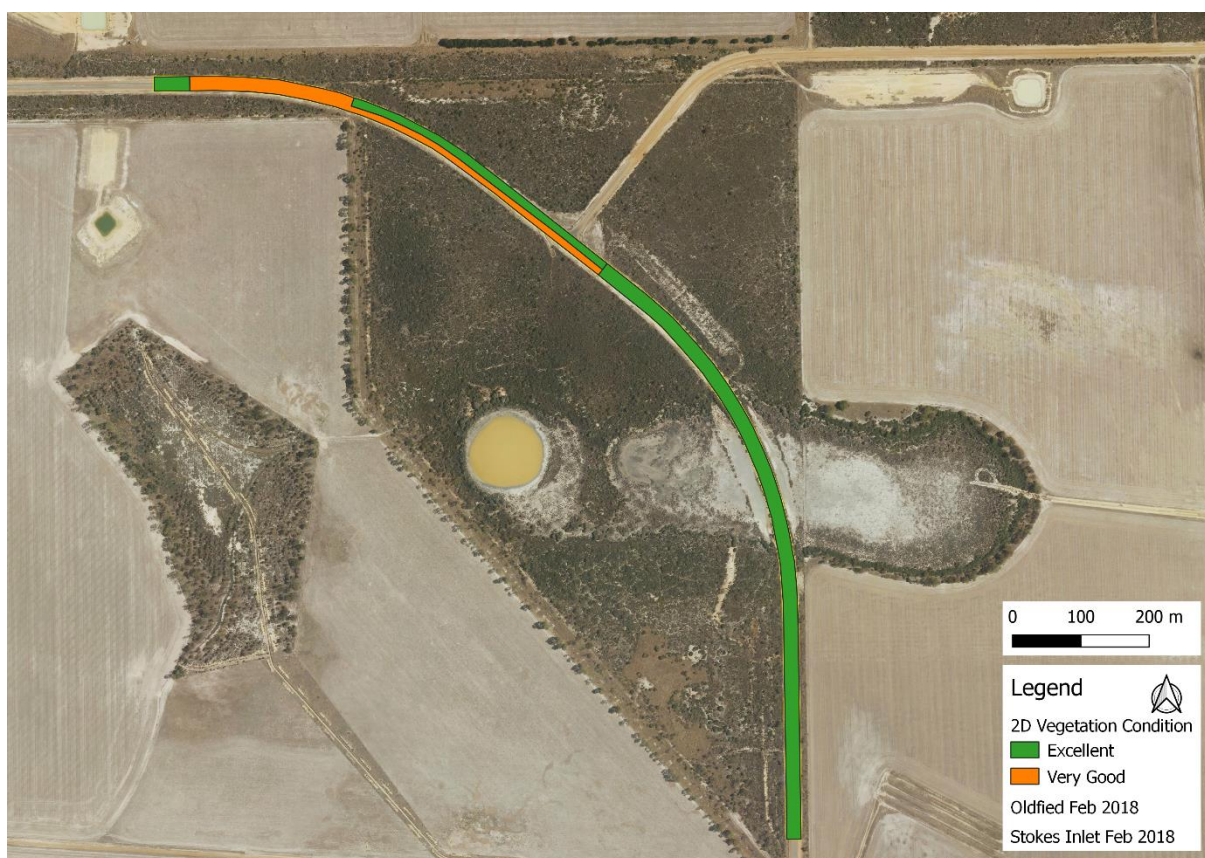
**Figure 7.** Vegetation condition across 'Site B – Cascade Road Bend' project, ranging from Very Good to Excellent condition, due to primarily to degradation from weed invasion.

The majority of the site was on Excellent or very good condition. Previous road work and some minor weed infestation were degrading factors. There was no evidence of any fires in the area. There was minimal weed invasion across the entirety of the proposed 'Site B – Cascade Road Bend' area. Overall, nine invasive species were identified within the project area (Appendix 8.1). Of these, the serious concern were Bridal Creeper, veldt grass and Victorian tea tree. The biological control bridal creeper rust fungus was spread at the site in winter 2021. It is highly likely that proposed works will increase the distribution of weeds and degrade vegetation along the entire road reserve where works occur. Ideally, regular wash downs during the course of works to remove weed seeds or follow up herbicide control of invasive species needs to occur. However, this will be extremely expensive to employ contractors and mobilise equipment, which may not be feasible with given budgets. The area to be cleared (0.125ha) was all in excellent condition.

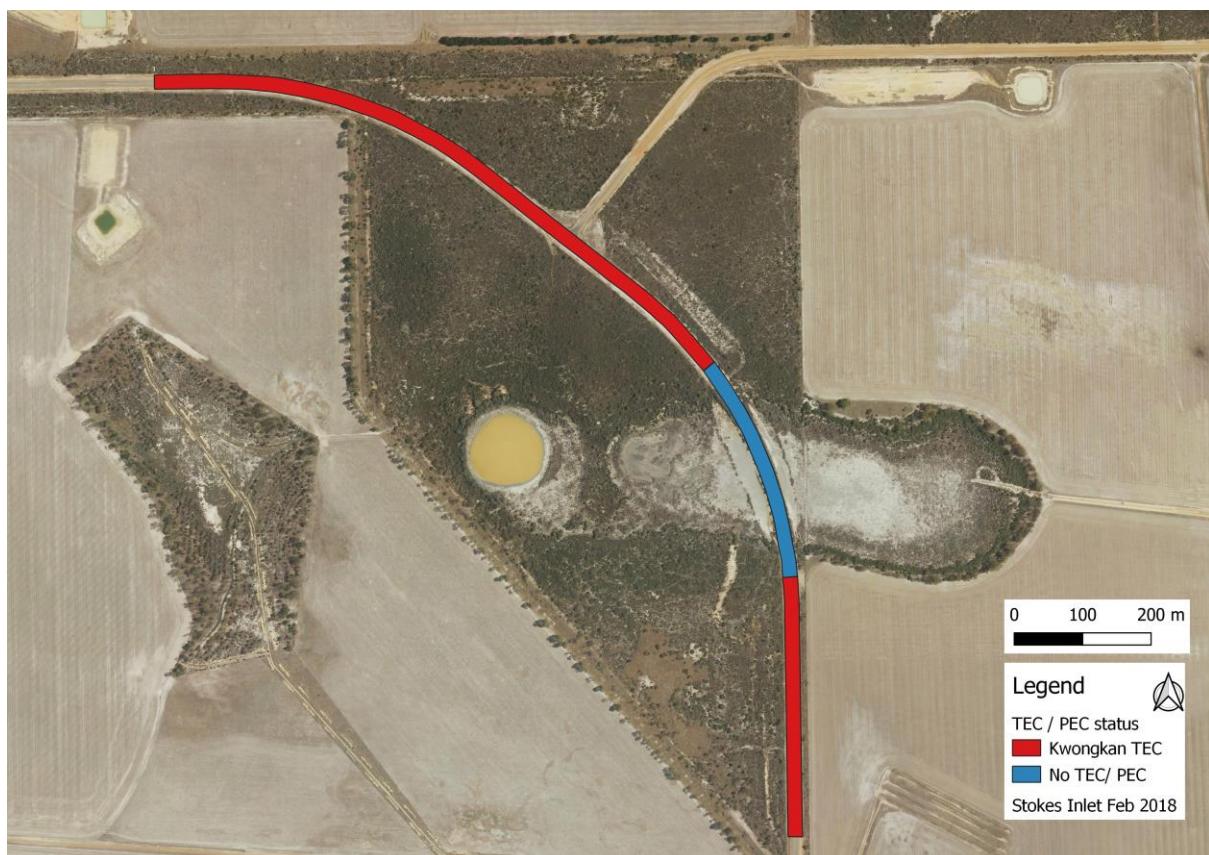
**Figure 8.** Vegetation type B in very good or excellent condition met threatened ecological community (TEC) 'Proteaceae Dominated Kwongkan Shrublands of the Southeast Coastal Floristic Province of Western Australia (Kwongkan)' within 'Site B – Cascade Road Bend' project.
