Collision between two Formula 4 powerboats resulting in serious injury to one driver at Stewartby Lake on 2 July 2017

SUMMARY

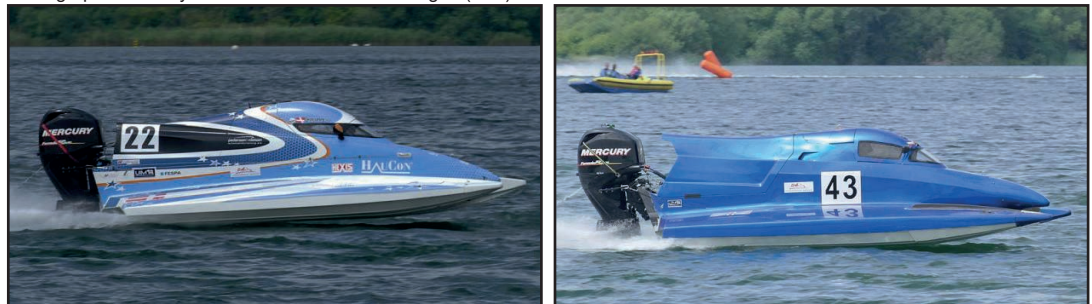
Figure 1: F4 Powerboats – *Boat 22* and *Boat 43*

On 2 July 2017, two Formula 4 (F4) powerboats (*Boat 22* and *Boat 43*) (**Figure 1**) collided at full speed while rounding a marker buoy during a world championship race at Stewartby Lake, Bedfordshire. *Boat 43* flipped over and its driver, unable to free himself from its flooded cockpit, lost consciousness and stopped breathing. The driver was released from the cockpit within about 5 minutes and was revived by the medical team on board one of the race circuit’s safety boats. He was taken to hospital for treatment and subsequently made a full recovery. *Boat 22* suffered hull damage and started to flood, but its driver was rescued unhurt.

The collision occurred because *Boat 22* veered suddenly and without warning into the path of *Boat 43* and the drivers had no time to react. The drag caused by the loss of a panel from *Boat 22*’s port hull was identified as the most likely cause of the powerboat’s unexpected change of direction. *Boat 43*’s driver almost drowned because he was unable to free himself, or be extracted from the cockpit, before his emergency air supply ran out.

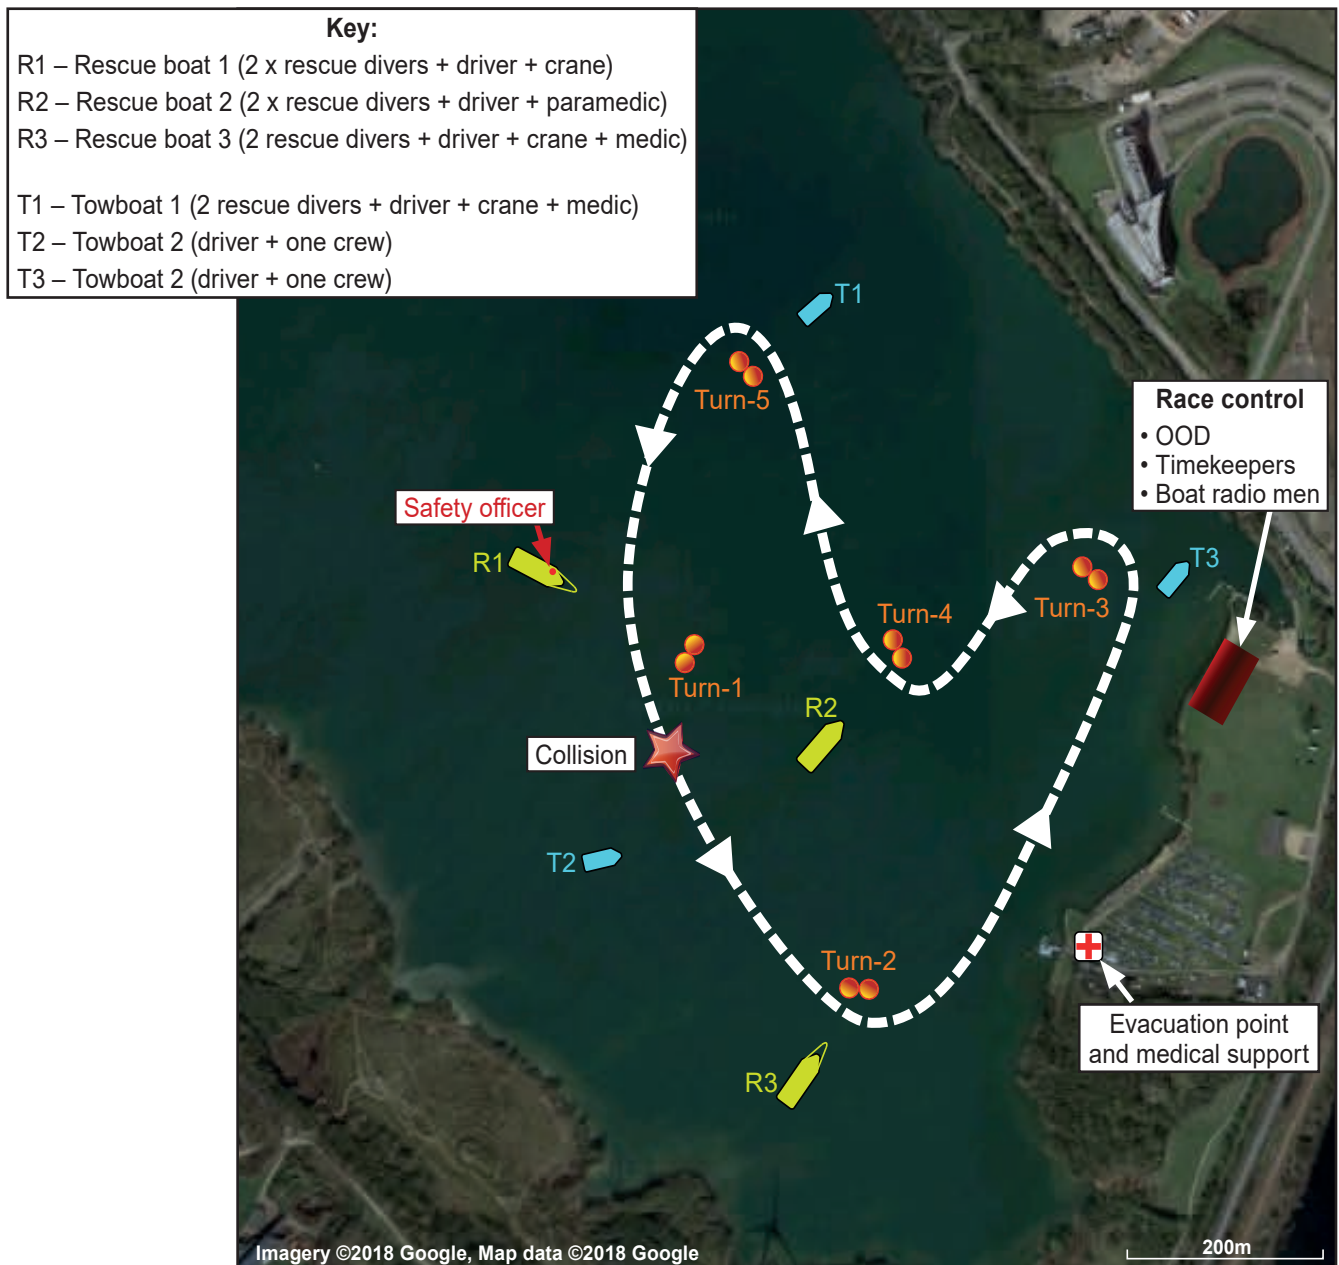
Figure 2: F4 course at Stewartby Lake

On the afternoon of 2 July, the environmental conditions were within the limits set for F4 racing; there was a gentle north-westerly breeze and the lake was calm with small ripples on the surface. The F4 powerboat course followed a 1.43km route around five sets of marker buoys (**Figure 2**).

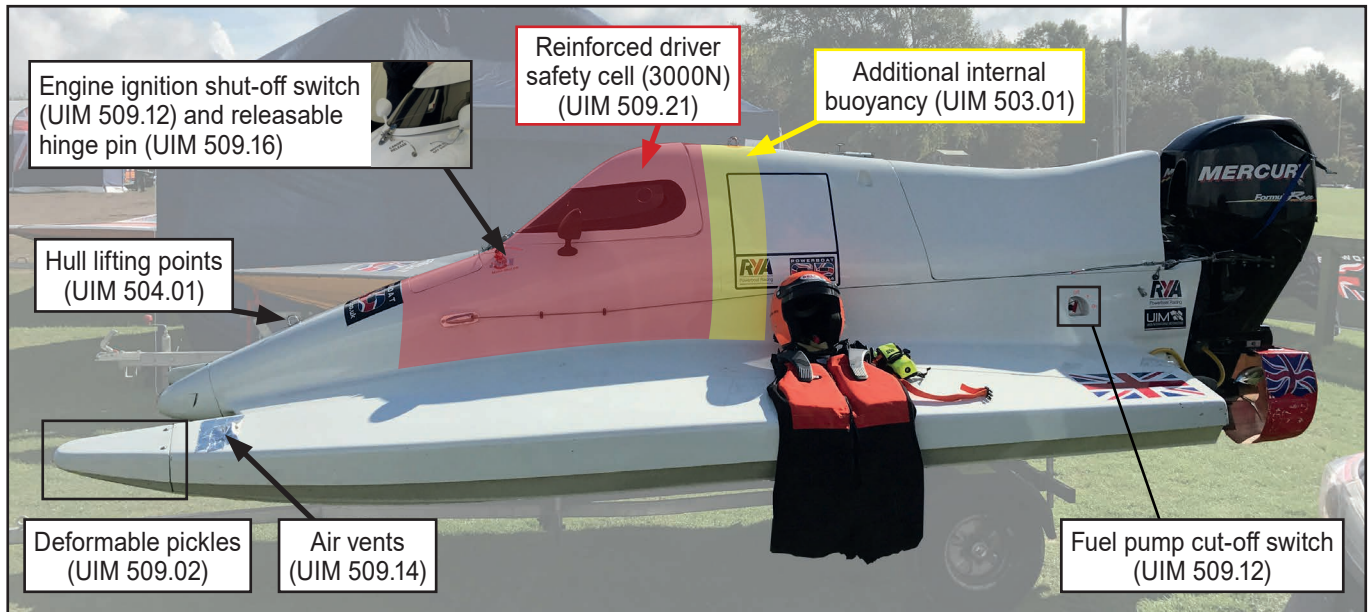
Figure 7: Overview of F4 powerboat safety features

UIM circuit rules required F4 boats to be built with several safety features designed to protect the driver in the event of an accident (**Figure 7**). The drivers had to be seated within an enclosed cockpit that was encased within a safety cell built to withstand an impact of 3000N⁶. Deformable hull and nose cones were required at the bow to help absorb the shock of impact without compromising watertight integrity. Additionally, if flooded or capsized, the hull had to remain afloat with its nose up. This was to allow rescue teams to attach either a flotation bag or crane hook to the boat's bow and lift its cockpit and driver clear of the water.
