River Barle, Dulverton, Somerset

An Advisory Visit by the Wild Trout Trust August 2016

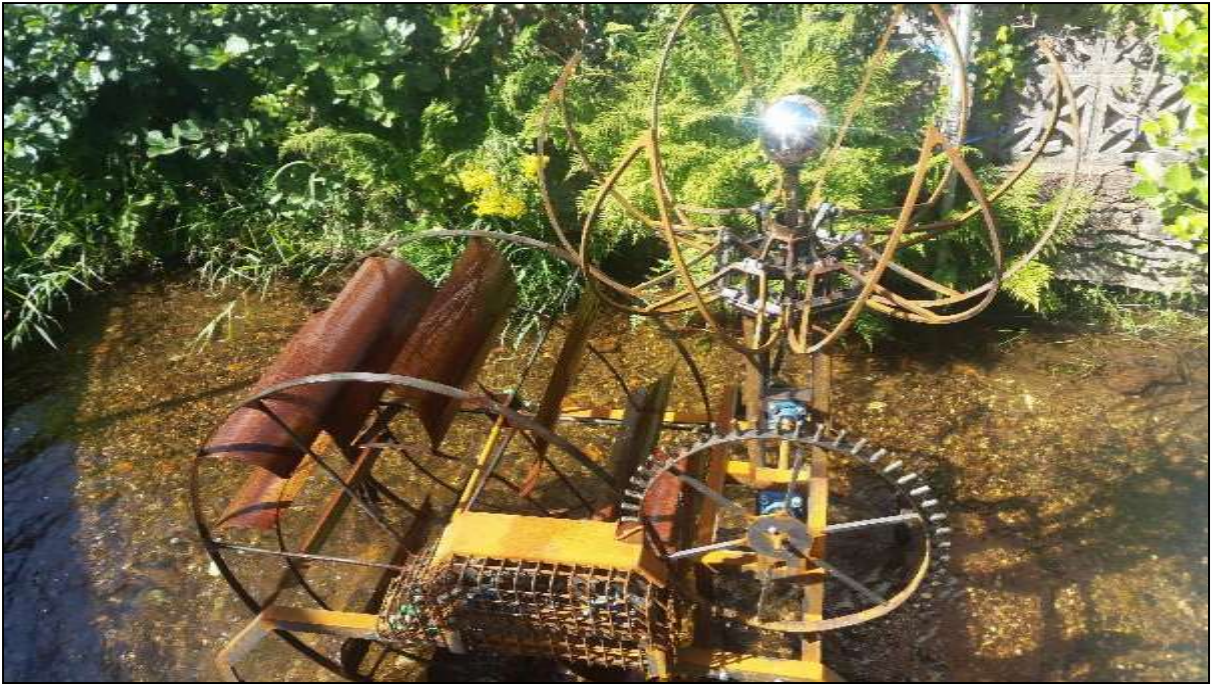
A short distance upstream the river flows under Bridge Street. In an effort to raise the profile of the mill leat with the local community and tourists, DWLCT was displaying a piece of kinetic sculpture artwork in the channel (Figure 6). The sculpture, consisting of a functional water wheel which as it turns drives a mechanical flower to slowly open and close, depicts both the industrial and natural heritage of the leat channel. It was encouraging to see that although the mill leat was originally created for purely industrial purposes, the DWLCT recognises the fact that it is nonetheless a living ecosystem and a habitat for wildlife. Reconciling these two potentially disparate components of the leat will be a complex and difficult, though ultimately rewarding challenge.

Figure 6: A temporary kinetic sculpture installation portrays both the industrial and natural heritage of the leat

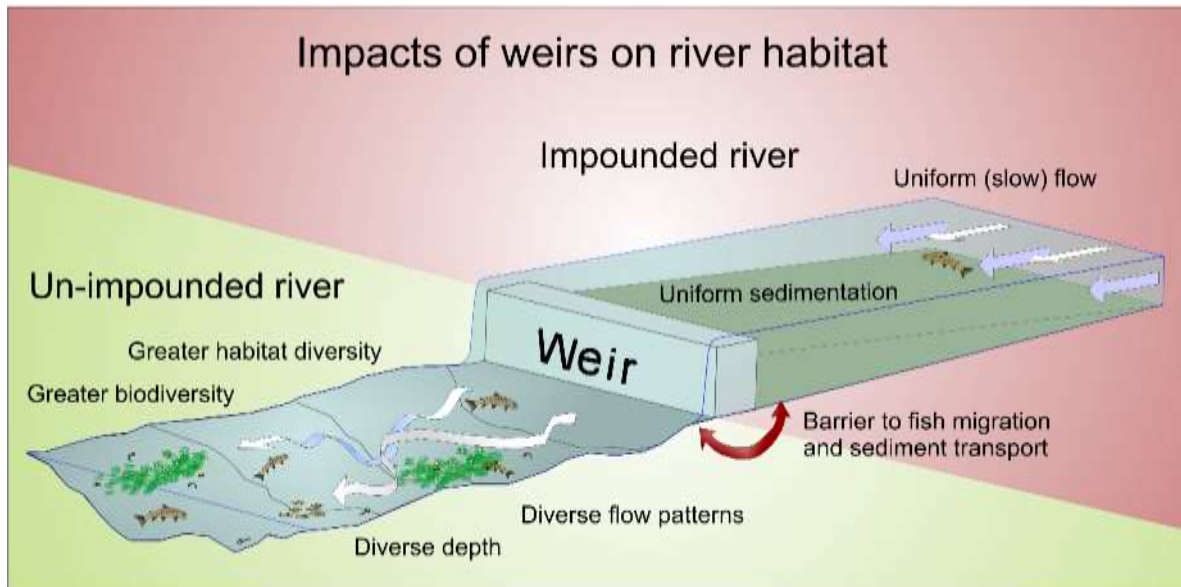
The weir itself causes a significant impounding effect on flow upstream for some distance and also interrupts natural sediment transport. This has increased habitat uniformity upstream (suppressing biodiversity) and the interruption of sediment supply to downstream reaches maybe affecting bank stability downstream (Figures 22 and 23). Impounded reaches also create easy hunting grounds for predators (particularly piscivorous birds) which can have significant impact upon the mortality of downstream migrating juvenile fish. Fish trapped below weirs are also more susceptible to stress and damage (as they attempt to ascend a weir) and are easy targets for predators.

Figure 22: An illustration showing the impacts of weirs on habitat

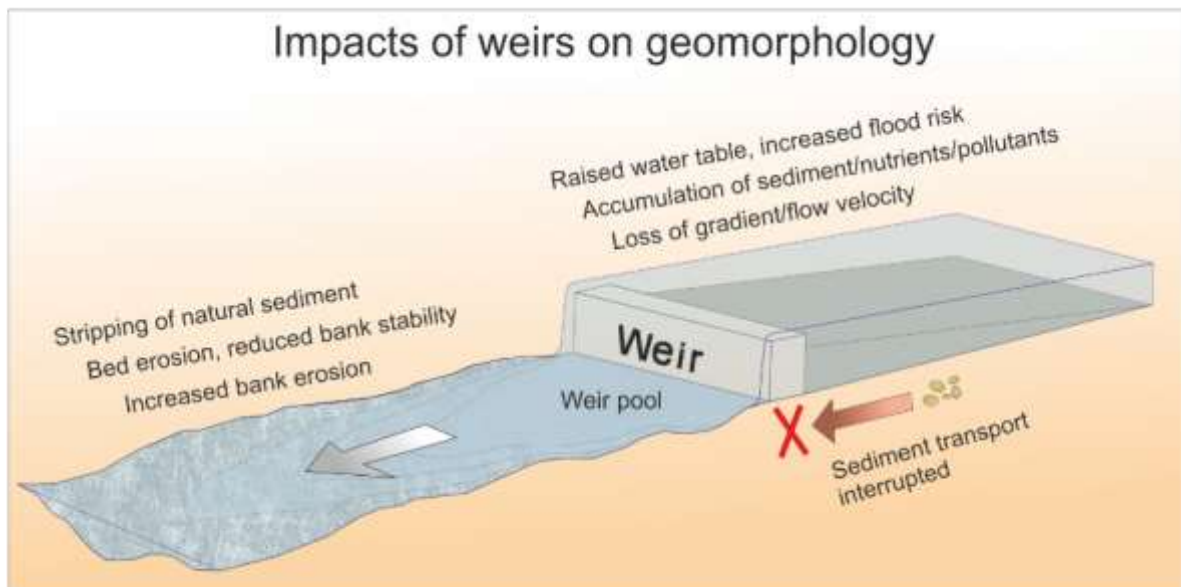
Figure 23: An illustration showing the impacts of weirs on geomorphology

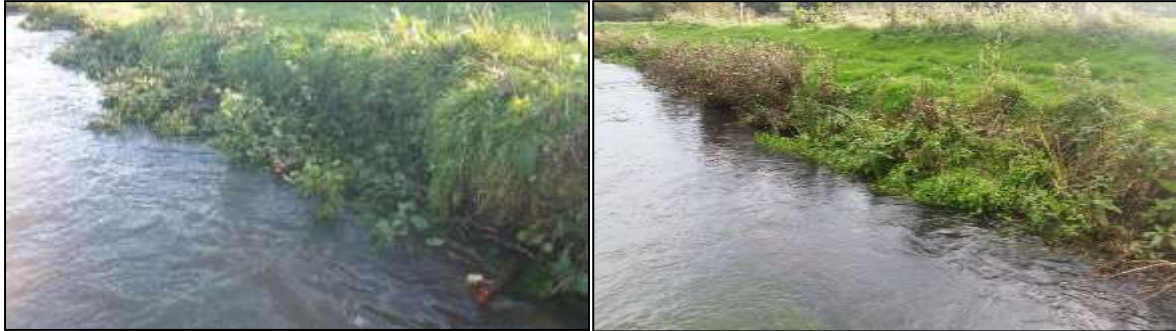
Figure 24: A marginal brushwood shelf immediately after installation (left) and after one year (right)

1. Replace the toe board shuttering along the public footpath between Lady Street and the Heritage Centre with a soft-engineered and diverse margin of true marginal wetland plant species. There are a number of techniques that could be employed to achieve this and a number of specialist soft-engineering/river restoration companies that can supply and install such features. Perhaps the most cost-effective option is to make use of locally-won brushwood arising from 'skylighting' tree works to create a narrow brushwood shelf (Figure 24 and as described on page 13). These features act as silt traps, slowing flow through them and encouraging fine sediment to drop out of suspension. Given sufficient time and afforded sufficient sunlight, the silt-laden brushwood will

become colonised with marginal plant species. However, considering that the seed bank within the sediment is quite likely to contain Himalayan balsam, it may be prudent to plant up the structures with desirable plant species. These can either be translocated from riverbanks nearby or purchased from reputable suppliers.

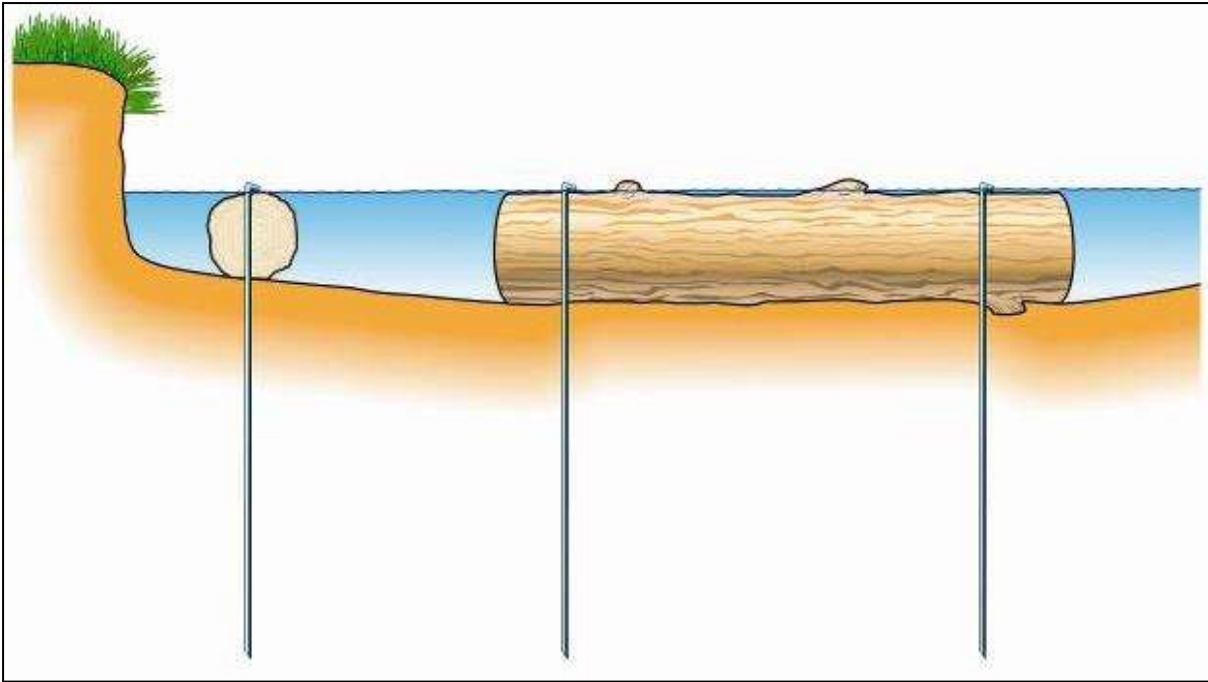
Figure 25: An illustration showing logs 'pinned' to the bed with reinforcing bar (rebar) driven through drilled holes

2. Consider installing a number of low-level, log flow deflectors in some of the more uniform reaches of the leat to help diversify flow conditions and locally mobilise gravel. This will provide a greater abundance and diversity of habitat for fish as well as help create patches of cleaned gravel where fine silt has been scoured away.

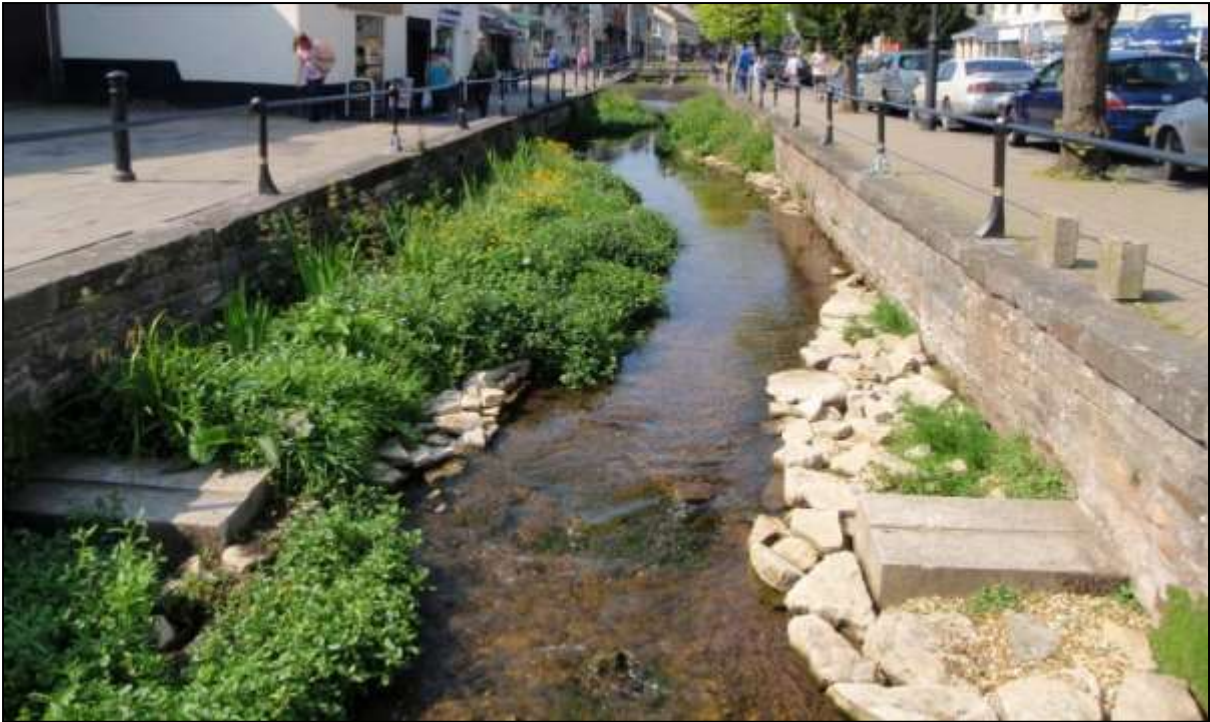
Figure 26: Planted stone berms in a hard-engineered channel in Midsomer Norton, Somerset

3. Where the bed of the leat is cobbled, armoured or otherwise too hard to penetrate with stakes or rebar, consider improving marginal habitat by introducing stone berms back-filled with gravel and soil. This technique has proved successful elsewhere in the county (Figure 26). Depending on the flow speeds and shear forces experienced in the leat during spate conditions, it may be prudent to fix every third or fourth stone to the bed by drilling into the stone, chemi-fixing a short section of threaded bar into the hole and then drilling another hole in the bed and placing the bar into it. This technique has been used in a concrete channel on a spate-prone section of the River Meon in Hampshire.

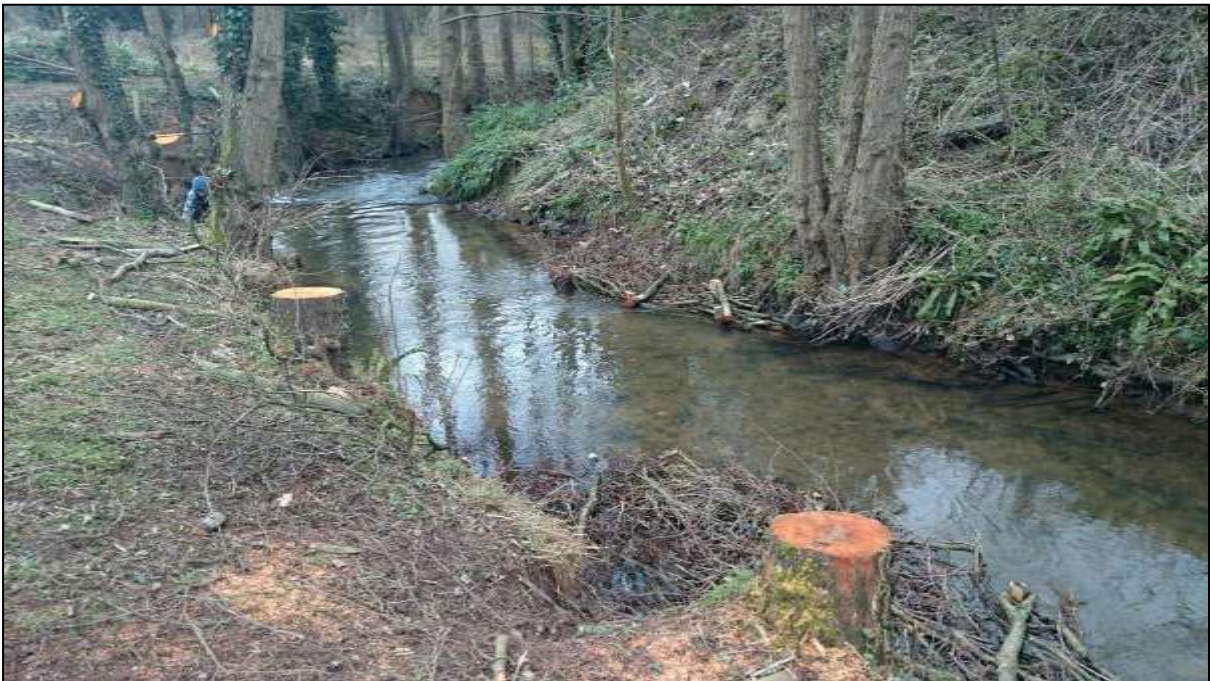
Figure 27: Small brushwood berms introduce flow diversity into a small stream

4. In some of the wider and straighter sections of the leat, consider creating some small brushwood berms to introduce some sinuosity and provide additional refuge habitat for fish and invertebrates as well as substrate for marginal plants.
